# TWA 800 Overview

Dr. Bernard S. Loeb

***National Transportation Safety Board***

Investigation Into Trans World Airlines Flight 800

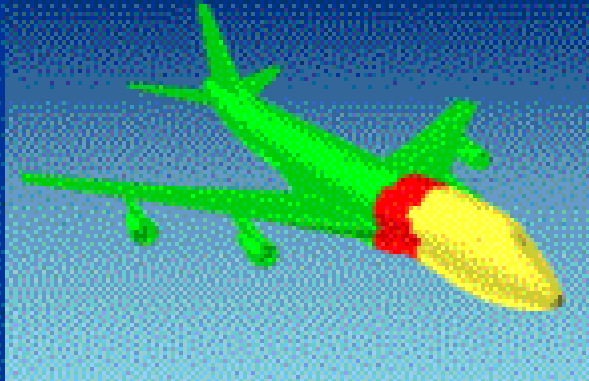
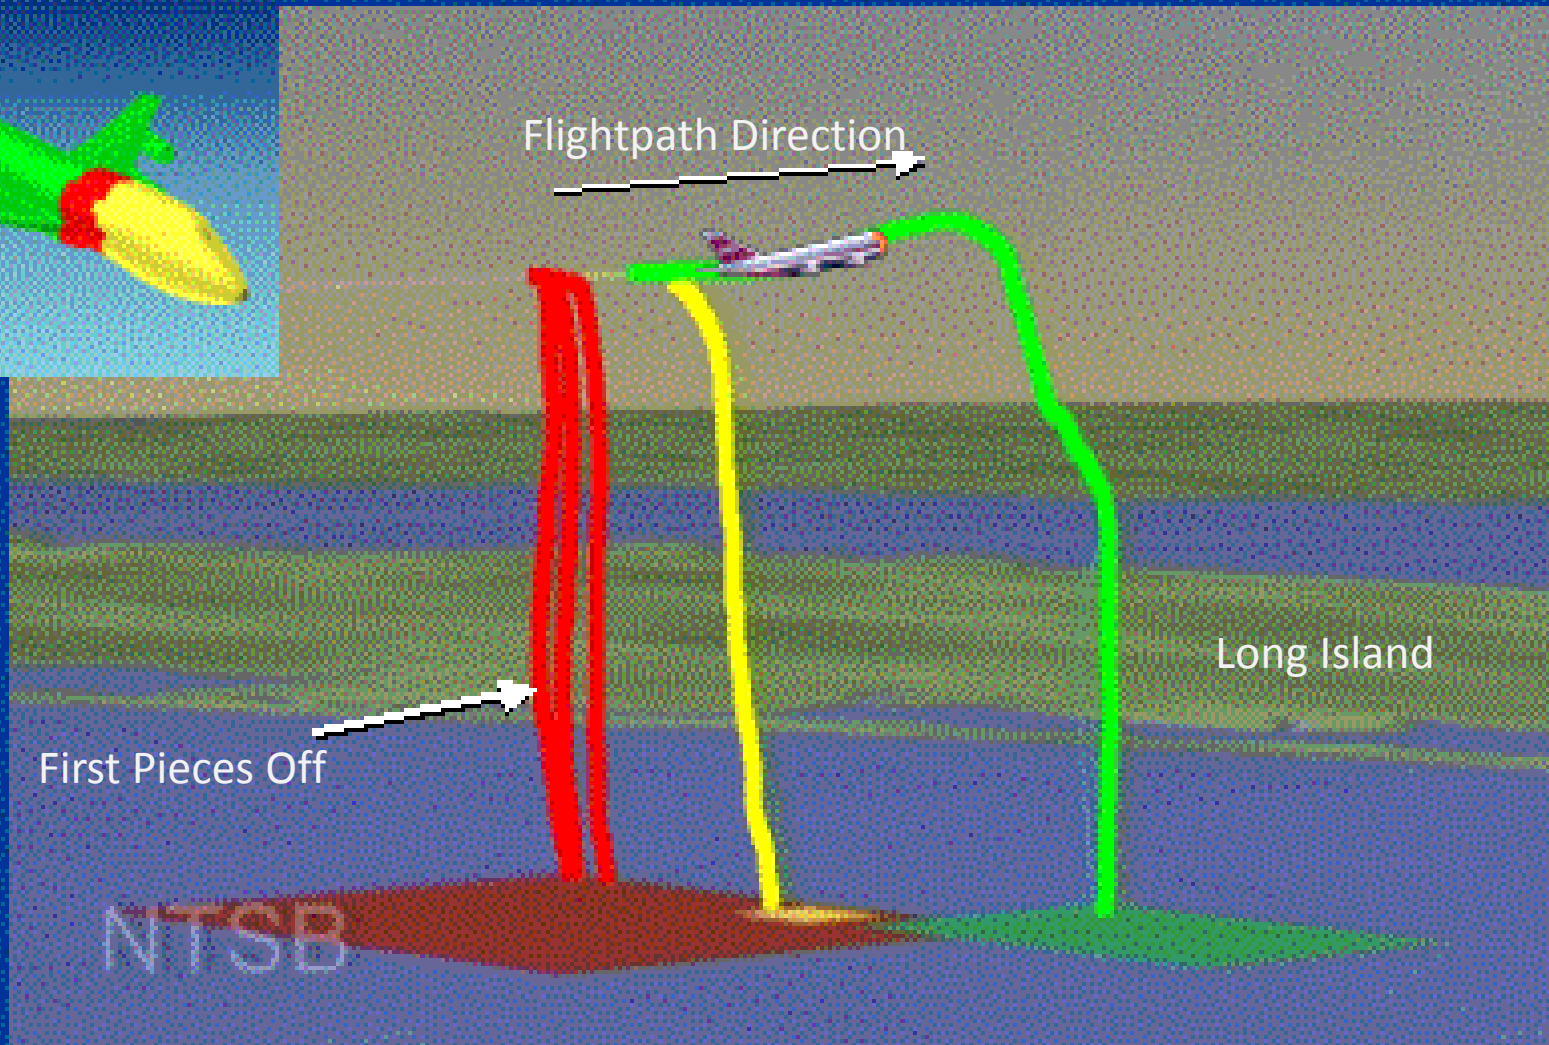
## Wreckage Dispersion: Red, Yellow, and Green Zones

- Radar data showing wide dispersion of primary returns after loss of transponder
- Wreckage recovery from green, yellow, and red zones

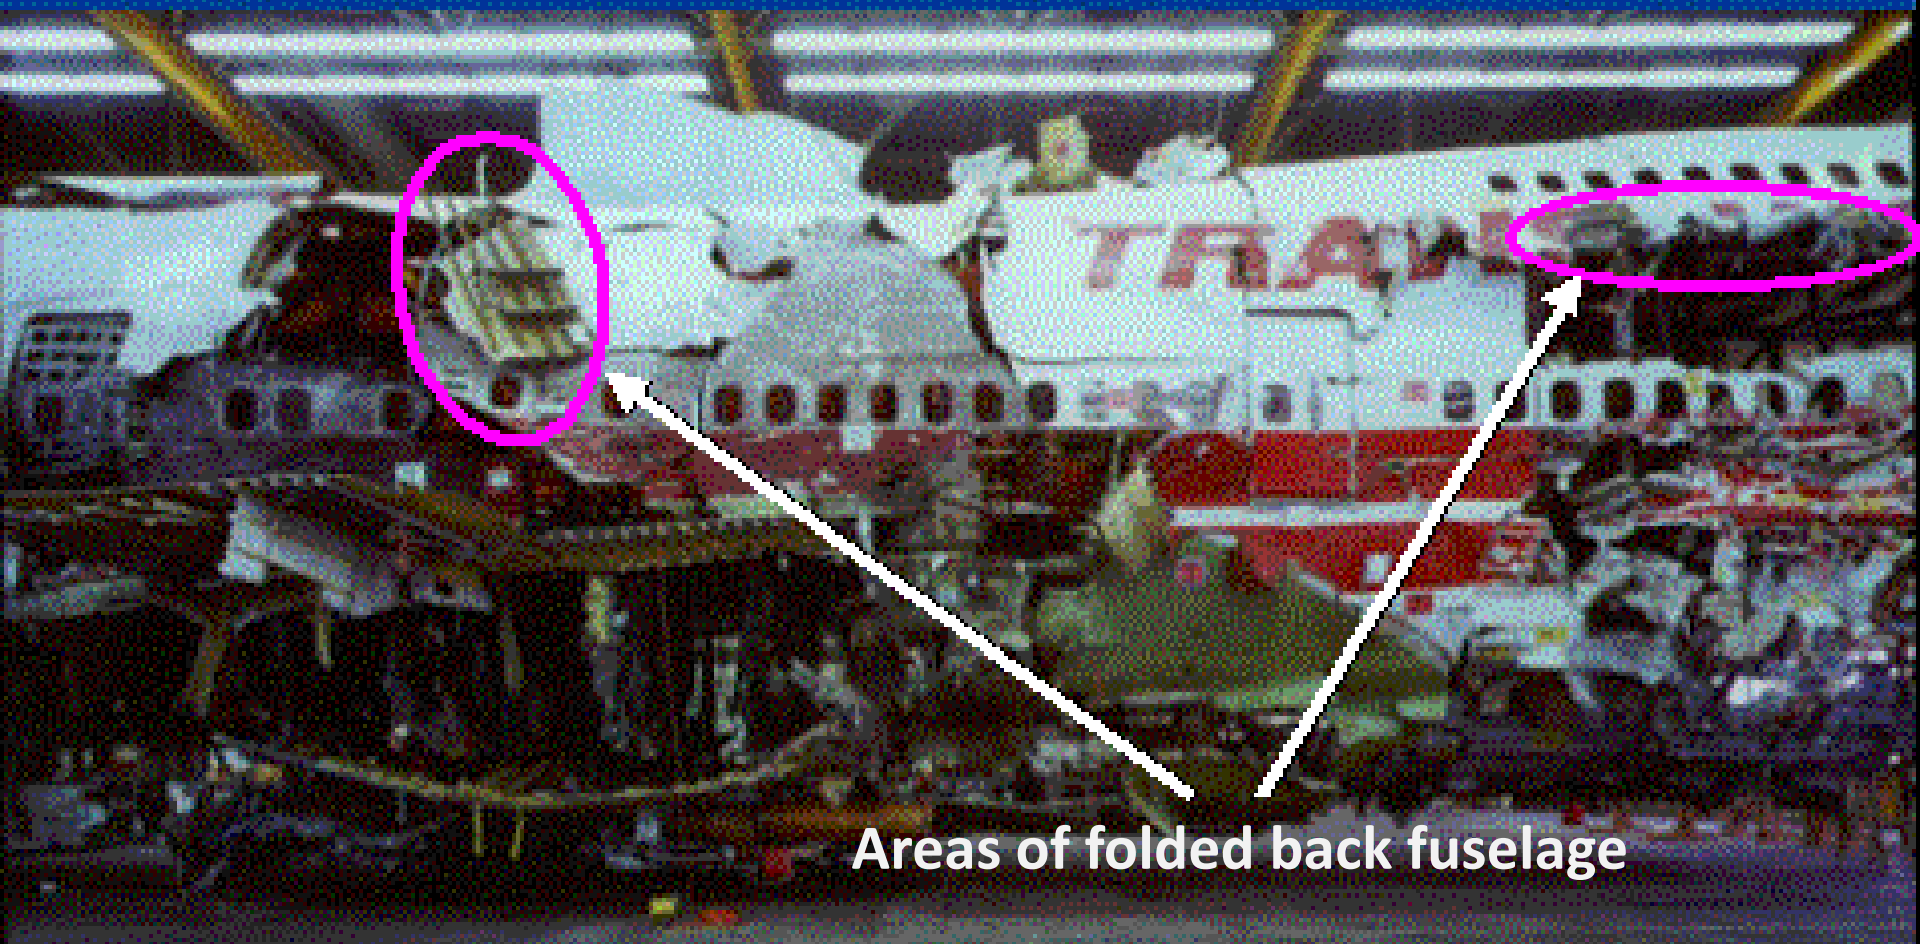
Reconstruction shows no evidence of large holes suggestive of missile penetration.

Areas of folded back fuselage

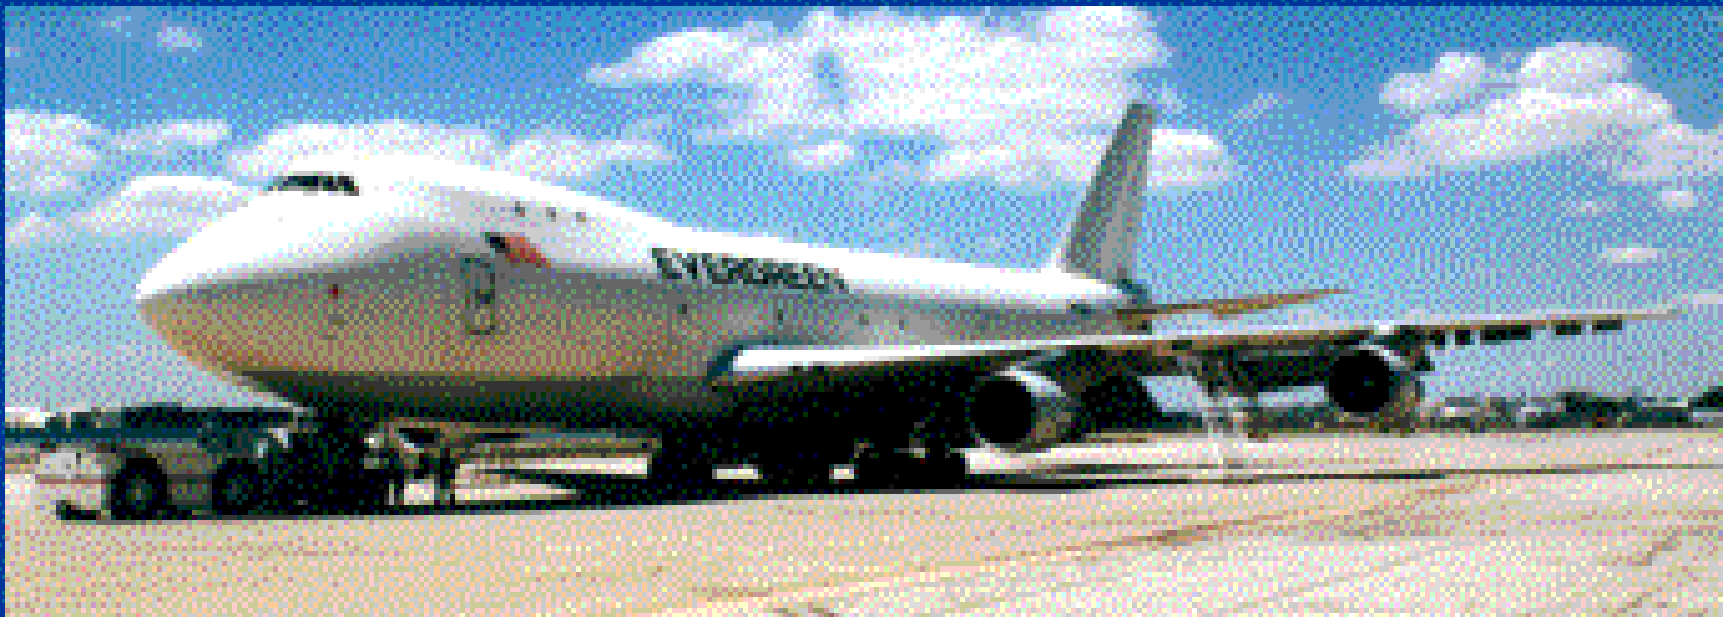
## **JFK FLIGHT TEST**

- Fuel/air vapor temperatures at the time of accident were 101° to 127° F
- Vapor could have ignited at 96° F
- Combustion pressures could exceed structural limitations of the center wing tank

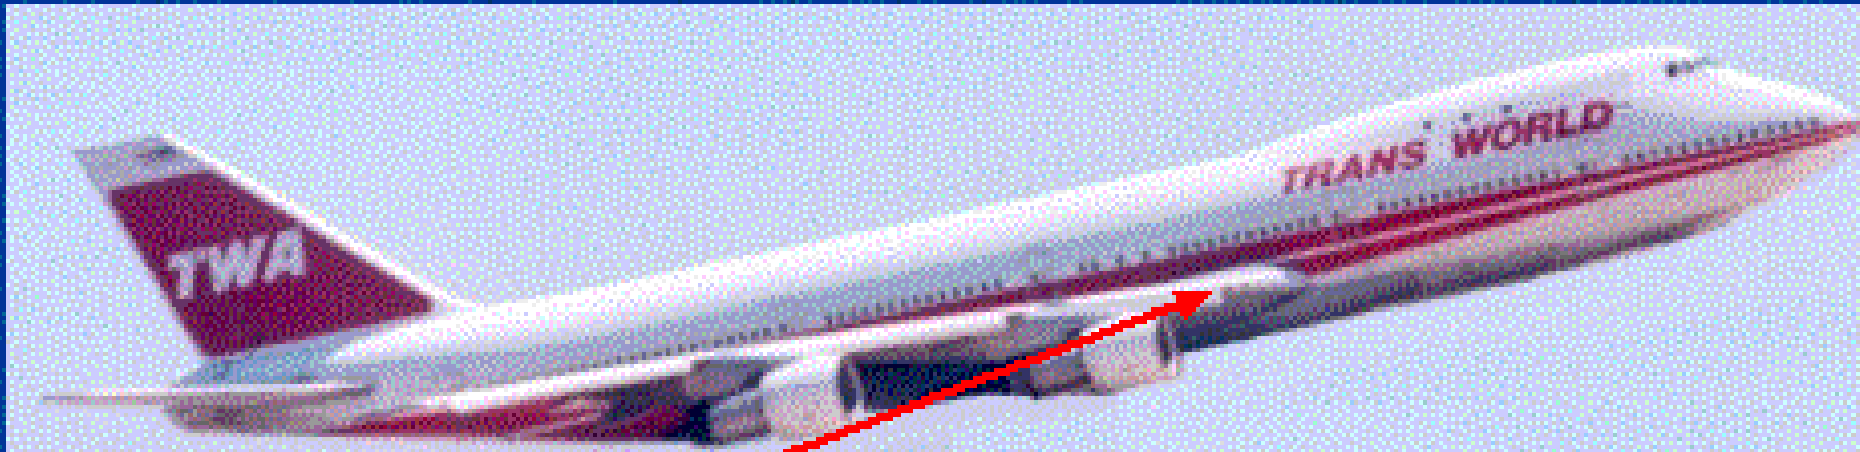
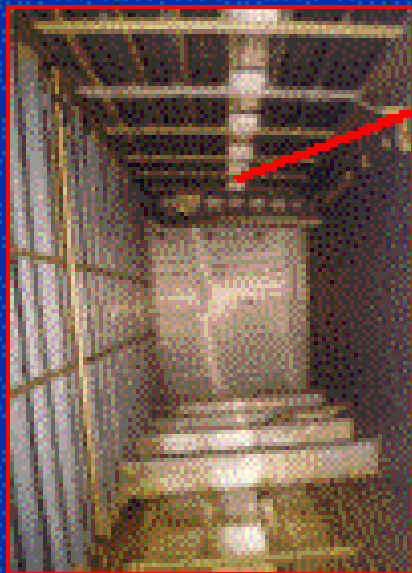
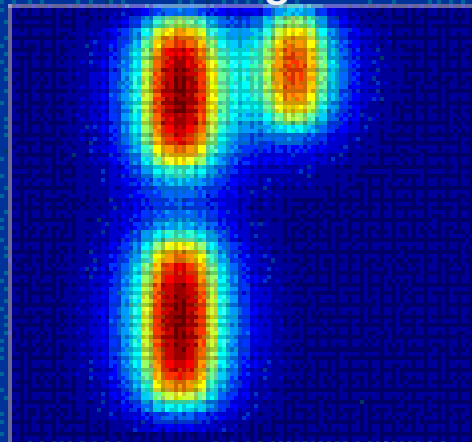
## Center Wing Tank Heating

Pack Heat Signature

- Preclude operation with explosive fuel/air mixtures in fuel tanks
- Consider long-term design modifications, such as fuel tank inerting
- Require short-term operational changes to reduce potential for flammable mixtures
