Accident Summary

- Cargo smoke warning during approach to PHL
- Smoke filled cockpit after landing
- Crew evacuated via slide at left forward (L1) door
- Major fire damage to airplane and cargo

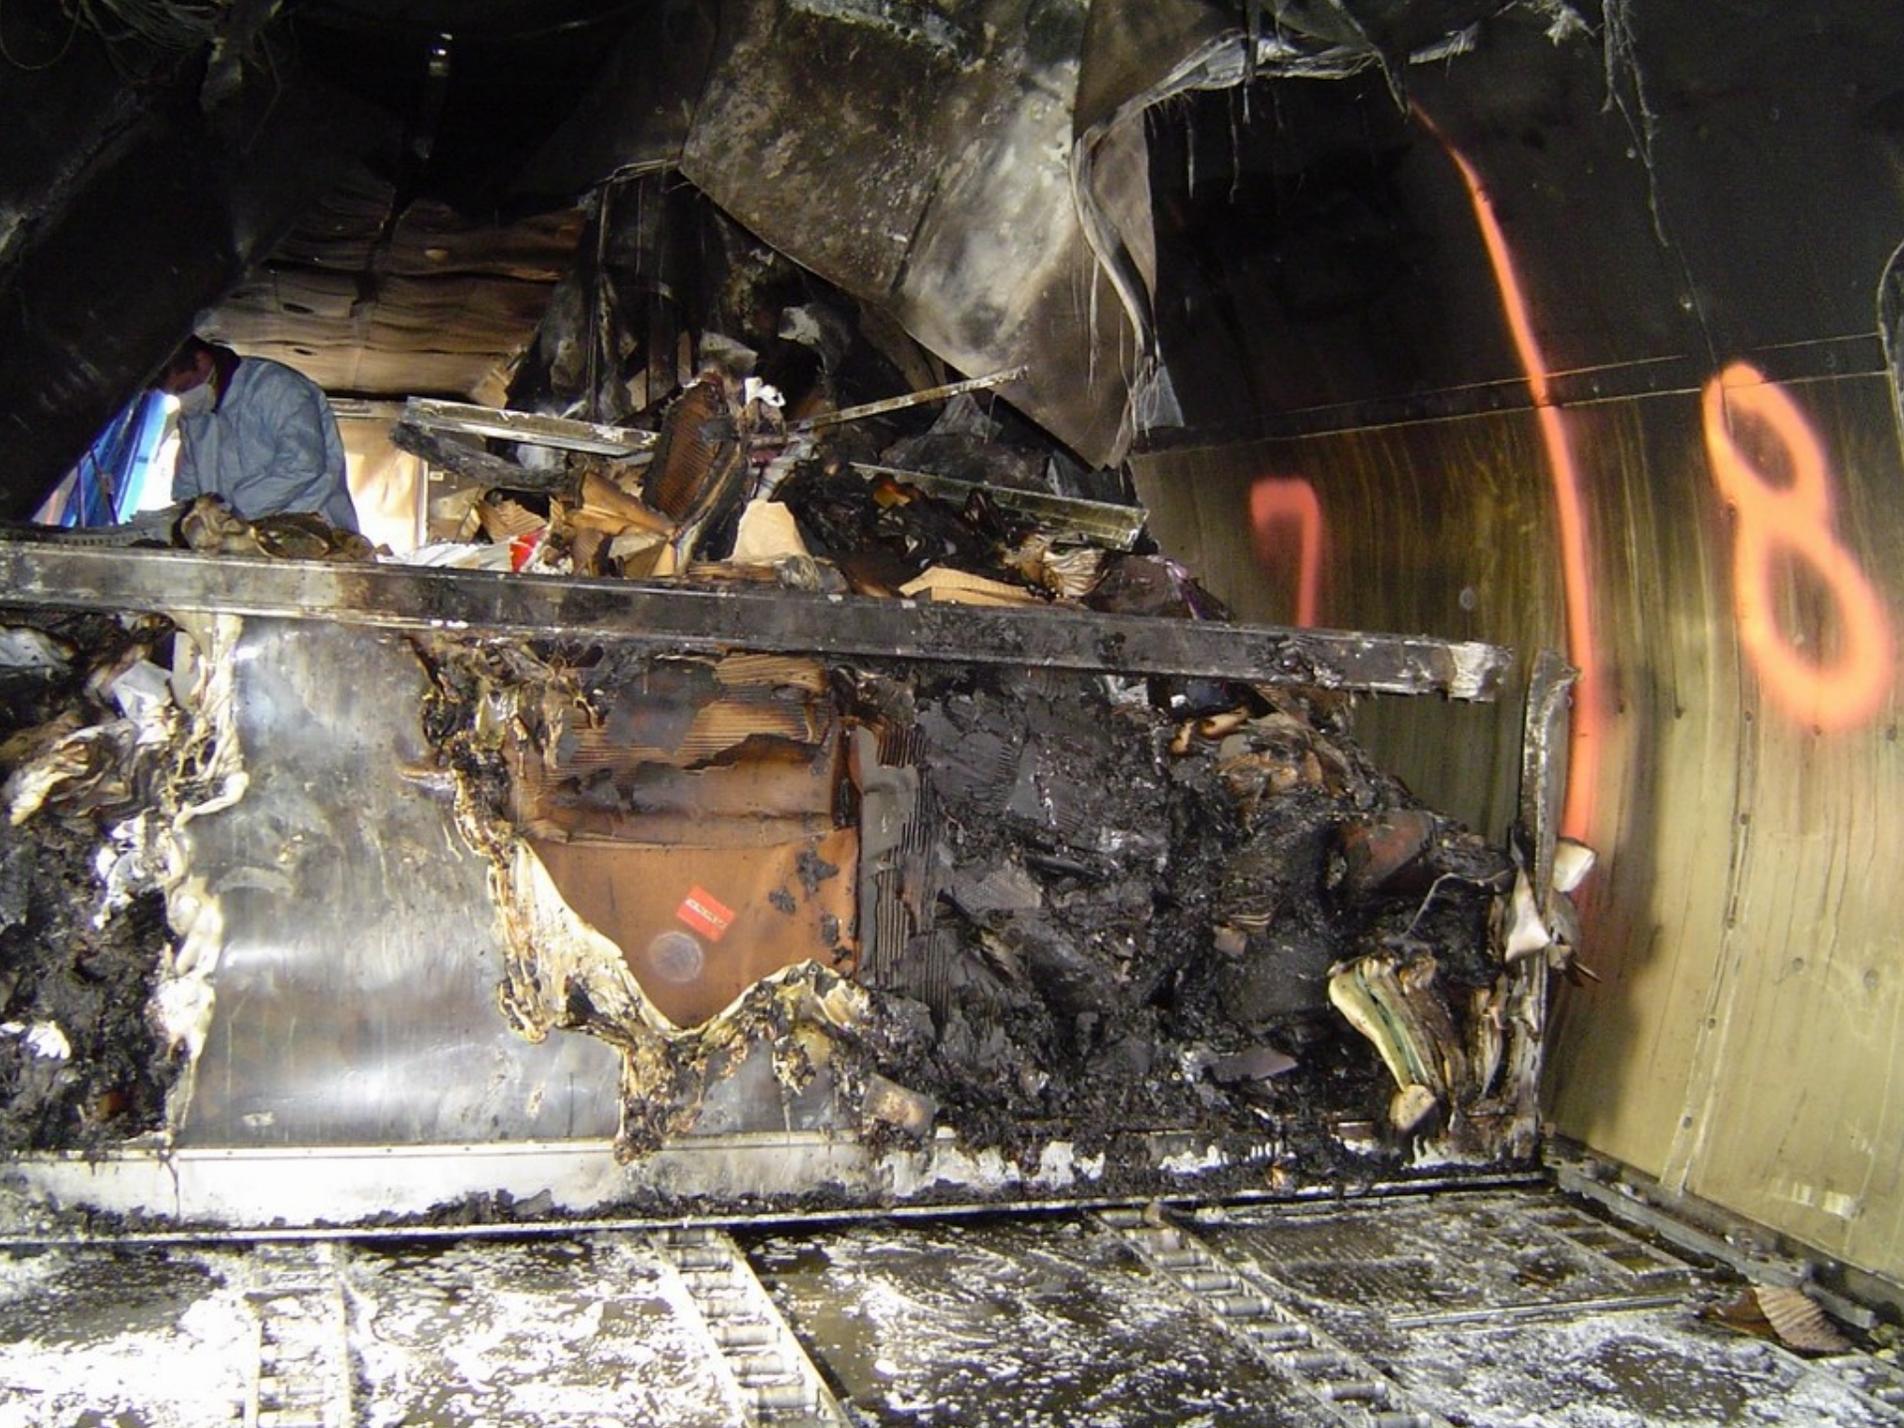
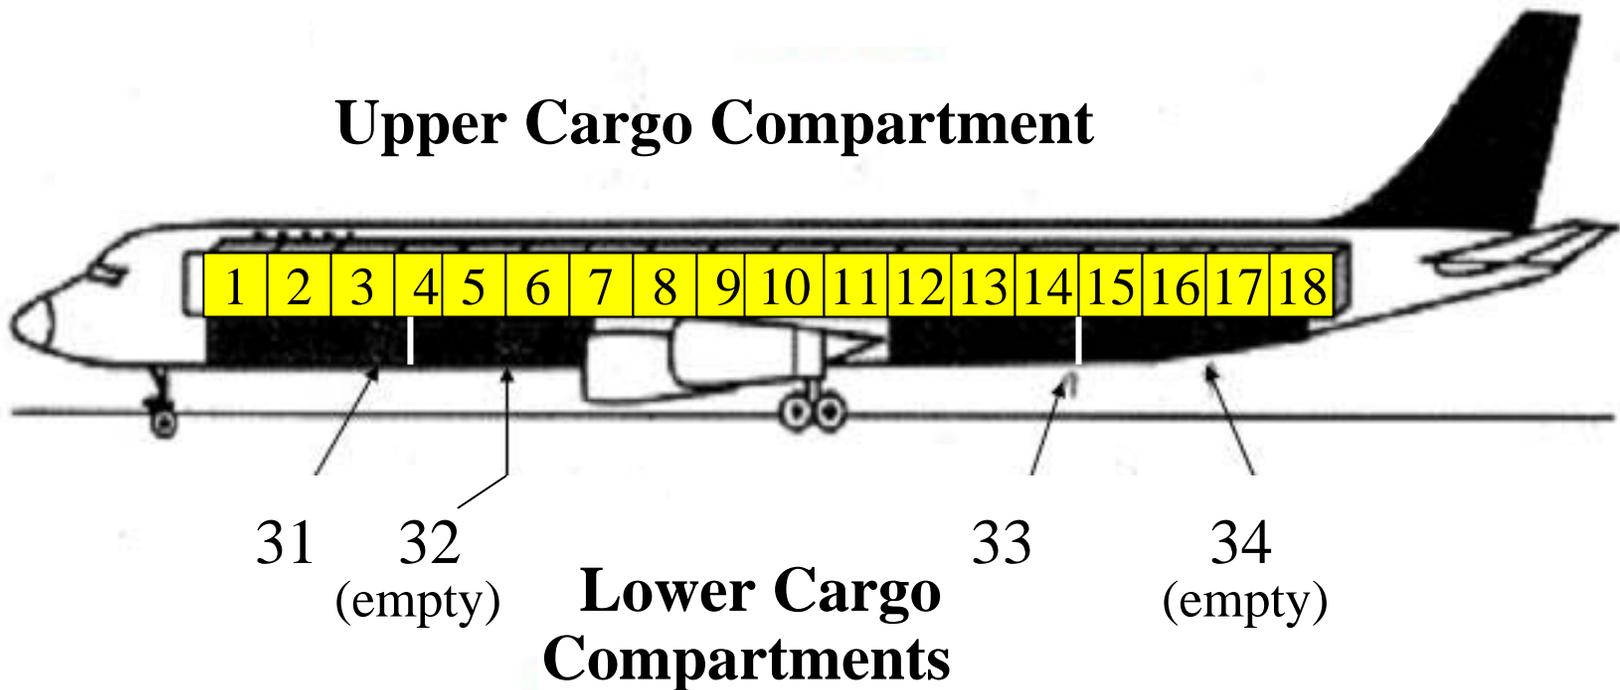
Location of Cargo

Upper Cargo Compartment
