NTSB National Transportation Safety Board

Natural Gas Transmission Pipeline Rupture and Fire

San Bruno, California
September 9, 2010

Opening Statement

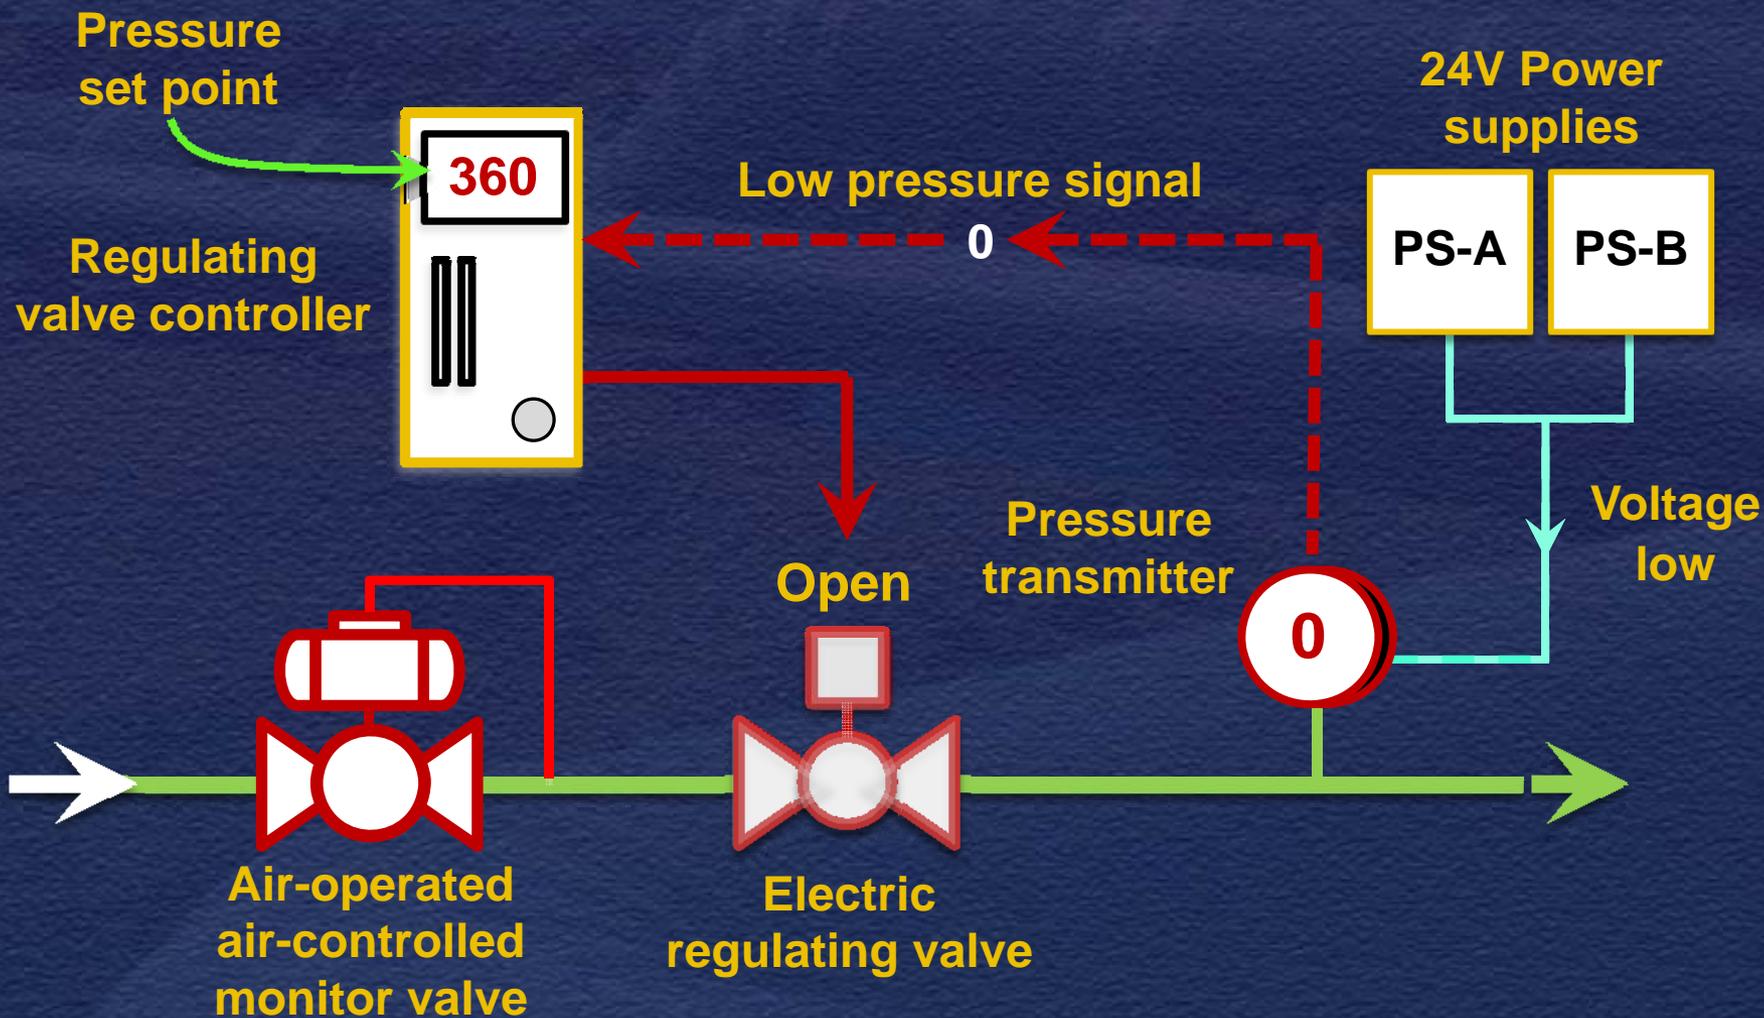
Regulating Valves (Sept. 9th)

- Local control panel displays went blank
- Power supplies A and B inside panel
- Power output voltages low and erratic
- Power supplies A and B serve pressure transmitters for valve controllers
- Low signals from pressure transmitters caused regulating valves to fully open

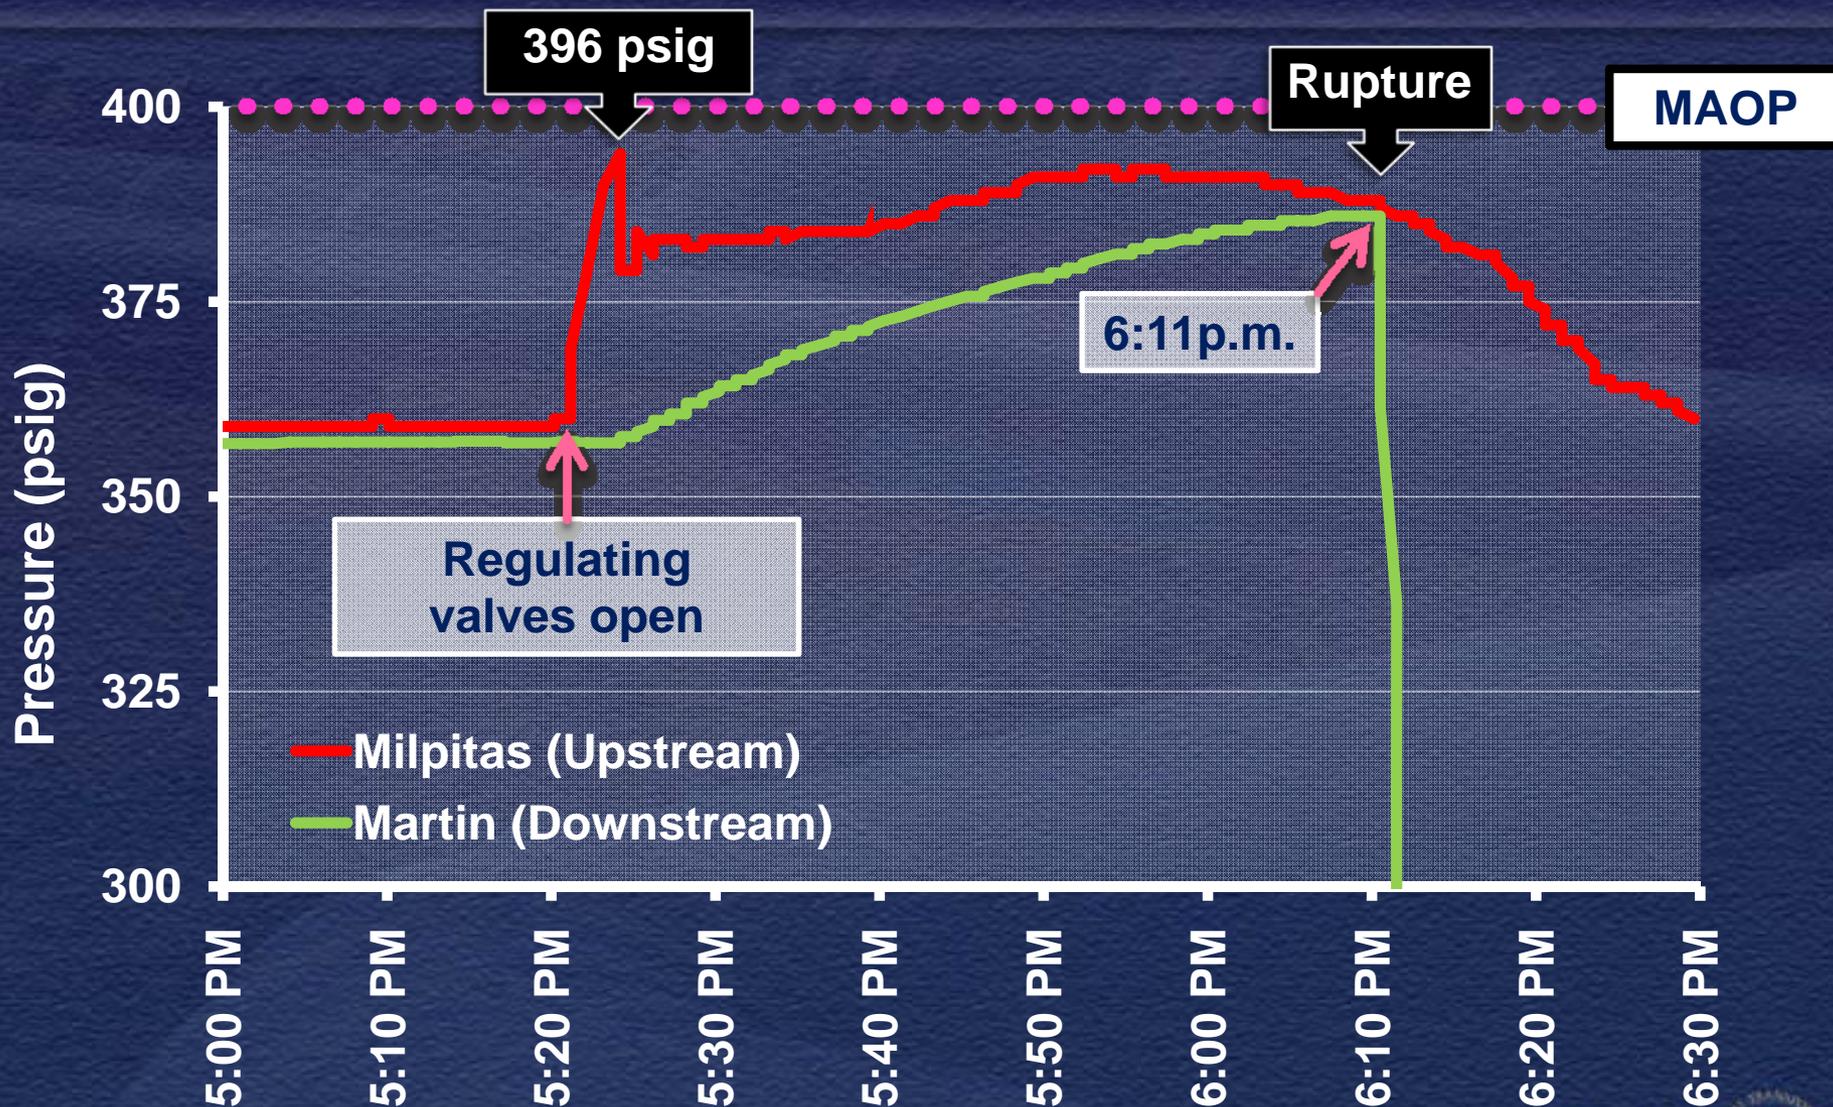
Line 132 Pressure Trends

- 5:22 p.m., primary pressure control lost
- Monitor valves react to control pressure
- Milpitas technician notified at 5:25 p.m. by SCADA center of high pressures
- SCADA center no longer receiving accurate SCADA information
- SCADA center unprepared for loss of Milpitas control

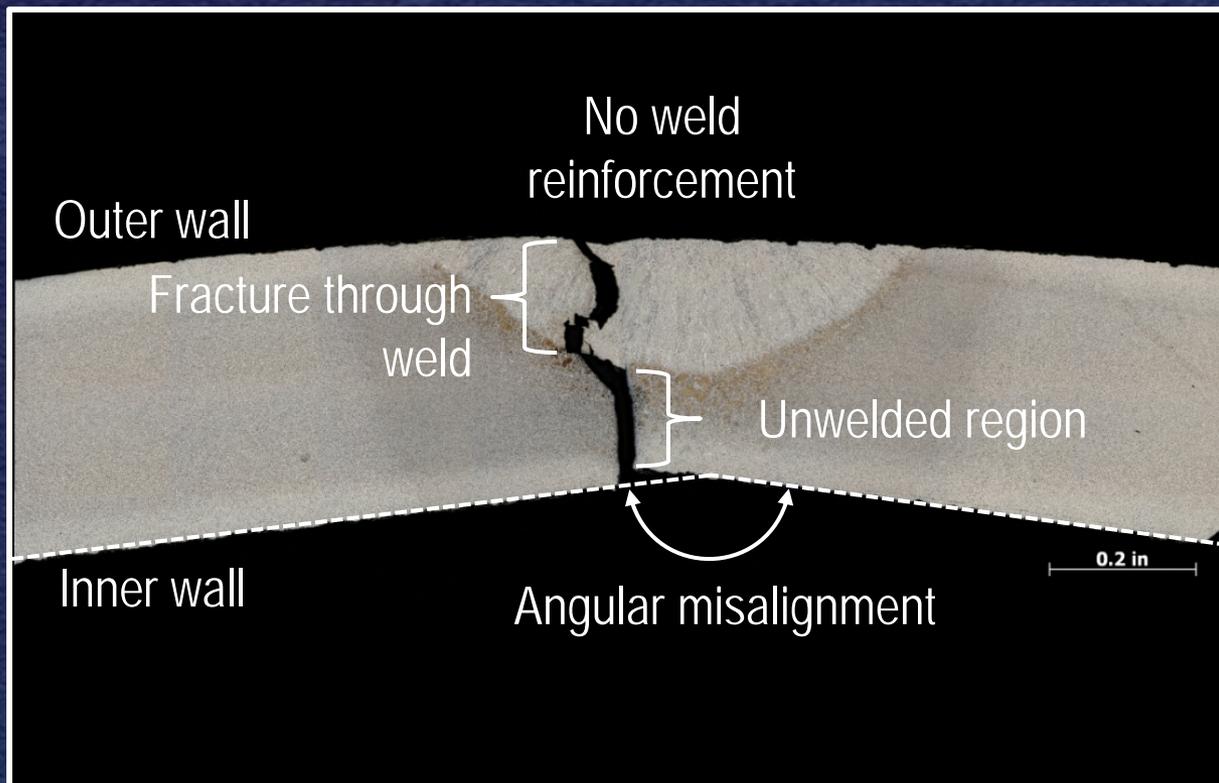
Incomplete Pup 1 Seam Weld

- Consolidated Western subjected DSAW pipe to proof test
- Pups 1, 2, and 3 would not have withstood pipe mill proof test
- Pipeline may not have passed field hydrostatic pressure test in 1956

- As part of 1956 construction six pups installed at rupture location
- Five pups fabricated at an unknown facility to no known specification
- Rupture initiated at an improperly welded longitudinal seam in pup 1
- Defective weld detectable by the unaided eye
