Office of Aviation Safety

Fuel Filtering Mike Hauf

Carson Helicopters S-61N
Operated by U.S. Forest Service
Weaverville, CA
August 5, 2008

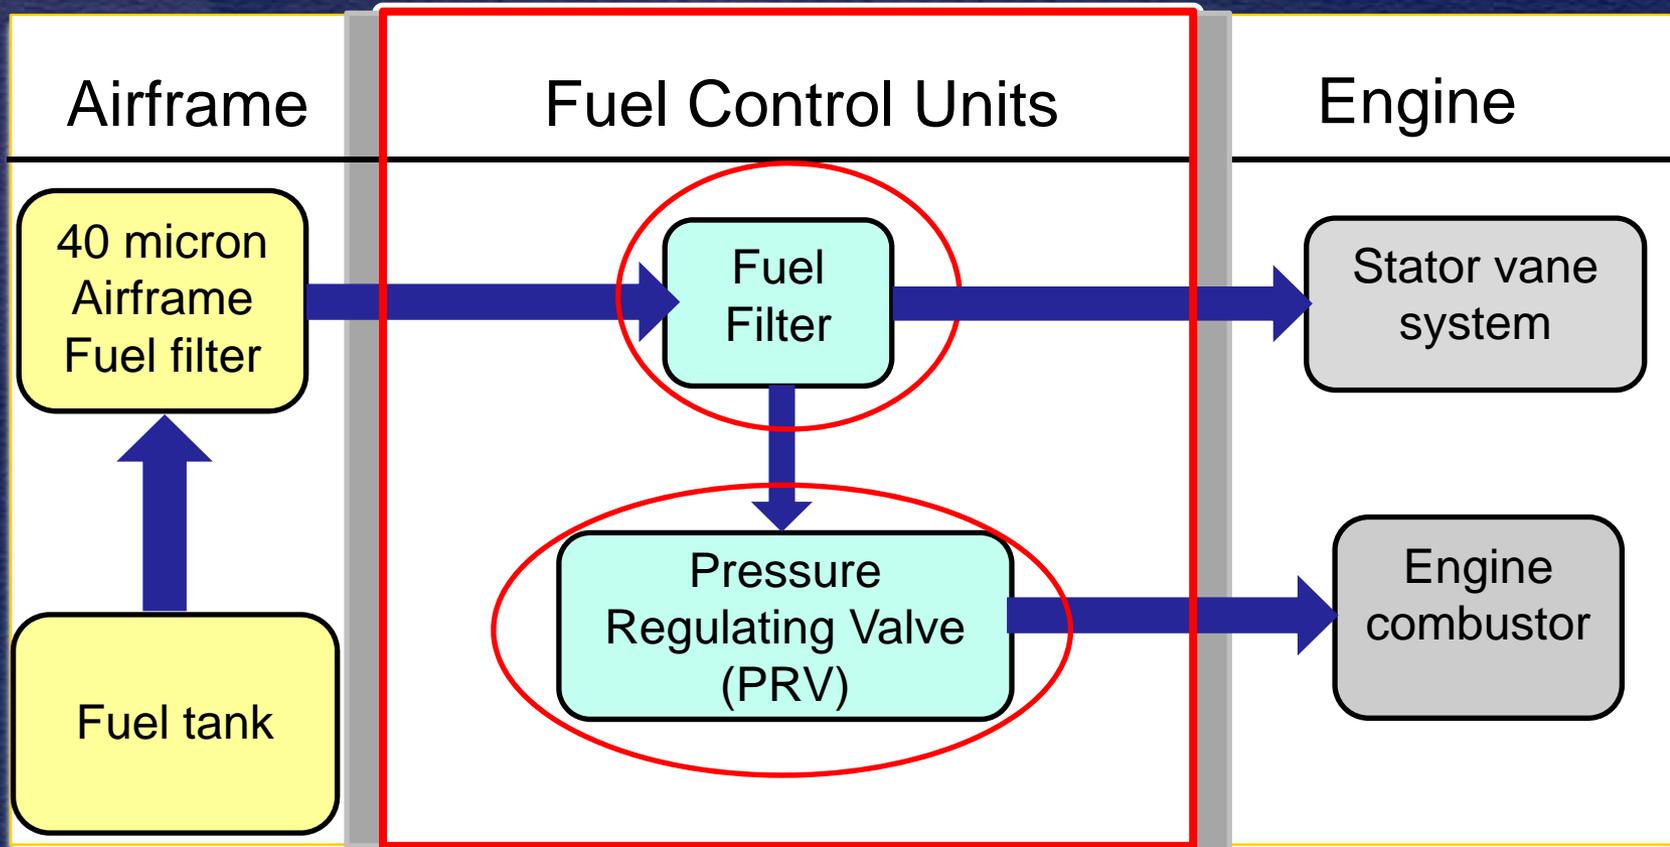
Airframe and Engine Fuel System

- Left filter 25% blocked and right filter 50% blocked
- Engines at topping shows sufficient fuel flow to engines
- Filter contains bypass valve to ensure constant fuel flow

- No contamination found by visual examination
- Trace contamination found with electron microscope
- Left PRV: 2-3 fragments of fiberglass; 10 micron diameter
- Right PRV: fragments of cloth; 20 microns thick
- Contamination did not affect fuel control operation
- Nonetheless, fuel filtering needs improvement

- FCUs susceptible to contamination
- Sikorsky Alert Service Bulletin issued January 2010
 - Replace the 40-micron airframe fuel filter element with a 10-micron element
 - 10-micron fuel filter reduces contamination to the FCU
- Carson had 10-micron filters in 2007 but had not installed in accident helicopter
