National Transportation Safety Board

NTSB Investigation and Findings:

*Over-pressurization of Natural Gas Distribution System,
Explosions, and Fires, in Merrimack Valley, Massachusetts*

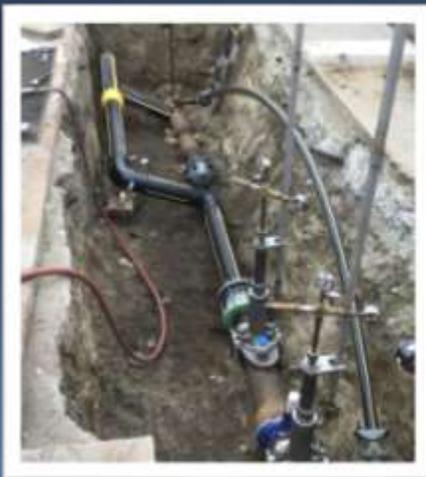
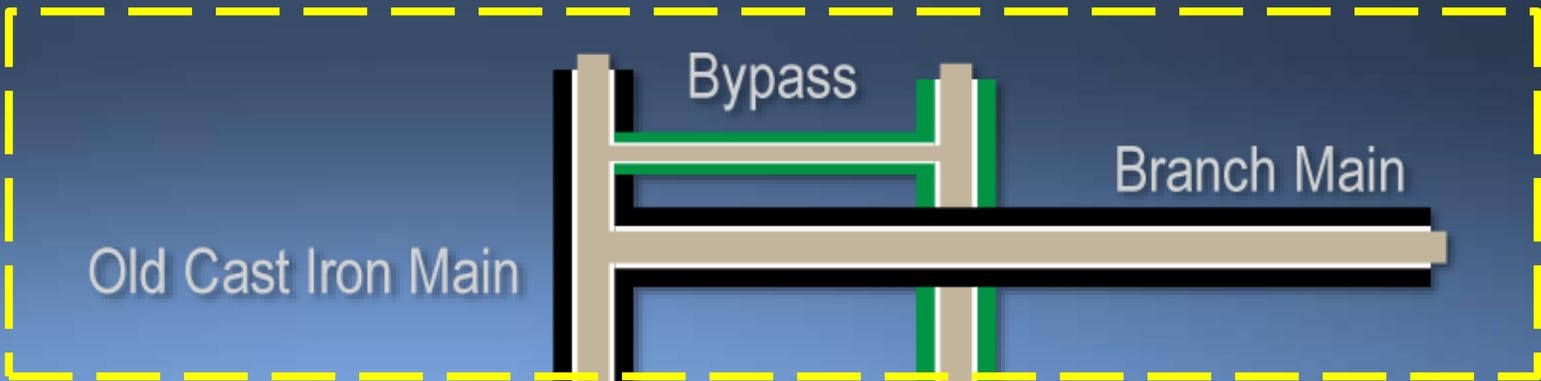
Old Cast Iron Main

Bypass

Branch Main

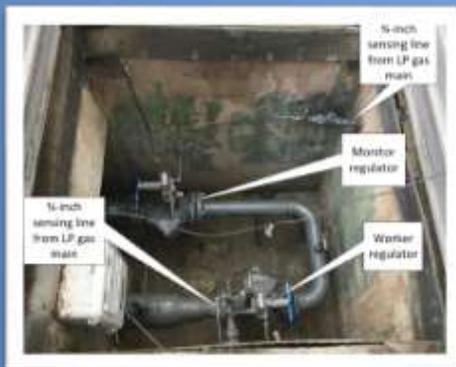
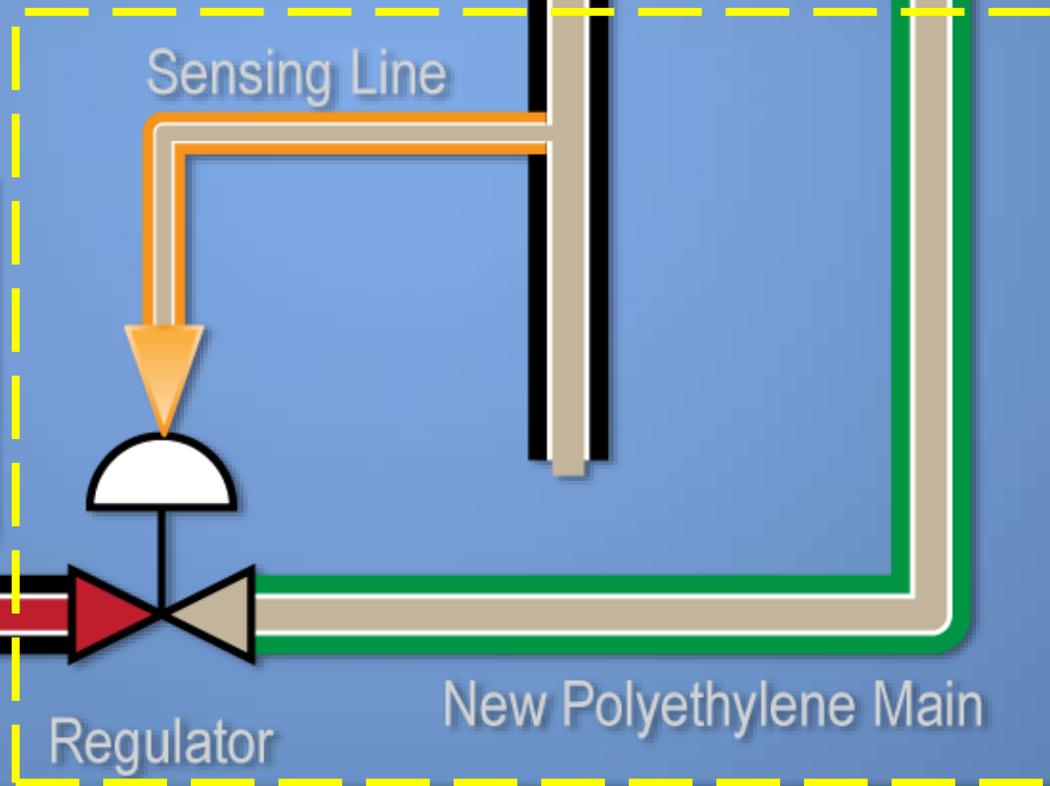
Sensing Line

Regulator

New Polyethylene Main

Columbia Gas of Massachusetts' weak engineering management that did not adequately plan, review, sequence, and oversee the construction project that led to the abandonment of a cast iron main without first relocating regulator sensing lines to the new polyethylene main.
