Testimony of

The Honorable T. Bella Dinh-Zarr, PhD, MPH
Board Member
National Transportation Safety Board

Committee on Commerce, Science, and Transportation
United States Senate

Are We Ready for the Next Hurricane Season?
Status of Preparation and Response Capabilities for 2018

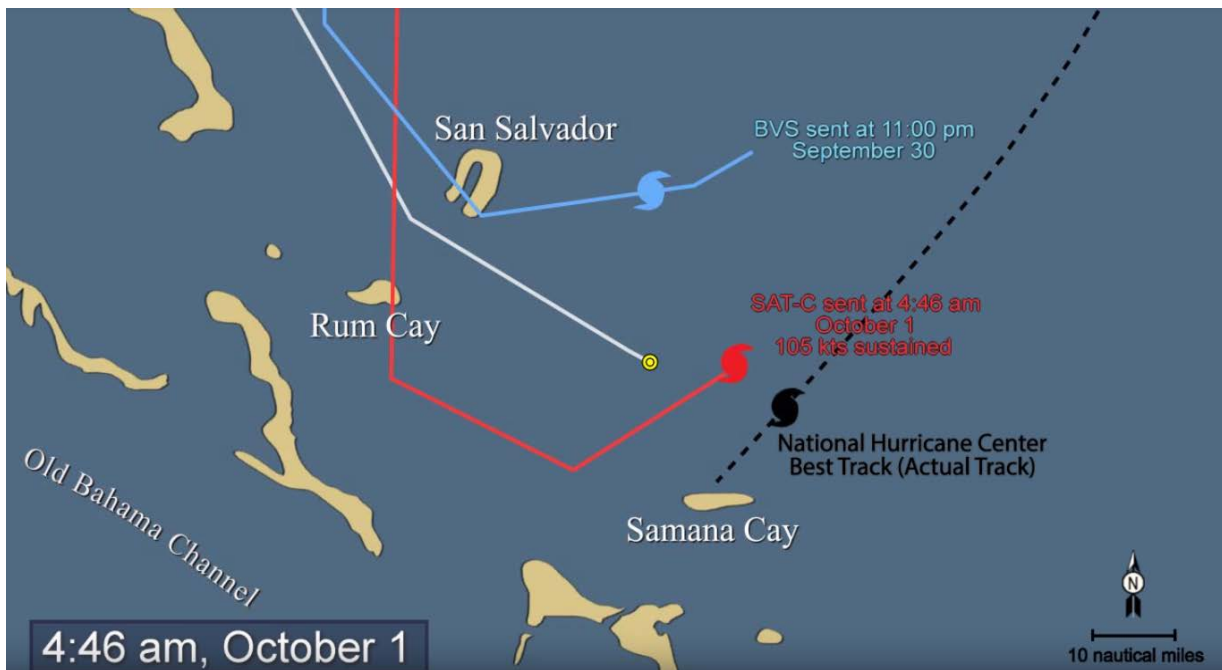
the captain to make educated decisions regarding the vessel's route, but the captain did not use it. Several times throughout the night of September 30 and into the early morning of October 1, the bridge crew noted their concerns about the ship's advancement toward a strengthening storm based on information from SAT-C and other sources; however, the captain may have felt confident about the ship's route and proximity to the storm. However, he was relying on BVS weather information that was many hours older than what the bridge crew was reviewing. Based on the information obtained from the VDR, it seems most likely that the captain did not realize that Sat-C was providing more current information than BVS.

At 4:45 a.m., on October 1, the captain downloaded a BVS weather file that had been sent to him at 11:04 p.m. the night before. Joaquin's position, forecast track, and intensity given in the file were consistent with the data in the advisory that had been delivered to the bridge via SAT-C almost 12 hours before, at 4:54 p.m. the previous afternoon. At 4:46 a.m., *El Faro's* SAT-C terminal received an advisory indicating that *El Faro* was 11 nm northwest of the storm center (**Figure 1**). By that time, the ship was experiencing a starboard list caused by increasing wind on the vessel's port side. As the ship continued to sail into the storm, the crew struggled to deal with a cascading series of events, including flooding and loss of propulsion, any one of which could have endangered the ship on its own.

Figure 1. *El Faro's* location in relation to available weather forecasts and poststorm analysis at 4:46 a.m. on October 1.
