NTSB ***SAFETY ALERT***

★ **Proper Use of Fiber or Nylon Self-Locking Nuts** ★

Inspecting nuts for age and condition and properly installing nuts is critical to ensuring tight connections

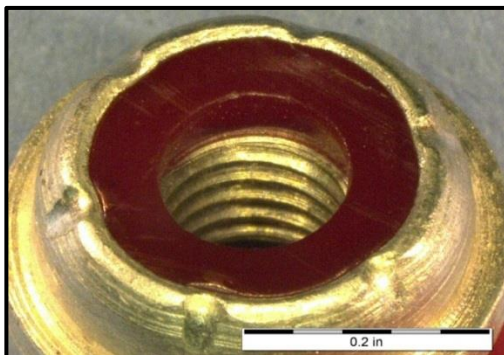
A new nylon insert.

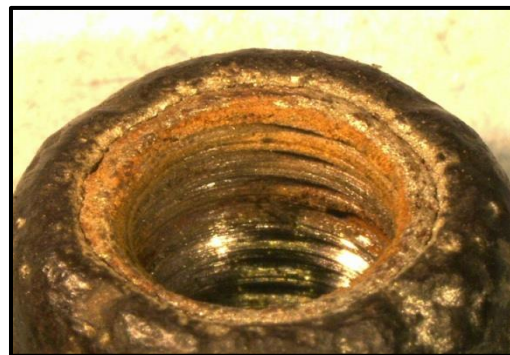
An old, degraded nylon insert.

- Comply with instructions in your aircraft's applicable maintenance manual or Federal Aviation Administration Advisory Circular 43.13-1B, [chapter 7](#), section 4, if there is no guidance on nut reuse in the manual.
- Confirm that the specified hardware is installed correctly.
- Ensure that adequate torque is required to spin the nut on the bolt. Be aware that binding in the assembly may produce a false indication of nut effectiveness.
- Throw out a nut that can be rotated on the thread by hand.
- Ensure that sufficient thread protrusion exists.
- Do not run a tap through the fiber or nylon insert because doing so removes the locking capability of the nut.

REMEMBER: WHEN IN DOUBT, THROW IT OUT!
