# National Transportation Safety Board

## Safety Recommendation

**Date:** May 21, 2010

**In reply refer to:** A-10-62 through -86

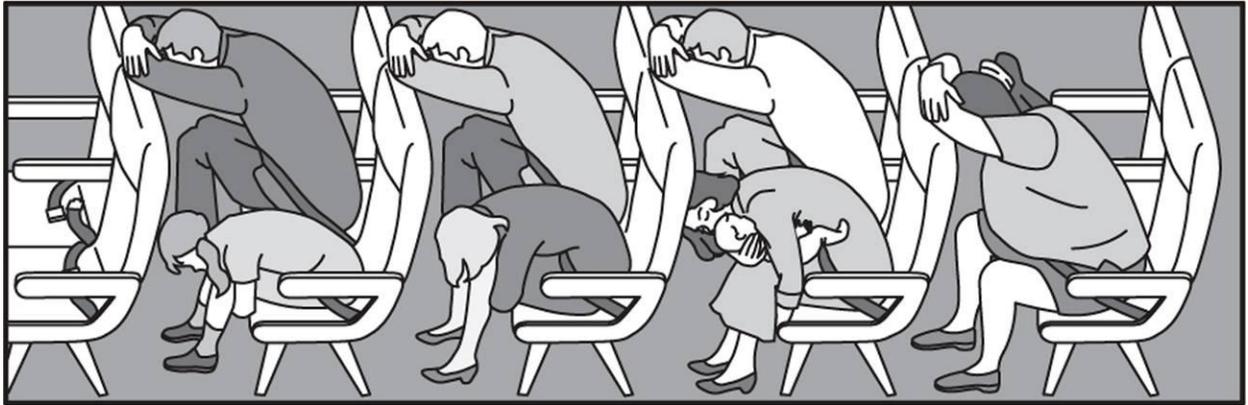
Of the four passengers who sustained serious injuries, three received their injuries during impact. The two female passengers who sustained very similar shoulder fractures both described assuming similar brace positions, putting their arms on the seat in front of them and leaning over. They also stated that they felt that their injuries were caused during the impact when their arms were driven back into their shoulders as they were thrown forward into the seats in front of them. The brace positions they described were similar to the one depicted on the US Airways safety information card, which is shown in figure 1.

**Figure 1.** Passenger brace positions shown in the US Airways safety information card.

The NTSB concludes that the FAA’s current recommended brace positions do not take into account newly designed seats that do not have a breakover feature and that, in this accident, the FAA-recommended brace position might have contributed to the shoulder fractures of two passengers. Therefore, the NTSB recommends that the FAA conduct research to determine the most beneficial passenger brace position in airplanes with nonbreakover seats installed. If the research deems it necessary, issue new guidance material on passenger brace positions.

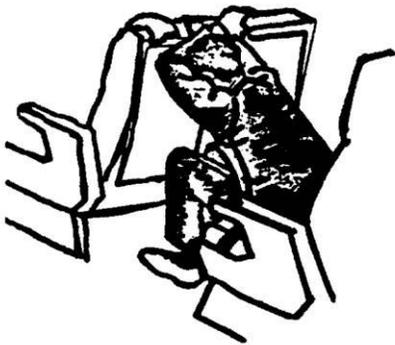
The brace positions shown on the US Airways safety information card were in accordance with current FAA guidance on brace positions contained in Appendix 4 of AC 121-24C, “Passenger Safety Information Briefing and Briefing Card,” which states, “in aircraft with high-density seating or in cases where passengers are physically limited and are unable to place their heads in their laps, they should position their heads and arms against the seat (or bulkhead) in front of them.” (See figure 2.)

**Figure 2.** Passenger brace position shown in AC 121-24C.
