National Transportation Safety Board

Safety Recommendation

In reply refer to: A-10-169 and -170

During its investigation of an amphibious float-equipped de Havilland Dash-3T (DHC-3T) airplane accident, the National Transportation Safety Board (NTSB) found that the emergency locator transmitter (ELT)¹ became dislodged from its mounting tray, detached from its antenna, and failed to transmit radio signals to alert personnel of the downed airplane. An ELT is activated automatically by crash forces and then transmits radio signals containing the airplane's identification and location, which are used by search and rescue organizations. These transmissions are a key component in the rapid location and rescue of passengers once an accident has occurred. This safety recommendation letter addresses the need for ELTs to remain secured to the airplane and operational during an accident.

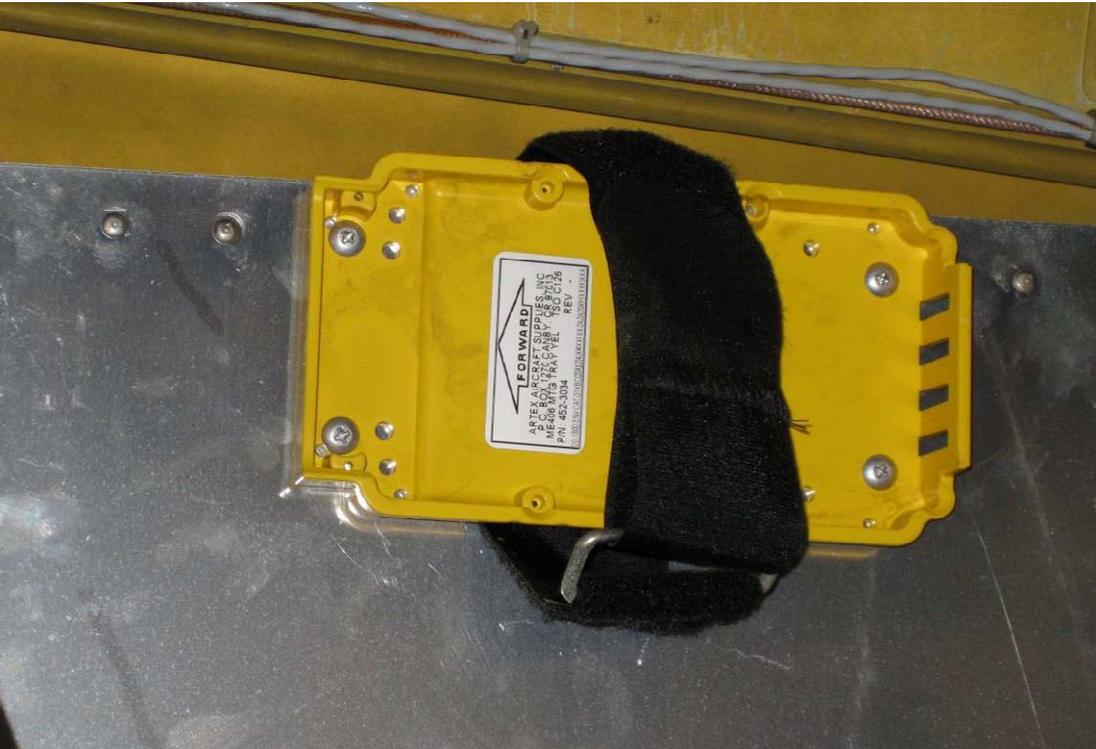
Figure 1. ELT tray with webbed strap mounted on sidewall of accident airplane.

121.5 MHz and 406 MHz beacons and the G-switch⁴ operated normally. Artex personnel also noted that, in the photograph of the ELT tray mounted in the accident airplane (see figure 1), the retention strap “appeared to be slid toward the aft section of the tray, out of its molded groove.” They added that, under normal installation practices, it should not be possible to physically place the retention strap in this position. Other than through photographs, NTSB investigators did not examine the mounting tray before its removal from the wreckage; therefore, it is not known if the retention strap was incorrectly positioned in the airplane at the time of installation or whether it occurred before or after the accident. If the strap were aft of its normal location, it is unknown if this condition was because of improper installation or maintenance, or an artifact of the accident forces. Because the preimpact position of the retention strap is not known, the NTSB is concerned that the design and certification standards concerning ELT retention may not be adequate and should be reassessed.

The precise reason that the ELT did not remain attached to the airplane is not known. However, it is possible that the ELT was not installed correctly, either at the time of installation or after the periodic inspections. A number of ELT manufacturers⁵ employ mounting designs similar to the one used for the Artex ME406; the ELT unit is attached to a mounting tray by various types of straps. In all cases, the retention capabilities of each system are dependent on proper installation, and any looseness or misalignment of the retention strap would increase the chance of accidental detachment of the ELT. The NTSB concludes that proper installation and inspection of ELT units is imperative to ensure they remain connected to the antenna and maintain functionality for rapid notification of aircraft accidents and prompt emergency response.

Inspection and proper mounting and retention of the ELT may help prevent detachment during an accident. However, these actions would not be effective if the cause of the ELT detachment is due to design characteristics or issues associated with the mounting location that were not identified during ELT certification testing. In this situation, the inadvertent detachment problem that occurred in this accident could occur in others. For example, the NTSB is concerned that a sidewall-mounted ELT may be subject to additional vertical loads during landing or turbulence, which may progressively loosen the strap.

Require a detailed inspection, during annual inspections, of all emergency locator transmitters installed in general aviation aircraft to ensure that the emergency locator transmitters are mounted and retained in accordance with the manufacturer's specifications. (A-10-169)

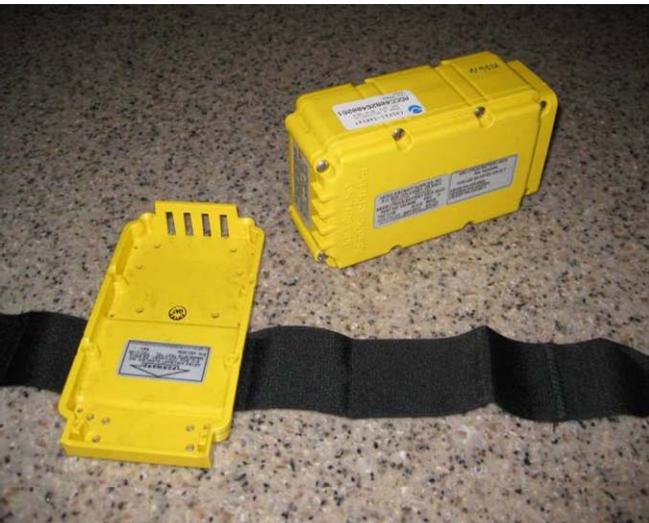
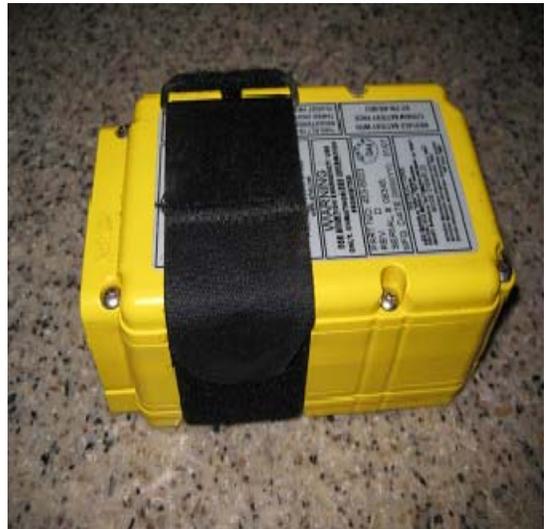
The Artex ME406 ELT is a two-piece unit that consisted of a mounting tray affixed to the aircraft and an ELT module that "nested" in the tray. The mounting tray (including a webbed strap) for the accident airplane's ELT module was mounted on the right sidewall of the aft cabin (see figure 1).³ Once mounted, the ELT unit was connected to the external antenna. The module was secured to the tray by the webbed strap with a "hook and loop" (Velcro) fastener (see figure 2).

Figure 2. Artex ME406 ELT and separate mounting tray (left); ELT in mounting tray, secured by Velcro strap (right).

Determine if the emergency locator transmitter (ELT) mounting requirements and retention tests specified by Technical Standard Order (TSO) C91a and TSO C126 are adequate to assess retention capabilities in ELT designs. Based on the results of this determination, revise, as necessary, TSO requirements to ensure proper retention of ELTs during airplane accidents. (A-10-170)
