National Transportation Safety Board

Safety Recommendation

In reply refer to: A-11-37 and -38

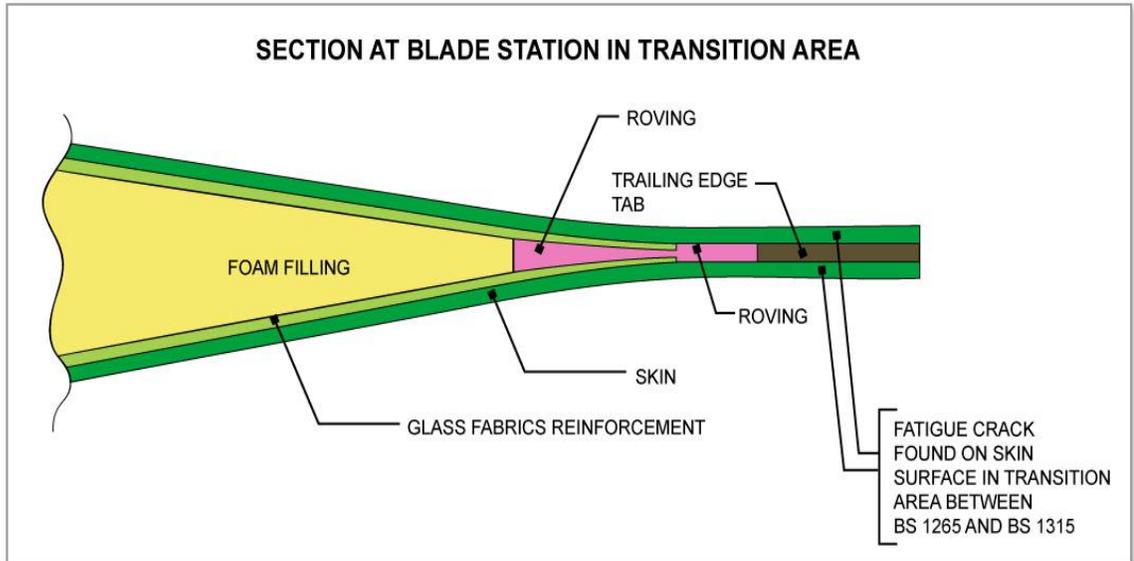
The main rotor blades on certain Eurocopter helicopters⁴ are manufactured from glass fiber-reinforced composite material skin and skin reinforcement layers that overlap a spar, foam core, trailing-edge roving, and trailing-edge tab (see figure). The trailing-edge roving is comprised of unidirectional fibers aligned parallel to each other in a spanwise direction. A transition area (of about 2 inches long) exists at the trailing edge of the blade between blade station (BS) 1265 and BS 1315 where the trailing-edge roving narrows toward the trailing-edge tab.

Figure. Trailing edge of blade.

The NTSB determined that the main rotor blade part number (P/N) 355A11-0030, serial number (S/N) 22312,⁵ of the accident helicopter fractured due to fatigue cracks in the trailing-edge skin that initiated within the transition area due to the misalignment of the unidirectional fibers in the trailing-edge roving.⁶ The NTSB's materials laboratory examined fragments of the trailing-edge roving and found that the fibers of the roving fractured at a stress lower than what would typically cause them to fracture. Thus, the strength of the roving was less than what was expected. Eurocopter also found that the trailing-edge skin adjacent to the misaligned trailing-edge roving fibers in the transition area showed evidence of fatigue cracking, and the trailing-edge roving showed evidence of a compression fracture. Further, erosion was found locally along the crack, indicating that the crack traversed through the trailing-edge skin and was visible on the outside of the blade.

The NTSB notes that the misalignment of the trailing-edge roving fibers⁷ occurred during manufacturing, when the fibers likely shifted during the curing process. Because the unidirectional fibers of the roving were not properly aligned (were not parallel) in the spanwise direction of the blade, a localized stiffness change occurred at the trailing edge. The misalignment of the fibers reduced the local load-carrying capacity of the roving, and the loads were transferred to the skin,

Require Eurocopter to revise its aircraft maintenance manual for all helicopters equipped with part number 355A11-0020 and/or 355A11-0030 main rotor blades to include, as part of the daily flight-related check, specific visual inspections of the trailing edge of the blades' upper and lower skin surfaces for cracks and surface deterioration/disfiguration. (A-11-37)

Once the Eurocopter aircraft maintenance manual is revised as described in Safety Recommendation A-11-37, notify operators of all Eurocopter helicopters equipped with part number 355A11-0020 and/or 355A11-0030 main rotor blades that they should revise their maintenance manuals to include specific daily visual inspections of the trailing edge of the blades' upper and lower skin surfaces for cracks and surface deterioration/disfiguration. (A-11-38)
