# National Transportation Safety Board

## Safety Recommendation

**In reply refer to:** A-13-18 and -19

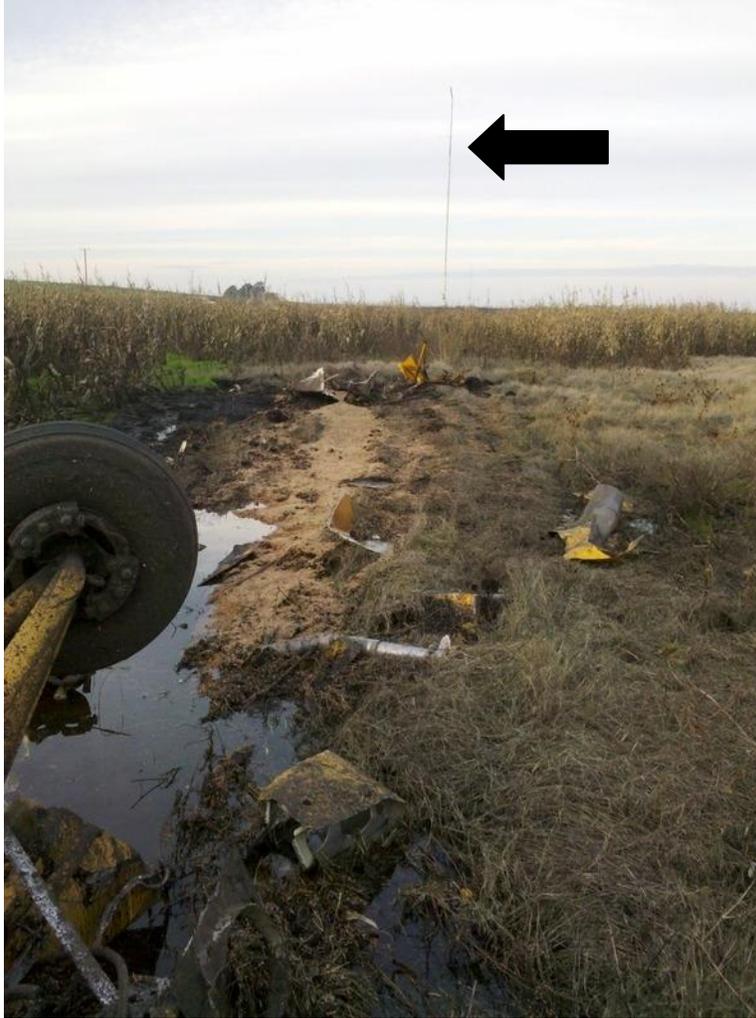
On January 10, 2011, about 1057 Pacific standard time, the left wing of a Rockwell International S-2R, N4977X, impacted an unmarked and unlighted MET during an aerial seed application flight on Webb Tract Island, Oakley, California.<sup>1</sup> Witnesses reported that they did not see the airplane perform any evasive maneuvers before the impact, indicating that the pilot did not see the obstruction. The pilot was fatally injured, and the airplane sustained substantial damage. Visual meteorological conditions prevailed and no flight plan was filed for the 14 *Code of Federal Regulations* (CFR) Part 137 flight. The NTSB's investigation found that the county

permit<sup>2</sup> for the MET had expired more than a year before the accident, but the MET had not been removed as stipulated by the permit's conditions of approval.

**Figure.** A photograph showing a MET (indicated by the black arrow), as seen from an accident site (NTSB case number WPR11LA094).

Revise the *Wind Energy Siting Handbook* to clearly indicate the hazards that meteorological evaluation towers (MET) pose to low-altitude aviation operations and encourage voluntarily marking them to increase their visibility by reference to Advisory Circular 70/7460-1, "Obstruction Marking and Lighting." (A-13-18)
