# National Transportation Safety Board

## Safety Recommendation

**In reply refer to:** A-13-22 and -23

### Damage to the Incident Airplane

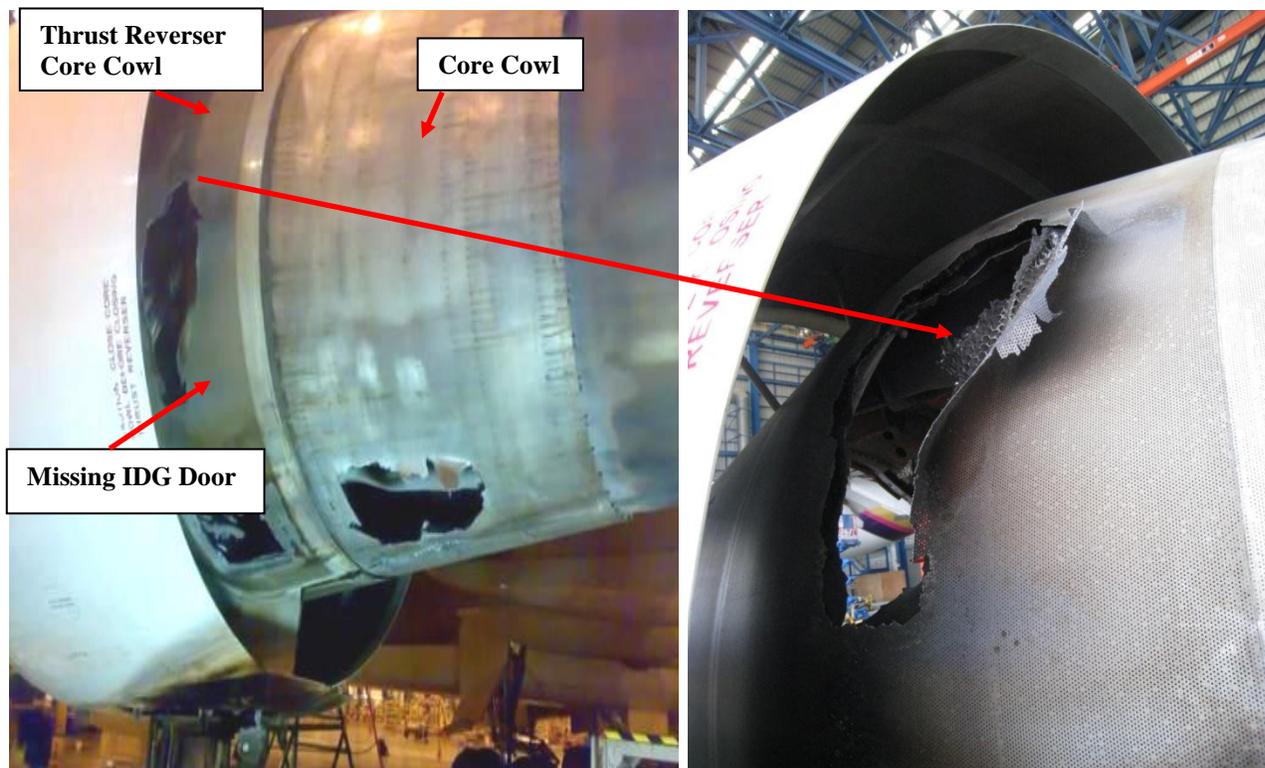
Initial examination of the No. 1 engine nacelle after landing revealed burnthrough holes in the outboard thrust reverser and core cowl. Figures 1 and 2 are photographs of the nacelle fire damage and thrust reverser core cowl fire damage to the engine.

**Figure 1.** Nacelle fire damage.

**Figure 2.** Thrust reverser core cowl fire damage.

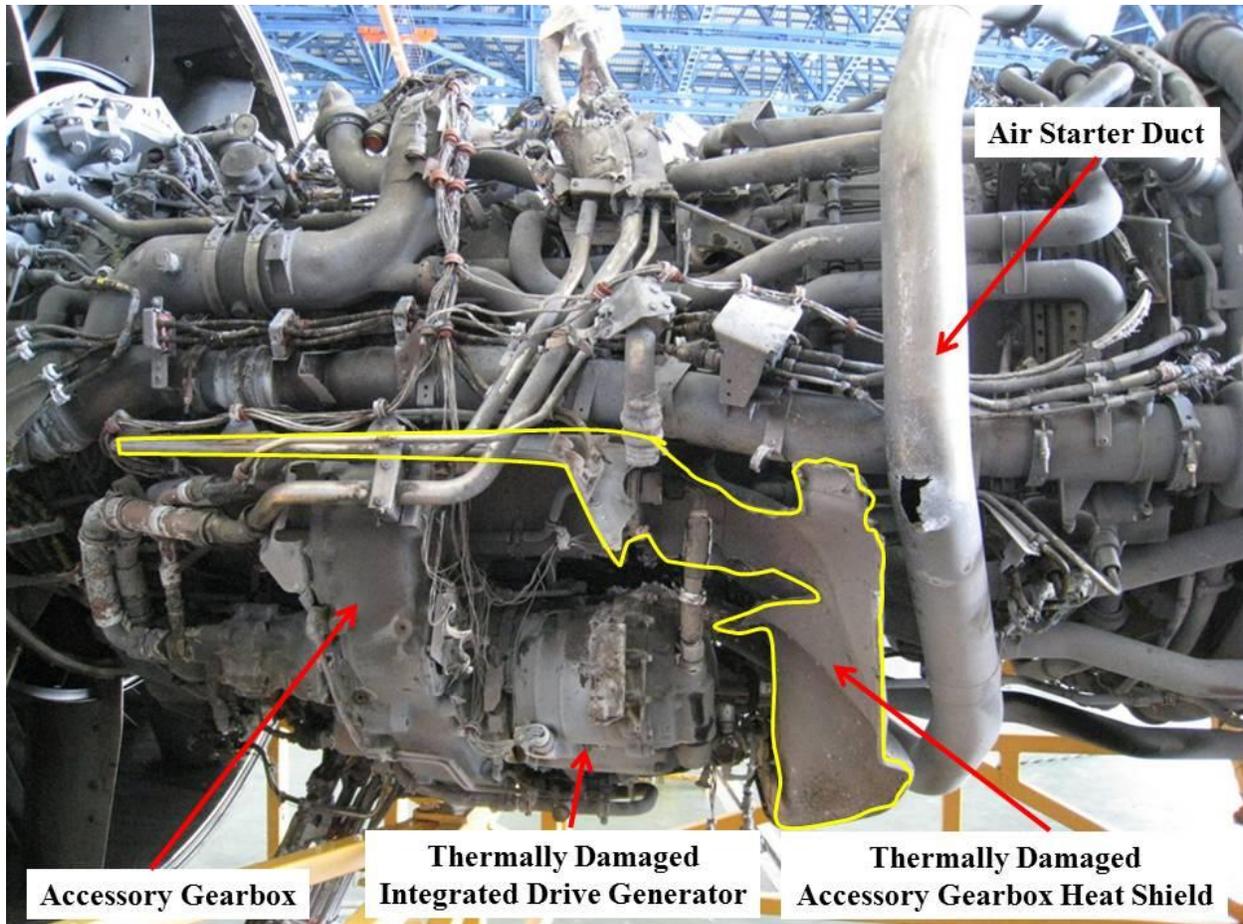
external B-sump oil supply and vent lines and the upper, middle, and lower low-pressure turbine (LPT) recoup lines. The high-temperature and high-pressure air from the LPT recoup line ducts impinged on the accessory gearbox heat shield and burned through the structure, damaging components beneath it. Specifically, the accessory gearbox heat shield exhibited four burnthrough holes of various sizes in the starter air duct and accessory cooling tube and above the integrated drive generator (IDG), and the aft edge of the heat shield was completely missing in the vicinity of the air starter valve and accessory gearbox pad drain line. The IDG housing was partially consumed by fire, exposing the internal gearing, and only about a cup of oil remained in the IDG.<sup>3</sup> Figure 3 shows the fire damage on the left side of the No. 1 engine.

**Figure 3.** Fire damage on the left side of the No. 1 engine.

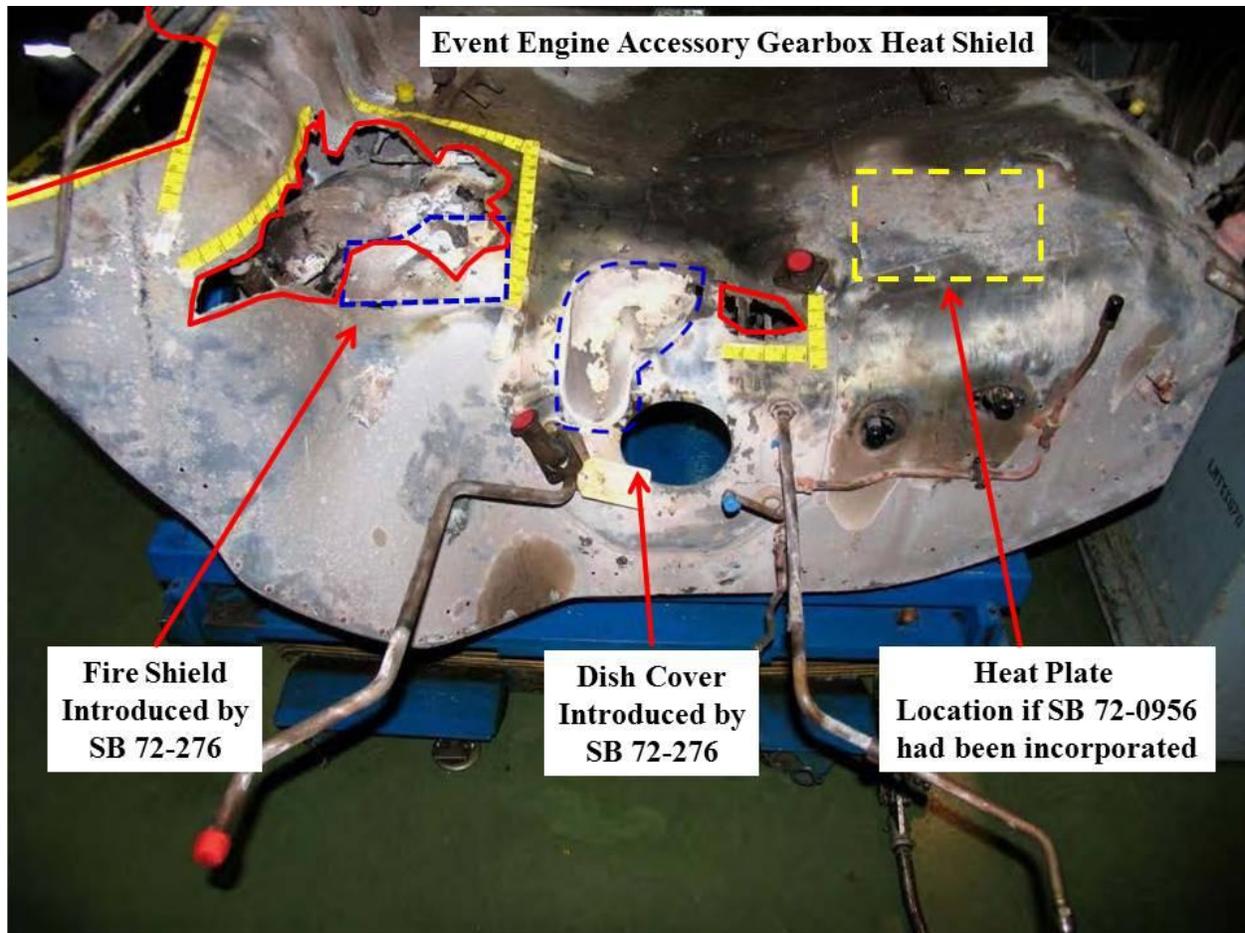
Visual inspection of the incident airplane’s accessory gearbox heat shield (part number 1378M49G05) confirmed that a fire shield and dished cover were installed in accordance with SB 72-276, but the heat plate introduced by SB 72-0956 was not installed. Figure 4 shows the incident airplane’s accessory gearbox heat shield damage and fire shield locations.

**Figure 4.** Incident airplane's accessory gearbox heat shield damage and fire shield locations. The red outlines indicate holes and missing materials, the blue outlines indicate installed patches/dished covers, and the yellow outline on the right indicates where the patch from SB 72-0956 would have been, had it been installed.

Require that General Electric (GE) redesign the accessory gearbox heat shield for GE CF6-80C2 model engines to provide fire protection from bearing compartment fires, failures, gas escaping from the low-pressure turbine and high-pressure turbine recoup lines, and any other possible fire sources that would affect the accessory compartment. Mandate the incorporation of the redesigned accessory gearbox heat shield in a timely manner. (A-13-22)
