National Transportation Safety Board

Safety Recommendation

Date: August 26, 2014

In reply refer to: A-14-67 and -68

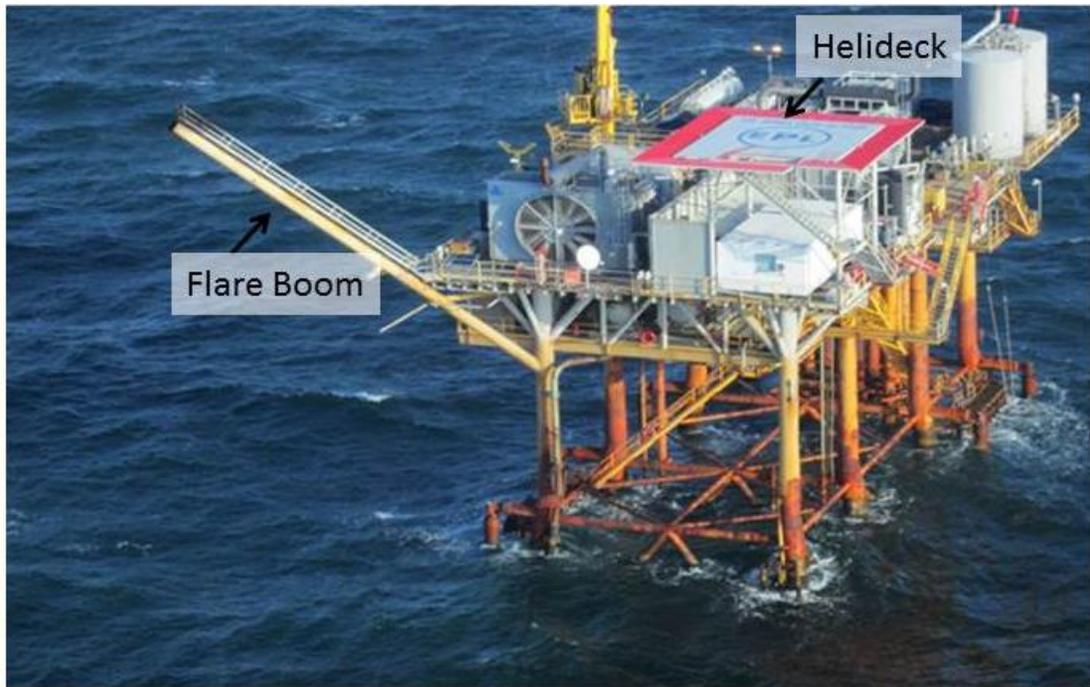
The pilot later reported that before departure, he brought the helicopter into a stationary hover in the middle of the helideck and made a “left pedal turn into the wind and in a direction to avoid the flare boom.” According to a monthly gas flaring and venting volume summary provided by the platform operator, the volume of methane vented on the day of the accident was the highest of the month and about 20 times the volume of the second highest day. The pilot was not aware before departing that methane gas was being vented. While a windsock is located on the platform to assist pilots in determining the prevailing wind direction, as recommended in industry guidance, the platform does not have a system visible to pilots indicating when gas is venting; such a system is particularly helpful since methane gas is colorless and odorless and pilots are not able to discern its presence. The following figure shows SS208H with its helideck and flare boom.

Figure. SS208H showing the helideck and flare boom.

In collaboration with the US Coast Guard, identify and develop comprehensive systems and procedures to mitigate the risk of ingestion of raw gas discharges, such as methane, by helicopters operating in the vicinity of offshore oil platforms. (A-14-67)

After appropriate mitigations are developed as recommended in Safety Recommendation A-14-67, require fixed offshore oil platform operators to implement these systems and procedures. (A-14-68)
