National Transportation Safety Board

Safety Recommendation

Date: August 26, 2014

In reply refer to: A-14-71

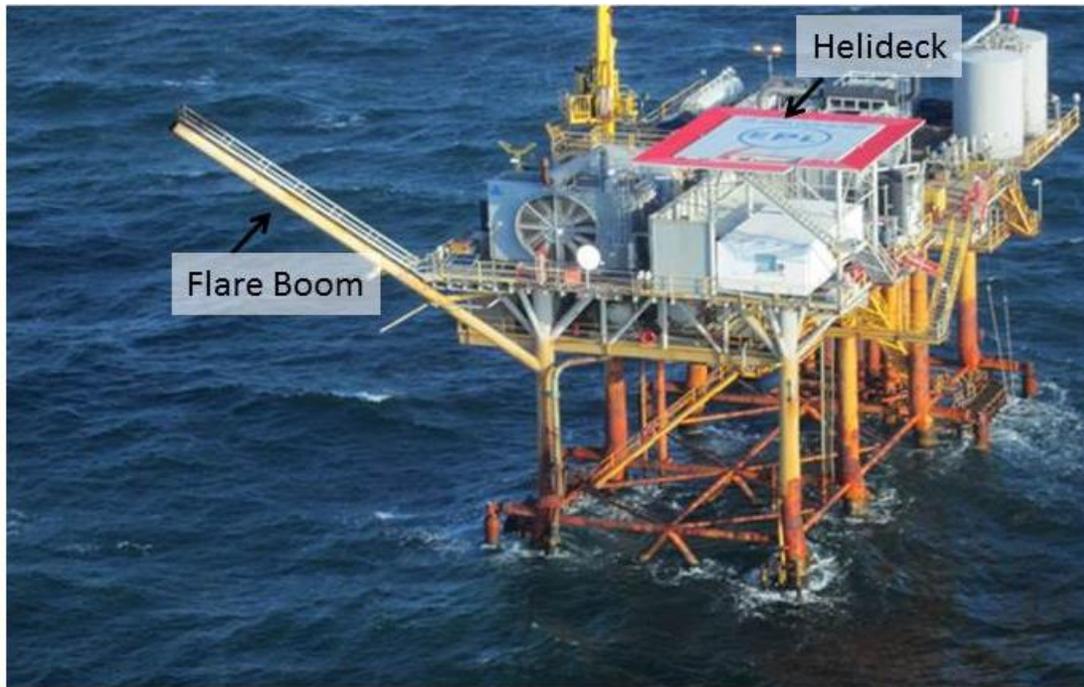
The pilot later reported that before departure, he brought the helicopter into a stationary hover in the middle of the helideck and made a “left pedal turn into the wind and in a direction to avoid the flare boom.” The pilot was not aware before departing that methane gas was being vented. While a wind sock is located on the platform to assist pilots in determining the prevailing wind direction, as recommended in industry guidance, the platform does not have a system visible to pilots indicating when gas is venting; such a system is particularly helpful since methane gas is colorless and odorless and pilots are not able to discern its presence. According to a monthly gas flaring and venting volume summary provided by the platform operator, the volume of methane gas vented on the day of the accident was the highest of the month and about 20 times the volume of the second highest day. The following figure shows SS208H with its helideck and flare boom.

Figure. SS208H showing the helideck and flare boom.

Finalize revisions to API Recommended Practice 2L, Recommended Practice for Planning, Designing, and Constructing Heliports for Fixed Offshore Platforms, to address the venting of raw gases, such as methane, as a risk to turbine-powered helicopters operating in the vicinity of fixed offshore oil platforms. (A-14-71)
