# National Transportation Safety Board

## Safety Recommendation

**In reply refer to:** A-00-66 through -71

In this letter, the National Transportation Safety Board recommends that the Federal Aviation Administration (FAA) take action to address the following safety issues related to runway incursions:<sup>1</sup> adequacy of ground movement safety systems and of air traffic control (ATC) procedures.

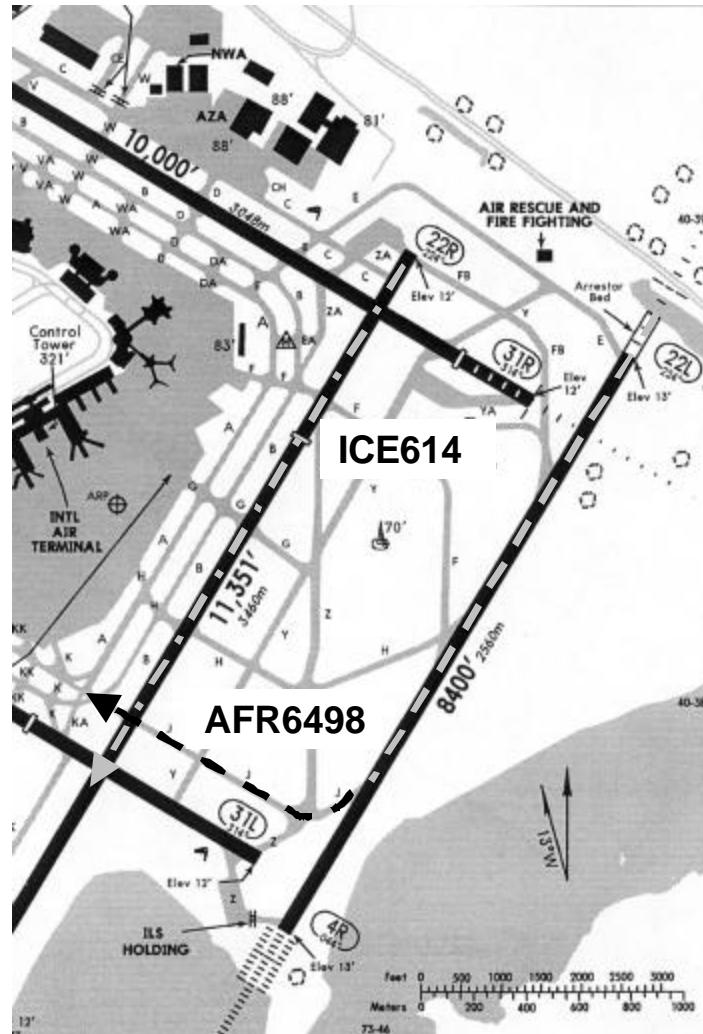
**Figure 2. JFK Airport Diagram.**

ICE614 cleared AFR6498 by about 100 feet vertically. The incident occurred in instrument meteorological conditions (IMC) at night. No injuries were reported, and neither airplane was damaged.

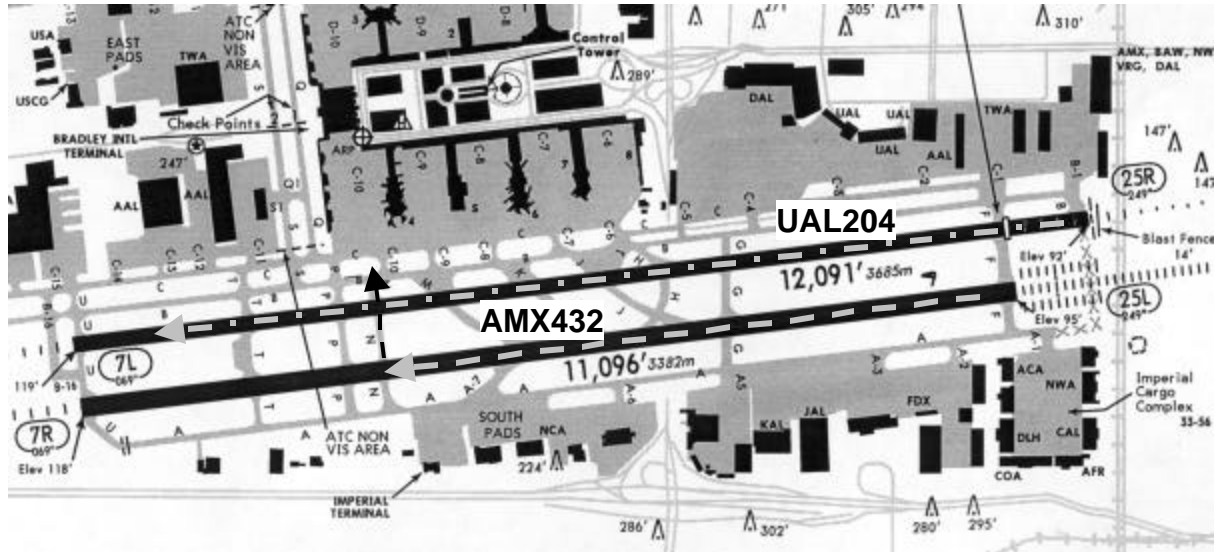
**Figure 3. LAX Airport Diagram.**

On November 22, 1999, about 2236 Pacific standard time, Aeromexico flight 432 (AMX432), an MD-80, and United Airlines flight 204 (UAL204), a 757, were involved in a runway incursion on runway 25R at Los Angeles International Airport (LAX), Los Angeles, California. (Figure 3 shows a diagram of LAX with references to both airplanes' positions.) The LAX local controller cleared AMX432 to land on runway 25L. After the airplane landed, the controller instructed the flight crew to turn right on taxiway N and hold short of runway 25R so that UAL204 could depart. According to the ATC voice recording, AMX432 read back "November cross 25R." (In a postincident interview, the

controller stated that she thought that the flight crew read back “short 25R.” The controller stated that AMX432 turned on taxiway N but then accelerated toward runway 25R. The controller restated the hold short instruction, but UAL204 had already flown over AMX432 by about 100 feet. The incident occurred in VMC at night. No injuries were reported, and neither airplane was damaged.

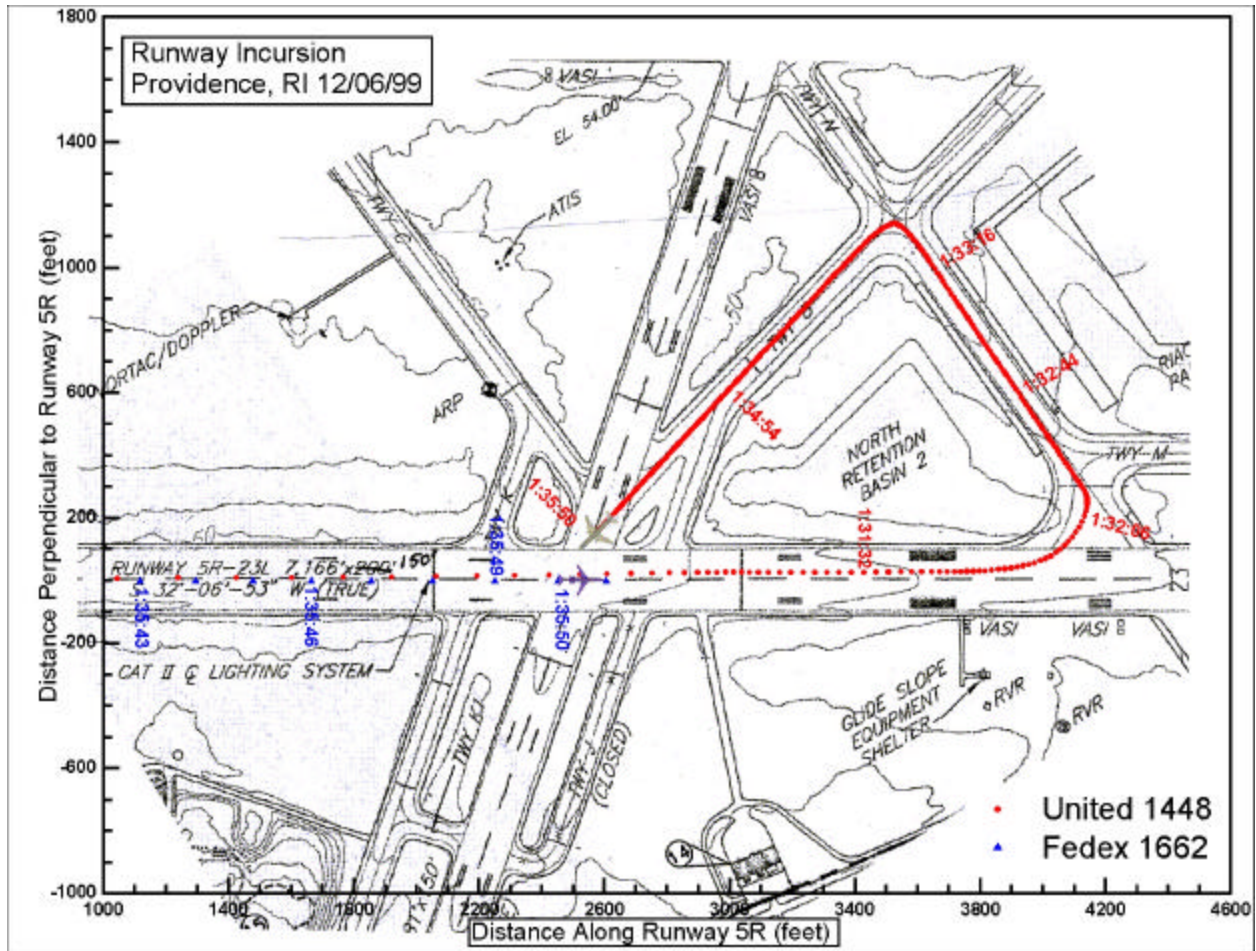
**Figure 4. PVD Airport Diagram.**

On December 6, 1999, about 2035 eastern standard time, United Airlines flight 1448 (UAL1448), a 757, and Federal Express flight 1662 (FDX1662), a 727, were involved in an incident on runway 5R at Theodore Francis Green State Airport (PVD), Providence, Rhode Island. (Figure 4 shows a diagram of PVD with references to both airplanes' positions.) The PVD control tower is not equipped with Airport Surface Detection Equipment (ASDE).<sup>7</sup> Therefore, controllers must visually monitor aircraft and, during low-visibility and night operations, rely on pilot position reports (instead of a surface radar display) to locate aircraft. At the time of the incident, the reported visibility was 1/4 mile, and the runway visual range (RVR) was 1,400 feet.

After UAL1448 landed on runway 5R, the PVD local controller instructed the flight crew to exit the runway to the left, proceed to the ramp via taxiways N and T, and report when the airplane crossed runway 16. The UAL1448 flight crew became disoriented and turned back toward runway 5R. The flight crew then stopped the airplane, advised the PVD local controller of its position, and stated that it believed that the airplane was on an active runway. While UAL1448 was deviating from its assigned taxi route, FDX1662 departed from runway 5R, passing near UAL1448. (The sound of FDX1662's takeoff can be clearly heard in the background of the ATC recording of UAL1448's transmission of a position report.) Although the flight crew of UAL1448 reported its belief that the airplane was on an active runway, the PVD local controller cleared US Airways flight 2998, a Boeing 737 (737), for takeoff from runway 5R. The 737 flight crew declined the clearance because of its concern about UAL1448's position. The incident occurred in IMC at night. No injuries were reported, and neither airplane was damaged.
