# National Transportation Safety Board

## Safety Recommendation

**In reply refer to:** H-12-1

## Accident Hose Assembly

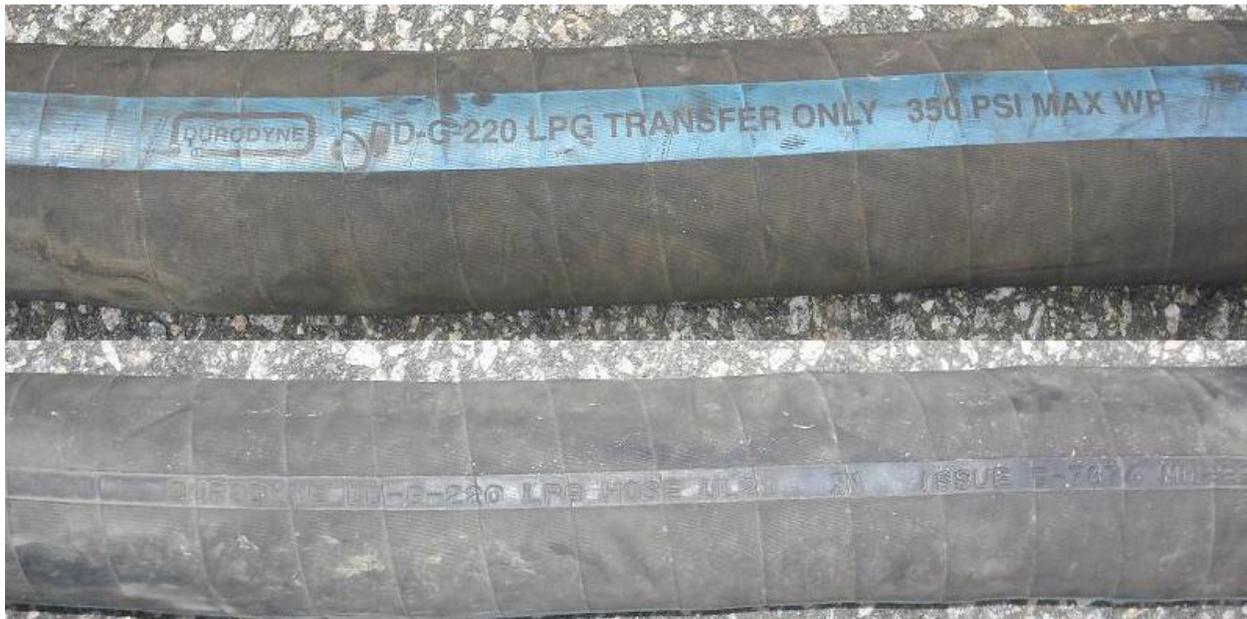
The hose was imprinted with text. One side of the black neoprene cover of the hose featured a blue Mylar stripe extending along the length of the hose with the Durodyne logo and “DD-G-220 LPG TRANSFER ONLY 350 PSI MAX WP” printed in black. The phrases “To prevent serious injury or property damage use for intended purpose only,” “Warning: Use of damaged hose could be hazardous; inspect hose and couplings prior to each use,” and “Textile reinforcements meet UL21” were also embossed along the imprinted blue Mylar stripe. The opposite side of the hose had “DURODYNE DD-G-220 LPG HOSE UL21 ISSUE E-7874 MH29239 SPEC DD-G-220 TEXTILE BRAID WP 350 PSIG 4Q05 INSPECT HOSE BEFORE USE” embossed on an imprinted stripe extending the length of the hose. (See figure 1.)

**Figure 1.** Blue Mylar and imprinted stripes on accident hose.

The exterior surfaces of the hose assembly contained only superficial abrasions. No gouges, slices, or other defects were noted on the surface of the hose, including the areas adjacent to and abutting the rupture area. The black text on the blue Mylar stripe was abraded in multiple locations so that the stenciling along the length of the hose could not be read; however, several sections of the hose assembly were free of abrasions or stains, and the text could be read. The embossed text on the imprinted line could be read along the length of the hose assembly.

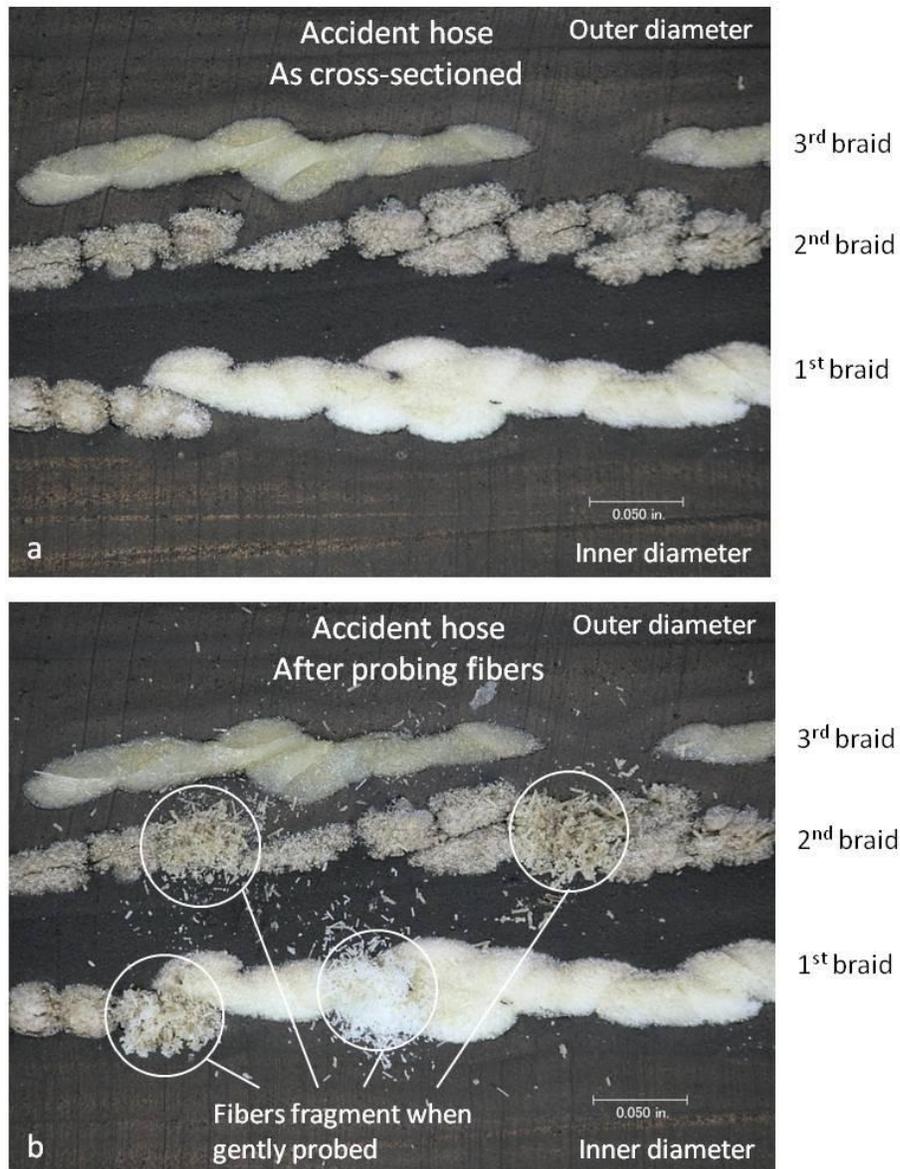
The reinforcing fibers in the two innermost PET braid layers of the hose assembly appeared to be severely damaged on both halves of the fracture surface along the entire length of the ruptured area. In some parts of the ruptured area, the fibers were clumped together and appeared to be encased in salt-like particles. Laboratory analysis of the hose assembly revealed that the fibers in the two innermost PET braid layers were degraded to the point that they were brittle and friable when strained or mechanically flexed. (See figure 2.)

**Figure 2.** Cross-section of accident hose showing brittleness of fibers in two innermost PET braid layers.

The PET used for the yarn braids is not chemically resistant to anhydrous ammonia or ammonium hydroxide. As documented in several studies,<sup>9</sup> exposure to anhydrous ammonia or ammonia-related compounds results in a chemical reaction (ammonolysis) that can cause PET fibers to degrade and lose strength.

The outer rubber layer of the accident hose had an array of small pinpricks along its length that was intended to allow the product that it was transferring to permeate through the rubber layers of the hose and escape to the atmosphere. The purpose of this is to prevent gas from becoming trapped in the hose wall and damaging the hose; this pinprick design is standard in rubber hoses for LPG and anhydrous ammonia service. When the anhydrous ammonia permeated through the rubber layers of the accident hose, it collected in the interstitial spaces of the fibers within the PET braids. Also, the accident hose was likely exposed to moisture, including humidity and rain, throughout its life cycle. Any absorbed and dissolved moisture contained in the accident hose likely would have converted the trapped anhydrous ammonia to ammonium hydroxide, leading to chemical degradation of the PET fibers.

Testing completed by both the NTSB's Materials Laboratory and an independent laboratory<sup>10</sup> confirms that the PET fibers in the accident hose had sustained chemical degradation that dramatically reduced the strength of the PET fiber. The NTSB concluded that the accident hose failed because it was not chemically compatible with the anhydrous ammonia in the cargo tank and that caused the chemical degradation, loss of mechanical strength, and ultimate failure of the cargo hose.

With the Pipeline and Hazardous Materials Safety Administration, jointly issue a safety advisory bulletin to inform cargo tank motor vehicle owners and operators, registered inspectors of these vehicles, and transfer facility operators about the circumstances of this accident and actions needed to prevent the occurrence of a similar accident. (H-12-1)
