National Transportation Safety Board

Safety Recommendation

In reply refer to: R-14-11

The Broken Compromise Joint Bars

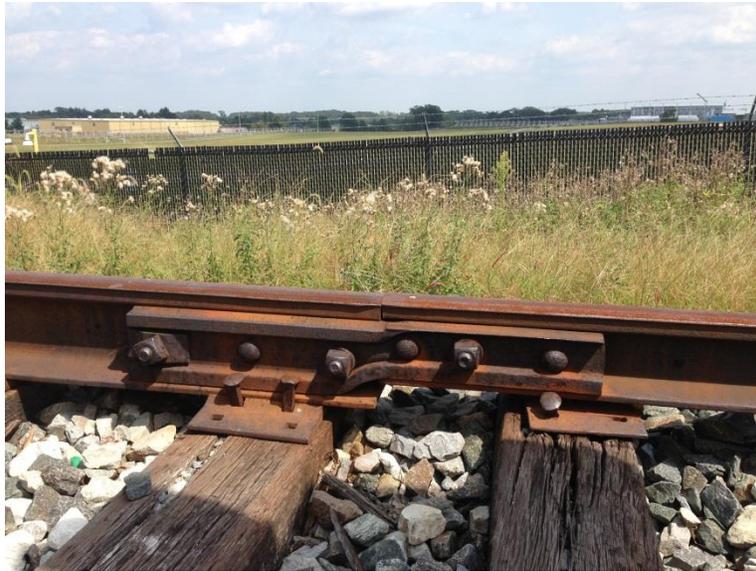
At the point of derailment, investigators found that a pair of 36-inch-long compromise joint bars on the north rail of track 4 were broken. Compromise joint bars are used to join two rails of different sizes, to compensate for the different heights of the rail head running surfaces. (See figure 1.) The compromise joint was made up of two separate bars that were bolted to the webs of the two running rails. In this application, the two rails were 136- and 131-pound rails.¹ The compromise joint bars that were found to be broken had been installed on April 4, 2013.

Figure 1. Photograph of an exemplar compromise joint bar

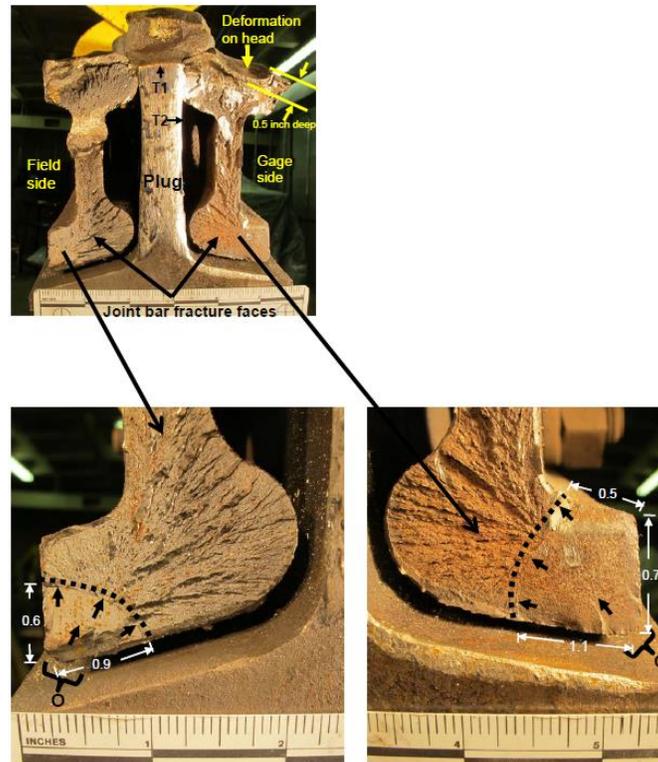
The broken compromise joint bars were examined at the accident scene by NTSB investigators and subsequently were examined in the NTSB Materials Laboratory in Washington, DC. The examination showed the gage side bar, which is the bar closest to the centerline of the track, exhibited crack arrest marks that are indicative of fatigue cracking. The fatigue crack emanated from multiple origins at the bottom of the bar. The compromise joint bar on the field side, which is the bar opposite the gage side, also contained a fatigue crack that originated at the bottom of the bar. (See figure 2.) In the two compromise joint bars, fatigue propagation extended up and partially through the middle portions of the bars.

Figure 2. Fractured pair of compromise joint bars and rail showing the east fracture face (top) and close-up photographs of the leg portions of the compromise joint bars (bottom). A fatigue crack emanated from the lower corner of each leg portion of the compromise joint bars in the areas indicated by brackets “O.” (Measurements of the fatigue cracks are shown in inches.)

Investigators measured the exposed portions of the fatigue cracks and determined the gage side bar, which exhibited the largest and oldest fatigue crack, was the first bar to break. The exposed portions of fatigue cracks on the field side bar were smaller, indicating it was the second bar to break. Investigators also measured the joined rails to determine whether the rail head running surfaces were properly matched. By design, the compromise joint bars create a 0.1875-inch difference at the base of the rails by raising up the smaller rail section so the rail head running surfaces are aligned. However, in this case, the 131-pound rail was worn and was 6.95 inches high, creating a 0.17-inch difference between the rail head heights of the 131- and the 136-pound rails. A mismatch of this magnitude would have been noticeable by sound and feel if traversed in a hi-rail inspection vehicle, and this mismatch would also have been noticeable to a trained inspector walking the track. Title 49 *Code of Federal Regulations* 213.115, “Rail End Mismatch,” allows no more than a 0.125-inch mismatch on the tread (head) of the rail end for a class 4 track.

joint with hanging ties” (insufficient ballast support) and “pumping under load” (vertical deflection) at the location of the subsequent derailment on main track 4. No corrective action was documented on the report. During on-scene examination of the derailment area, NTSB investigators found conditions consistent with deflection under the insulated joint. The NTSB investigators determined that the combination of the rail-head mismatch and the vertical deflection under the insulated joint caused the compromise joint bars to fail from fatigue cracking.

Revise the Track Safety Standards specified in Title 49 *Code of Federal Regulations* 213.233(b)(3), removing the exemption for high-density commuter railroads and requiring all railroads to comply with these requirements: (1) to traverse each main track by vehicle or inspect each main track on foot at least once every 2 weeks, and (2) to traverse and inspect each siding, either by vehicle or on foot, at least once every month. (R-14-11)
