National Transportation Safety Board

Safety Recommendation

In reply refer to: R-14-12

The recommendation is derived from the NTSB's ongoing investigation of the derailment and subsequent collision of two Metro-North passenger trains in Bridgeport, Connecticut, on May 17, 2013. As a result of our investigation to date, the NTSB is issuing two safety recommendations, one of which is addressed to Metro-North. Information supporting this recommendation is discussed below.

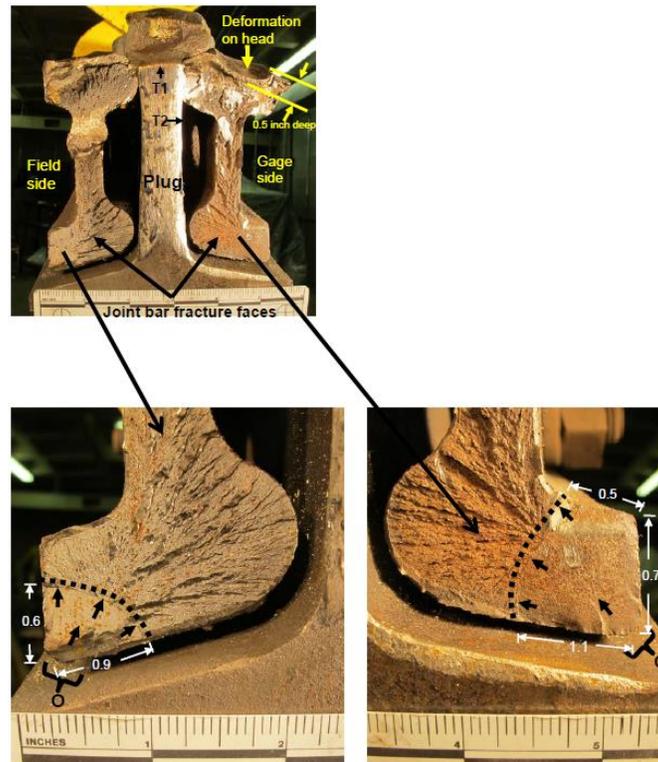
The broken compromise joint bars were examined at the accident scene by NTSB investigators and subsequently were examined in the NTSB Materials Laboratory in Washington, DC. The examination showed the gage side bar, which is the bar closest to the centerline of the track, exhibited crack arrest marks that are indicative of fatigue cracking. The fatigue crack emanated from multiple origins at the bottom of the bar. The compromise joint bar on the field side, which is the bar opposite the gage side, also contained a fatigue crack that originated at the

bottom of the bar. (See figure 2.) In the two compromise joint bars, fatigue propagation extended up and partially through the middle portions of the bars.

Figure 2. Fractured pair of compromise joint bars and rail showing the east fracture face (top) and close-up photographs of the leg portions of the compromise joint bars (bottom). A fatigue crack emanated from the lower corner of each leg portion of the compromise joint bars in the areas indicated by brackets “O.” (Measurements of the fatigue cracks are shown in inches.)

Investigators measured the exposed portions of the fatigue cracks and determined the gage side bar, which exhibited the largest and oldest fatigue crack, was the first bar to break. The exposed portions of fatigue cracks on the field side bar were smaller, indicating it was the second bar to break. Investigators also measured the joined rails to determine whether the rail head running surfaces were properly matched. By design, the compromise joint bars create a 0.1875-inch difference at the base of the rails by raising up the smaller rail section so the rail head running surfaces can match. However, in this case, the 131-pound rail was worn and was 6.95 inches high, creating a 0.17-inch difference between the rail head heights of the 131- and the 136-pound rails. A mismatch of this magnitude would have been noticeable by sound and feel if traversed in a hi-rail inspection vehicle, and this mismatch would also have been noticeable to a trained inspector walking the track. Title 49, *Code of Federal Regulations* 213.115, titled “Rail End Mismatch,” allows no more than a 0.125-inch mismatch on the tread (head) of the rail end for a class 4 track.

The last track inspection in the area of the derailment had been performed on May 15, 2013, 2 days before the accident, by inspectors in a hi-rail vehicle.² Metro-North records indicate the inspection was most likely performed from track 2. The inspectors documented an “insulated joint with hanging ties” (insufficient ballast support) and “pumping under load” (vertical deflection) at the location of the subsequent derailment on main track 4. No corrective action was documented on the report. During on-scene examination of the derailment area, NTSB investigators found conditions consistent with deflection under the insulated joint. The NTSB investigators determined that the combination of the rail-head mismatch and the vertical deflection under the insulated joint caused the compromise joint bars to fail from fatigue cracking.

Revise your track inspection program to include requirements (1) to traverse each main track by vehicle or inspect each main track on foot at least once every 2 weeks, and (2) to traverse and inspect each siding, either by vehicle or on foot, at least once every month. (R-14-12)
