National Transportation Safety Board

Safety Recommendation

In reply refer to: R-15-03

This recommendation addresses the M-8 passenger railcar body mounting bolts (as installed by the passenger railcar manufacturer). The recommendation is derived from our investigation of the derailment and subsequent collision of two Metro-North passenger trains in Bridgeport, Connecticut, on May 17, 2013. As a result of this component of the investigation, we have issued three safety recommendations, of which one is addressed to Metro-North. Information supporting this recommendation is discussed below.

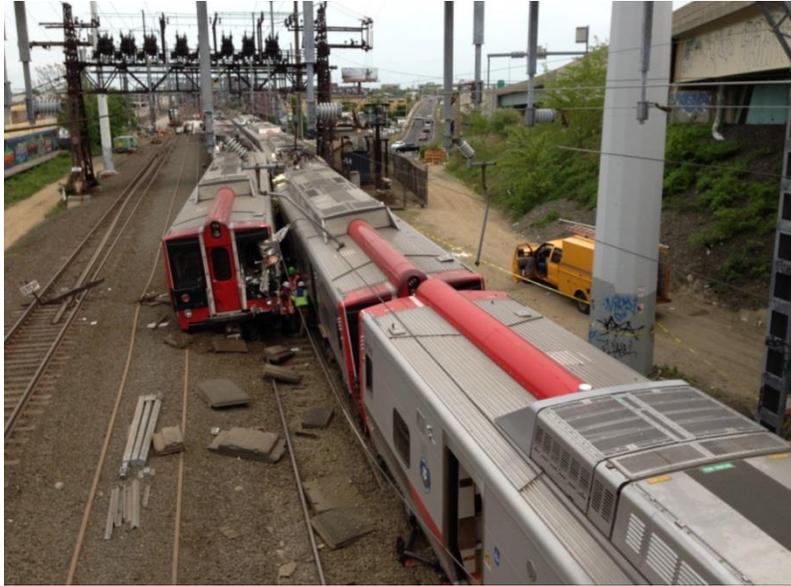
The NTSB determined that the probable cause of the derailment was an undetected broken pair of compromise joint bars on the north rail of track 4 on the Metro-North New Haven

subdivision at MP 53.25 resulting from: (1) the lack of a comprehensive track maintenance program that prioritized the inspection findings to schedule proper corrective maintenance; (2) the regulatory exemption for high-density commuter railroads from the requirement to traverse the tracks they inspect; and (3) Metro-North's decisions to defer scheduled track maintenance.

Figure 1. View of the accident between Metro-North passenger trains 1548 (right) and 1581 (left).

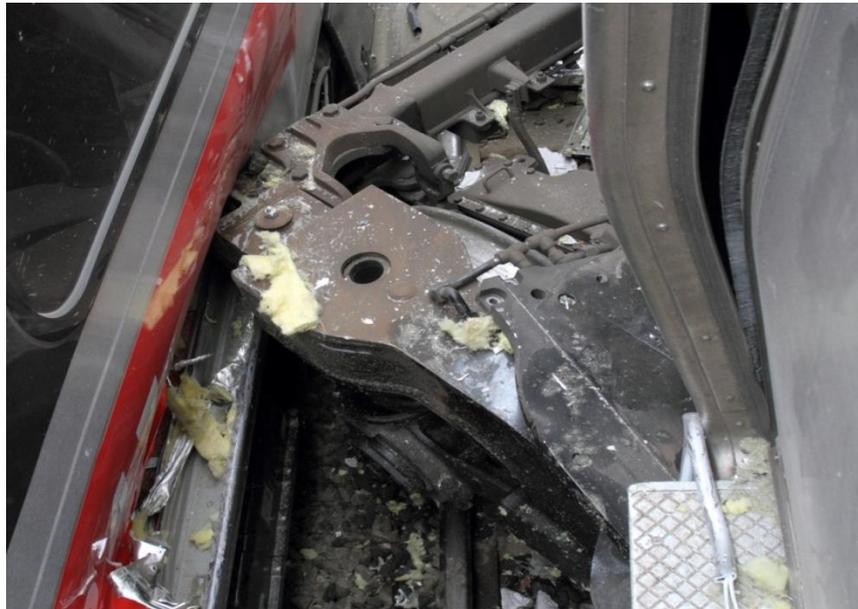
In the collision, a truck assembly from lead passenger railcar 9193 of striking passenger train 1581 detached from the railcar body. The truck moved laterally, rotated, and protruded from under the passenger railcar. The front left corner of the truck struck and raked passenger railcar 9247, which was the fourth passenger railcar of train 1548. The raking impact created a sidewall intrusion into the occupant space of passenger railcar 9247. (See Figure 2.)

An examination of the detached truck assembly identified that all of the mounting bolts had failed. On M-8 passenger railcars, the truck assembly is attached to the passenger railcar body with eight 1.25-inch diameter Grade 5 bolts at 952 foot-pounds of torque.

Figure 2. Photograph of the detached truck assembly from Metro-North passenger railcar 9193 of the striking passenger train protruding into passenger railcar 9247.

As part of the NTSB's investigation, the FRA commissioned the Volpe National Transportation Systems Center (Volpe) to evaluate the M-8 passenger railcar truck mount. The Volpe evaluation reviewed the finite element analysis provided by the railcar manufacturer to demonstrate compliance with 49 CFR 238.219. Volpe evaluated both the current Grade 5 bolts and the upgraded Grade 8 bolts. The findings indicated that Grade 5 bolts do not appear to support the required 250,000-pound load and that Grade 8 bolts do appear to support the required load.

The NTSB is concerned that the margin of safety in the current design of the M-8 passenger railcar truck-to-railcar body attachment is inadequate. The NTSB believes that the Grade 5 mounting bolts used in M-8 passenger railcars do not ensure that the truck assembly will remain attached to the railcar body during an accident. The truck of passenger railcar 9193 detached from the railcar body during a relatively low-speed accident due to failed mounting bolts. As a result, the detached truck assembly intruded into the occupant space of passenger railcar 9247, increasing the severity of the accident.

Replace the Grade 5 mounting bolts in the M-8 passenger railcar fleet with stronger bolts to ensure that the railcars comply with Title 49 *Code of Federal Regulations* 238.219. (R-15-03)
