National Transportation Safety Board

Safety Recommendation

In reply refer to: R-15-6 (Urgent)

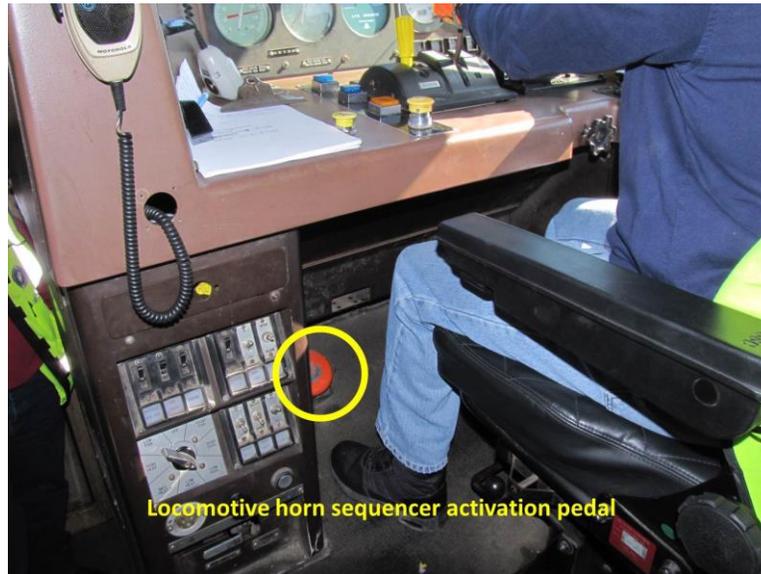
side) under the control console. (See figure 1.) Documentation provided by the UP indicated that the pedal is pressed once and released to activate the system. The pedal is pressed again to deactivate the system.

Figure 1. Locomotive horn sequencer pedal from exemplar UP locomotive.

- The horn sequencer was activated with a single push of the sequencer foot pedal located under the engineer's control console at several speeds ranging from 20 mph to 75 mph.
- The sequencer sounded the standard grade-crossing horn cadence (long, long, short, long) repeatedly at all speeds until the sequencer foot pedal was again depressed, which silenced the horn.

Based on examination of the Lococam data and the operating characteristics of the horn sequencer, we determined that the southbound train's horn sequencer was active for a 4-minute 6-second period before the accident.

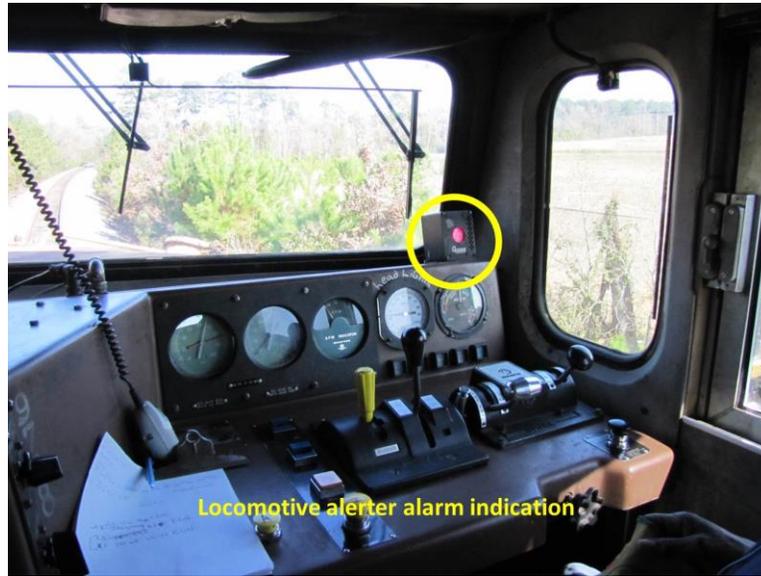
The alerter alarm cycle begins with 10 seconds of visual alarms of increasing intensity followed by 10 seconds of visual and audible alarms of increasing intensity. (See figure 2.) After this sequence, if the engineer does not perform an input or action to reset the alerter (one of the control inputs and actions listed above), the alerter relay is deenergized, the alarm is silenced, and the brakes are applied.

Figure 2. Exemplar locomotive alerter indication.

As discussed above, event recorder data from the southbound train show that the horn sounded repeatedly during the 4-minute 6-second period that began at 2:23:47. During the first 1 minute 49 seconds (109 seconds) while the horn was sounding, the throttle remained in position 8. The data revealed no other actions that would have reset the alerter. During the 109 seconds, the average speed of the southbound train was 32.5 mph. Using the formula for calculating the timeout period, at this speed if the horn sequencer had not been configured to reset the alerter, the alerter would have alarmed about 74 seconds after the horn sequencer was activated.

The data show that at 2:25:36, with the horn sequencer still activated, the throttle was moved from position 8 to position 7. This action would have reset the alerter timing cycle. And for the next 2 minutes 16 seconds, the horn continued sounding the grade-crossing cadence. The data revealed no other actions that would have reset the alerter. During this time, the average speed of the southbound train was 41 mph. Again, using the formula for calculating the timeout period, at this speed, if the horn sequencer had not been configured to reset the alerter, the alerter would have alarmed about 59 seconds after the throttle moved from position 8 to position 7, requiring the engineer to reset the alerter twice during the 2 minutes 16 seconds before the horn sounds ended.

The current configuration of the horn sequencer on the UP's locomotives prevented the alerter from activating and initiating a penalty brake application at least three times before the collision. Although the Hoxie accident investigation is ongoing, we are concerned about automatic locomotive control systems that prevent the operation of the alerter. We believe that if the alerter had not been repeatedly reset, it would have alarmed in the minutes before the collision with visual and audible alarms and a penalty brake initiation had the engineer not responded. Although we cannot determine whether an alerter activation would have prevented

Inform your members of the circumstances of this accident and the risks posed by automated inputs that reset alerter cycles. Urge your members to assess their locomotive alerter systems to (1) identify any inputs that reset the alerter cycle without intervention by crew members and (2) determine ways to eliminate such resets.

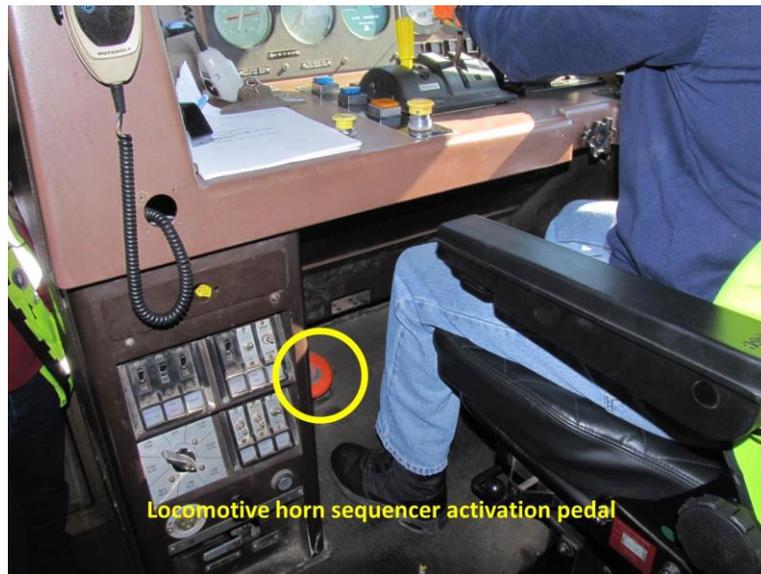
side) under the control console. (See figure 1.) Documentation provided by the UP indicated that the pedal is pressed once and released to activate the system. The pedal is pressed again to deactivate the system.

Figure 1. Locomotive horn sequencer pedal from exemplar UP locomotive.

- The horn sequencer was activated with a single push of the sequencer foot pedal located under the engineer's control console at several speeds ranging from 20 mph to 75 mph.
- The sequencer sounded the standard grade-crossing horn cadence (long, long, short, long) repeatedly at all speeds until the sequencer foot pedal was again depressed, which silenced the horn.

Based on examination of the Lococam data and the operating characteristics of the horn sequencer, we determined that the southbound train's horn sequencer was active for a 4-minute 6-second period before the accident.

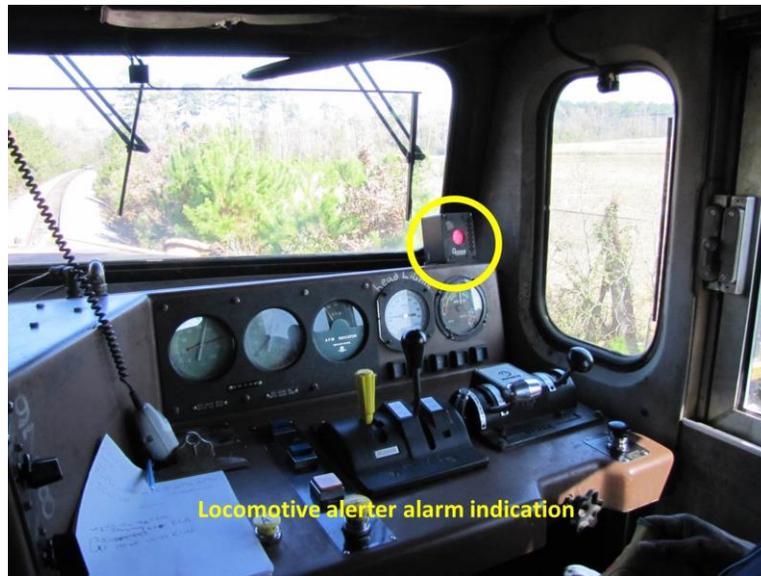
The alerter alarm cycle begins with 10 seconds of visual alarms of increasing intensity followed by 10 seconds of visual and audible alarms of increasing intensity. (See figure 2.) After this sequence, if the engineer does not perform an input or action to reset the alerter (one of the control inputs and actions listed above), the alerter relay is deenergized, the alarm is silenced, and the brakes are applied.

Figure 2. Exemplar locomotive alerter indication.

As discussed above, event recorder data from the southbound train show that the horn sounded repeatedly during the 4-minute 6-second period that began at 2:23:47. During the first 1 minute 49 seconds (109 seconds) while the horn was sounding, the throttle remained in position 8. The data revealed no other actions that would have reset the alerter. During the 109 seconds, the average speed of the southbound train was 32.5 mph. Using the formula for calculating the timeout period, at this speed if the horn sequencer had not been configured to reset the alerter, the alerter would have alarmed about 74 seconds after the horn sequencer was activated.

The data show that at 2:25:36, with the horn sequencer still activated, the throttle was moved from position 8 to position 7. This action would have reset the alerter timing cycle. And for the next 2 minutes 16 seconds, the horn continued sounding the grade-crossing cadence. The data revealed no other actions that would have reset the alerter. During this time, the average speed of the southbound train was 41 mph. Again, using the formula for calculating the timeout period, at this speed, if the horn sequencer had not been configured to reset the alerter, the alerter would have alarmed about 59 seconds after the throttle moved from position 8 to position 7, requiring the engineer to reset the alerter twice during the 2 minutes 16 seconds before the horn sounds ended.

The current configuration of the horn sequencer on the UP's locomotives prevented the alerter from activating and initiating a penalty brake application at least three times before the collision. Although the Hoxie accident investigation is ongoing, we are concerned about automatic locomotive control systems that prevent the operation of the alerter. We believe that if the alerter had not been repeatedly reset, it would have alarmed in the minutes before the collision with visual and audible alarms and a penalty brake initiation had the engineer not responded. Although we cannot determine whether an alerter activation would have prevented

Inform your members of the circumstances of this accident and the risks posed by automated inputs that reset alerter cycles. Urge your members to assess their locomotive alerter systems to (1) identify any inputs that reset the alerter cycle without intervention by crew members and (2) determine ways to eliminate such resets.

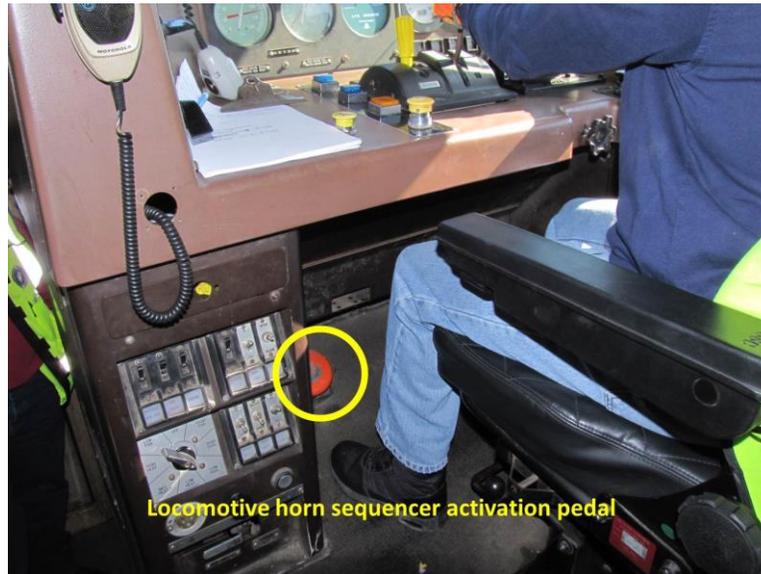
side) under the control console. (See figure 1.) Documentation provided by the UP indicated that the pedal is pressed once and released to activate the system. The pedal is pressed again to deactivate the system.

Figure 1. Locomotive horn sequencer pedal from exemplar UP locomotive.

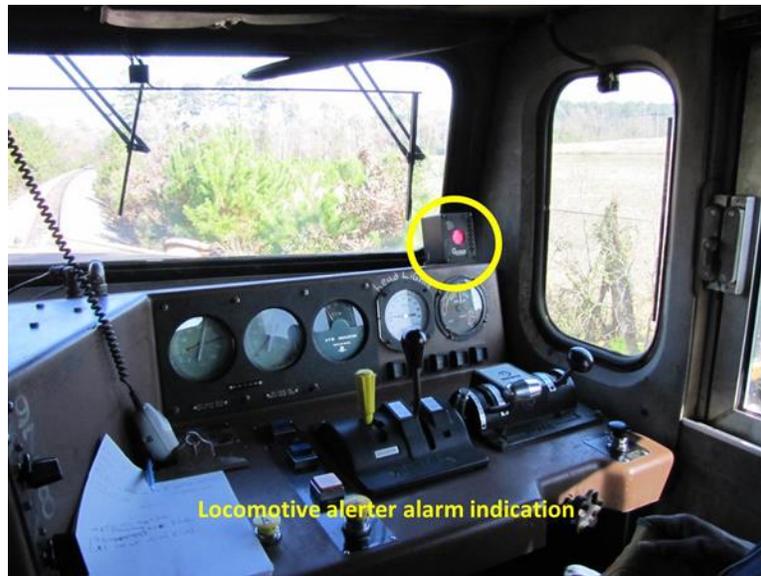
The alerter alarm cycle begins with 10 seconds of visual alarms of increasing intensity followed by 10 seconds of visual and audible alarms of increasing intensity. (See figure 2.) After this sequence, if the engineer does not perform an input or action to reset the alerter (one of the control inputs and actions listed above), the alerter relay is deenergized, the alarm is silenced, and the brakes are applied.

Figure 2. Exemplar locomotive alerter indication.

As discussed above, event recorder data from the southbound train show that the horn sounded repeatedly during the 4-minute 6-second period that began at 2:23:47. During the first 1 minute 49 seconds (109 seconds) while the horn was sounding, the throttle remained in position 8. The data revealed no other actions that would have reset the alerter. During the 109 seconds, the average speed of the southbound train was 32.5 mph. Using the formula for calculating the timeout period, at this speed if the horn sequencer had not been configured to reset the alerter, the alerter would have alarmed about 74 seconds after the horn sequencer was activated.
