National Transportation Safety Board

Safety Recommendation

In reply refer to: R-15-25

We urge the Washington Metropolitan Area Transit Authority (WMATA) to take action on the safety recommendation issued in this letter. This recommendation is derived from our ongoing investigation of the electrical arcing and smoke accident near the WMATA L'Enfant Plaza station in Washington, D.C., on January 12, 2015, and supported by evidence from the February 11, 2015, electrical arcing and smoke incident at the Court House station. Although our investigation is not yet completed, this recommendation addresses a safety issue requiring immediate action. Information supporting this recommendation is discussed below.

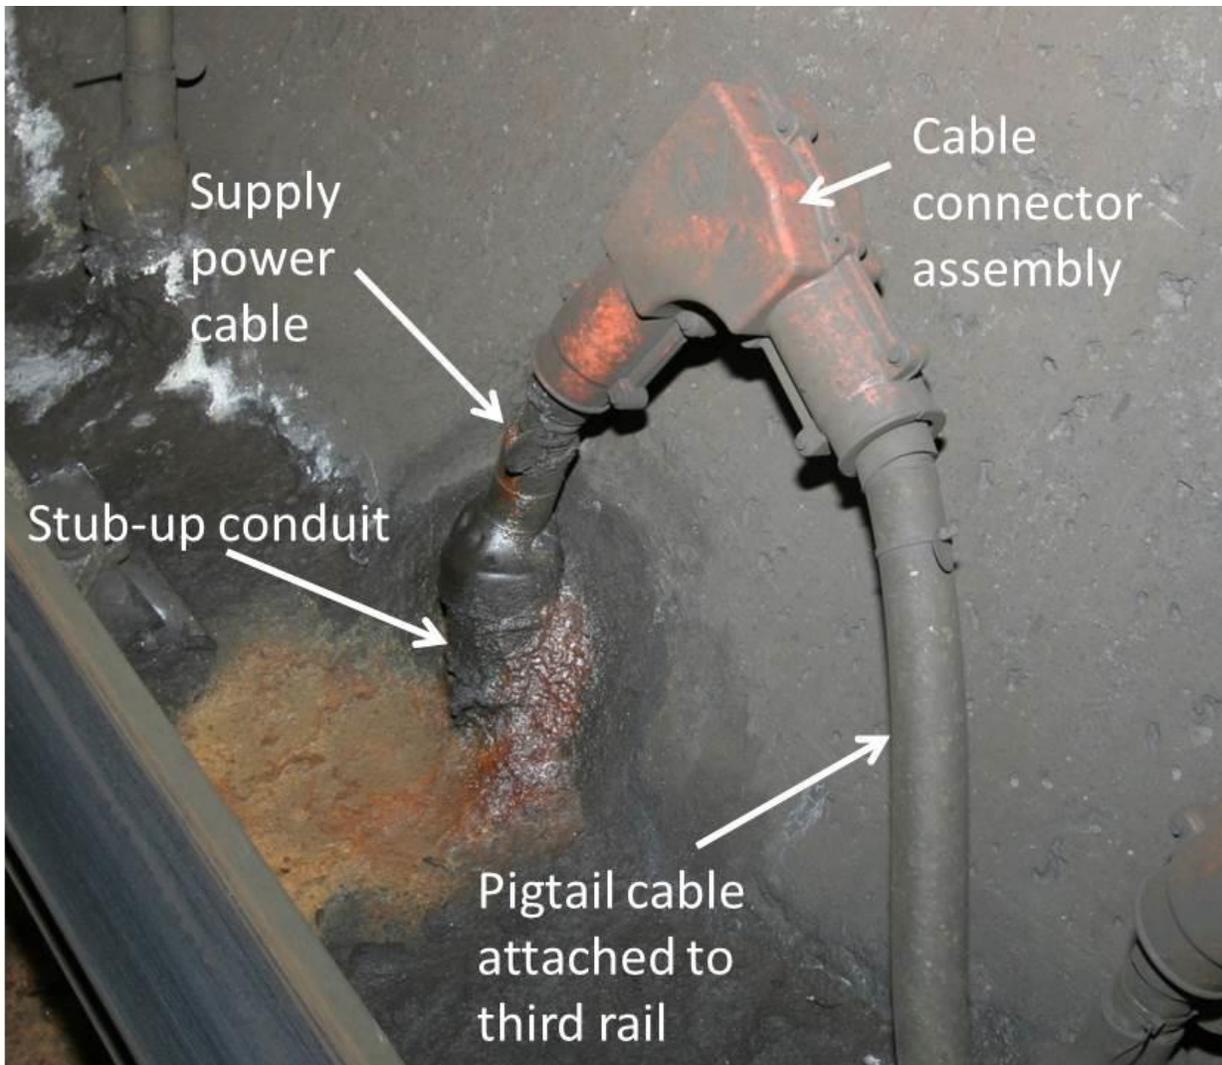
Figure 1 shows the typical arrangement of a supply power cable connected to a pigtail cable, which is welded to the third rail (a cable connector assembly protects the bolted terminal lugs).⁵ The supply power cable is brought to the surface of the tunnel through a stub-up conduit.⁶ In figure 2, the two upper images show the thermally damaged connector cover from the Court House station incident; in the lower image, the thermal damage is identified along the length of the pigtail cable.

Figure 1. A typical stub-up conduit with supply power cable, cable connector assembly, and pigtail cable.

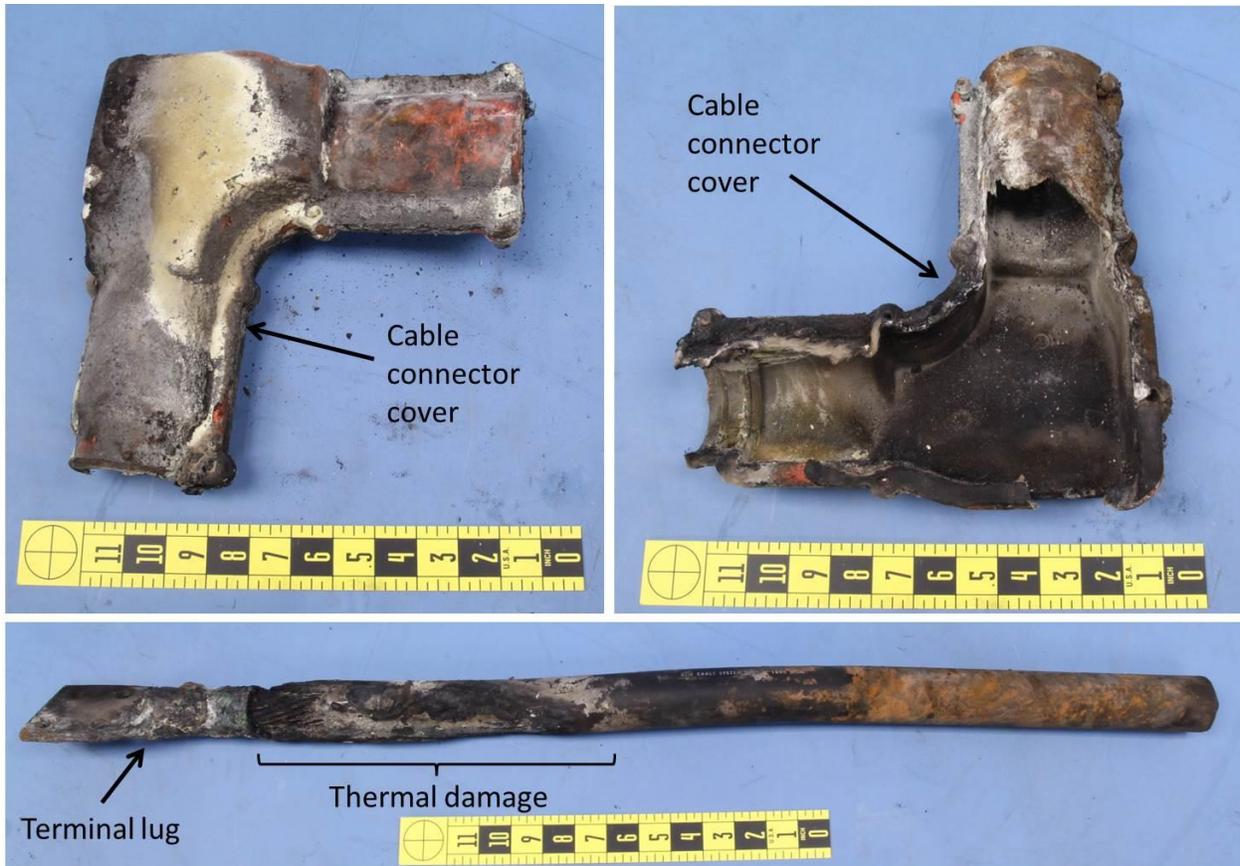
The laboratory evaluation of evidence recovered from the Court House station incident revealed that smoke in the tunnel was generated by thermal damage to about 11 inches of power cable insulation and a portion of the fiberglass cable connector cover. The signatures on the damaged power cable were consistent with a short circuit due to electrical arc tracking. The arc tracking occurred between a terminal lug inside a cable connector assembly and extended along the surface of a section of the pigtail cable leading to the third rail.⁴ The terminal lug was inside a connector cover at the time of the arc tracking, and the cable was lying on the tunnel floor. Inspection revealed no evidence of cable insulation chafing or direct contact between the lug and a grounding medium.

Figure 2. Section of electrical power cable from Court House station incident exhibiting thermal damage. The two upper images show the connector cover from the Court House station incident; in the lower image, the thermal damage is identified on the cable insulation.

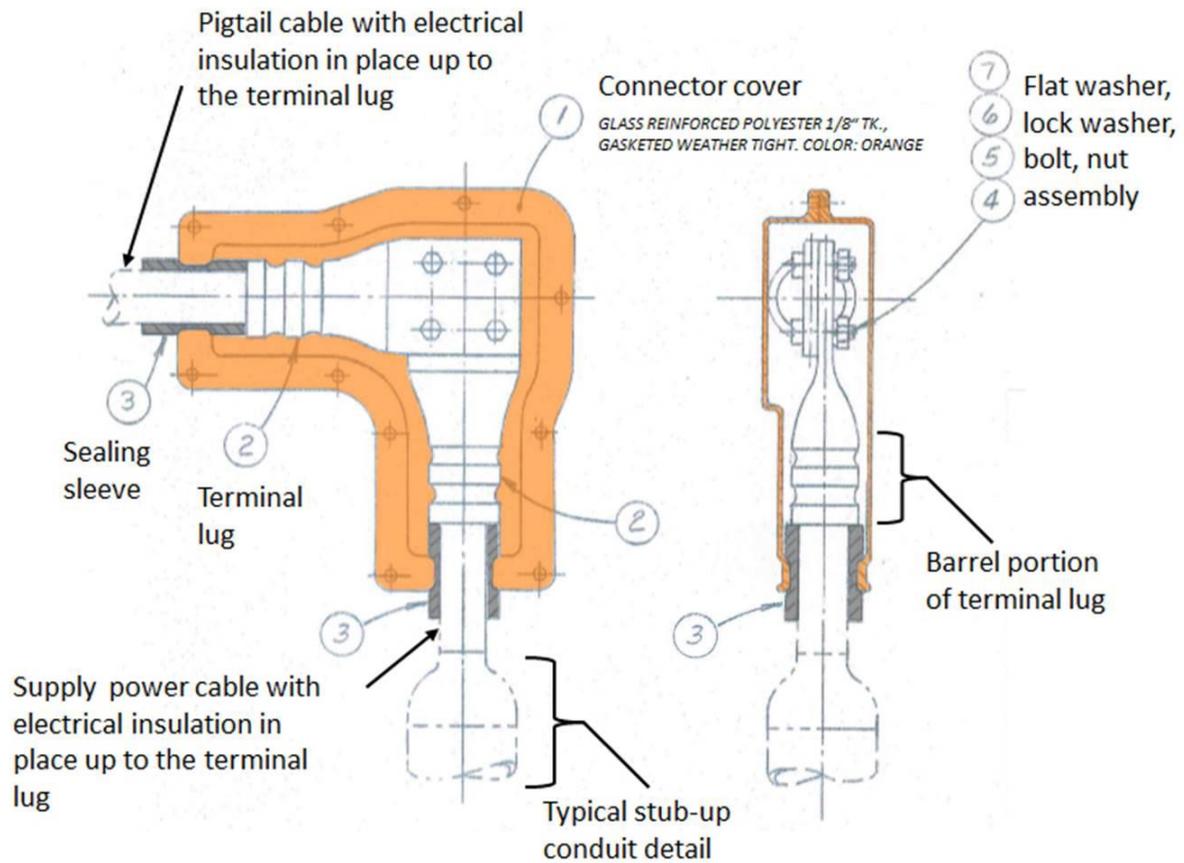
Figure 3 shows the correct cable connector assembly in accordance with WMATA’s engineering design specifications. According to WMATA engineering and procurement documents and discussions with engineering personnel, the power cable connector covers are designed to be weather tight when installed with all sealing sleeves (see figure 3).⁷ However, investigators found that the failed power cable connector assembly at the Court House station incident location was missing its sealing sleeves. Figure 4 shows an in-service assembly without the sealing sleeves. NTSB investigators have found a number of other power cable connector assemblies throughout the WMATA Metrorail system constructed without sealing sleeves; often with heat shrink tubing or electrical tape used in place of the sealing sleeves; and with different types of terminal lugs, some of which are not specified for use with their connector covers.⁸

Figure 3. Cable connector assembly showing the correct arrangement of the terminal lugs, connector cover, and sealing sleeves. The typical arrangement of electrical power cables is identified.

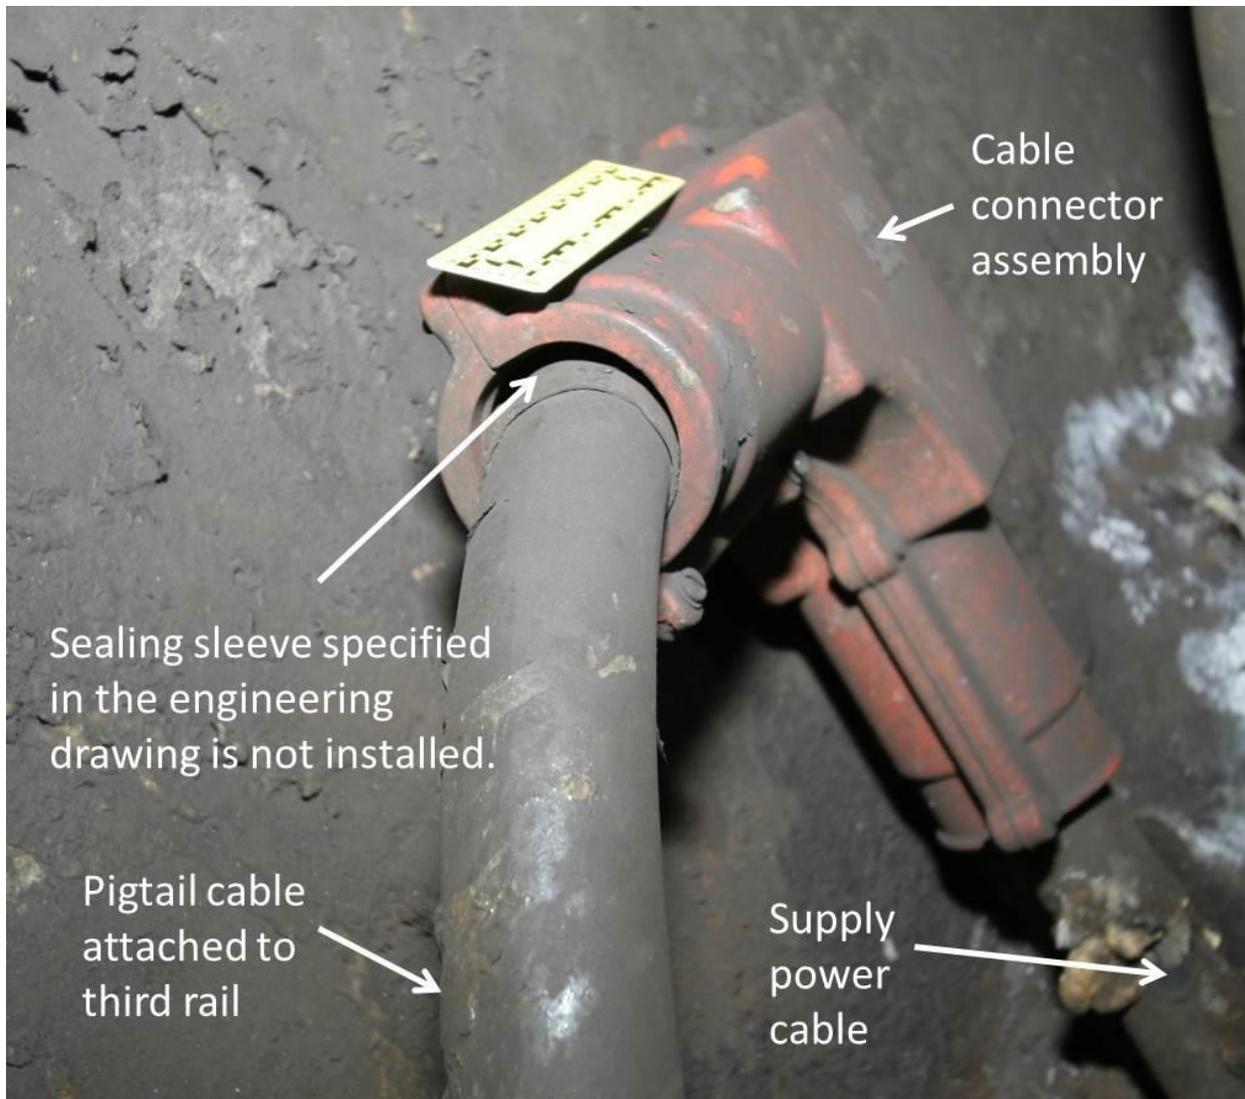
These power cable connector assemblies were not in accordance with WMATA's engineering design specifications.

Figure 4. Installed cable connector assembly without required sealing sleeve.

According to discussions with WMATA, it does not have a program to ensure that power cable connector assemblies are installed in accordance with its engineering design specifications. The specified cable connector covers are installed; however, WMATA has allowed maintenance crews and contractors to use various types of terminal lugs and sealing methods. In what should be identical assemblies throughout the system, NTSB investigators have found numerous power cable connector assemblies that are not in accordance with WMATA's engineering design specifications. These assemblies are frequently missing sealing sleeves and use a variety of different terminal lugs. Even the postaccident repairs made to the power cable connector assembly at L'Enfant Plaza did not include the sealing sleeves indicated in the WMATA engineering design specifications. Although the investigation of the L'Enfant Plaza accident is ongoing and additional analysis is needed before the cause can be determined, the damaged power cable in the Court House station incident is consistent with electrical arc tracking due to contaminants and moisture on the power cable surface. The NTSB concludes that WMATA's third rail electrical power cable systems are susceptible to electrical arc tracking at improperly constructed power cable connector assemblies, which can lead to short circuits that can generate fire and smoke in tunnels.

Promptly develop and implement a program to ensure that all power cable connector assemblies are properly constructed and installed in accordance with your engineering design specifications, including the weather tight seals that prevent intrusion by contaminants and moisture. (R-15-25)

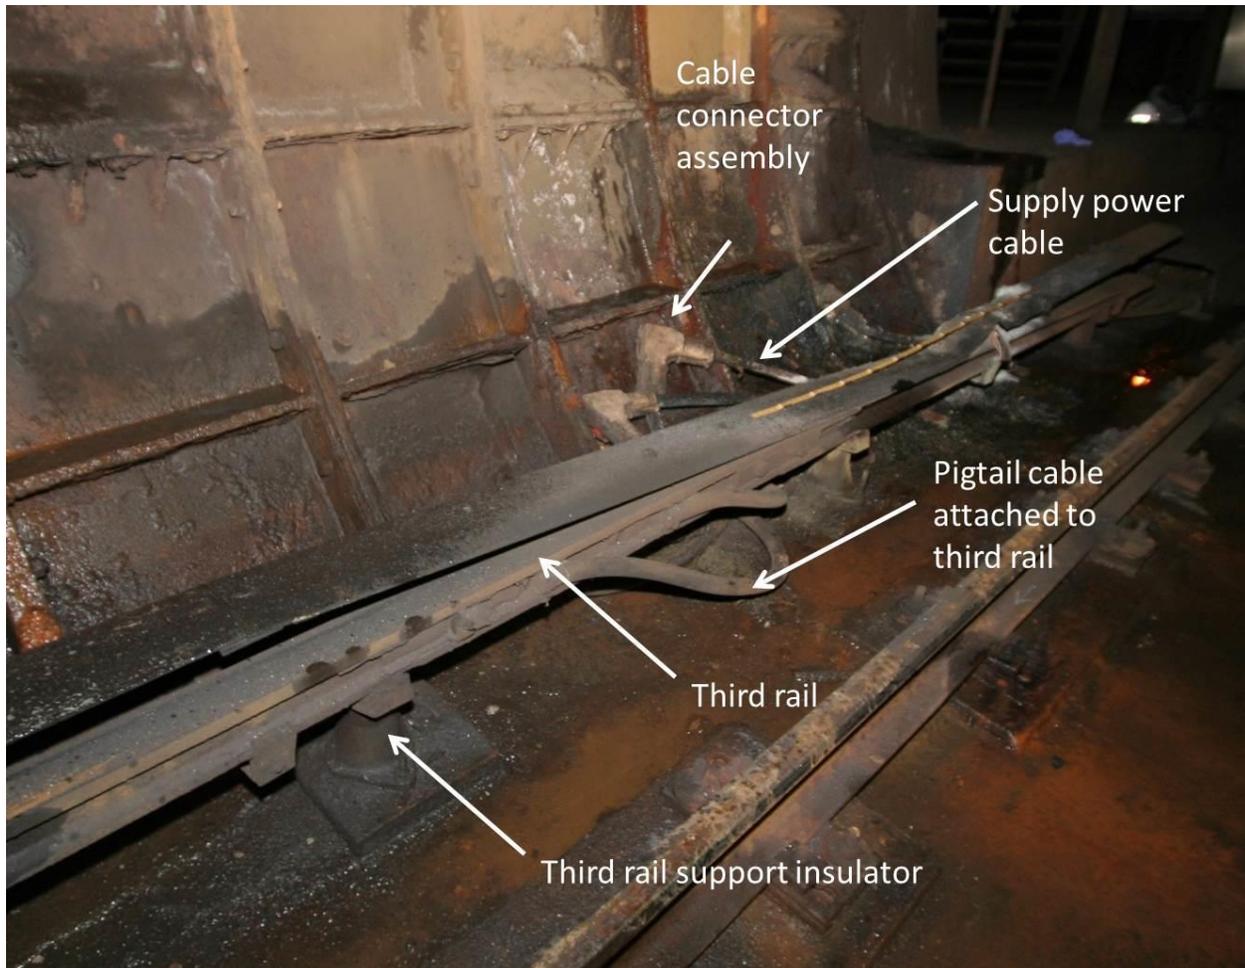
There are many transit systems operating in the United States where the trains are powered by a third rail that is supported on electrical isolation insulators.⁹ Figure 5 shows components of the third rail power distribution system at the L'Enfant Plaza accident location. There are three primary areas where electrical arc tracking can occur:

1. Along the surface of the third rail support insulators, between the third rail and the floor of the tunnel.
2. Along the insulated surface of the pigtail cable, between the terminal lug in the connector assembly and the floor of the tunnel (or along the insulated surface of the cable, between the third rail end of the pigtail cable and the floor of the tunnel).
3. Along the insulated surface of the supply power cable, between the terminal lug in the connector assembly and the floor of the tunnel.

Figure 5. Third rail components with insulating surfaces susceptible to electrical arc tracking at L'Enfant Plaza accident location.
