# National Transportation Safety Board

## Safety Recommendation

**Date:** May 28, 2010

**In reply refer to:** A-10-96 and -97 and  
A-04-11, -15, and -16 (Reiteration)

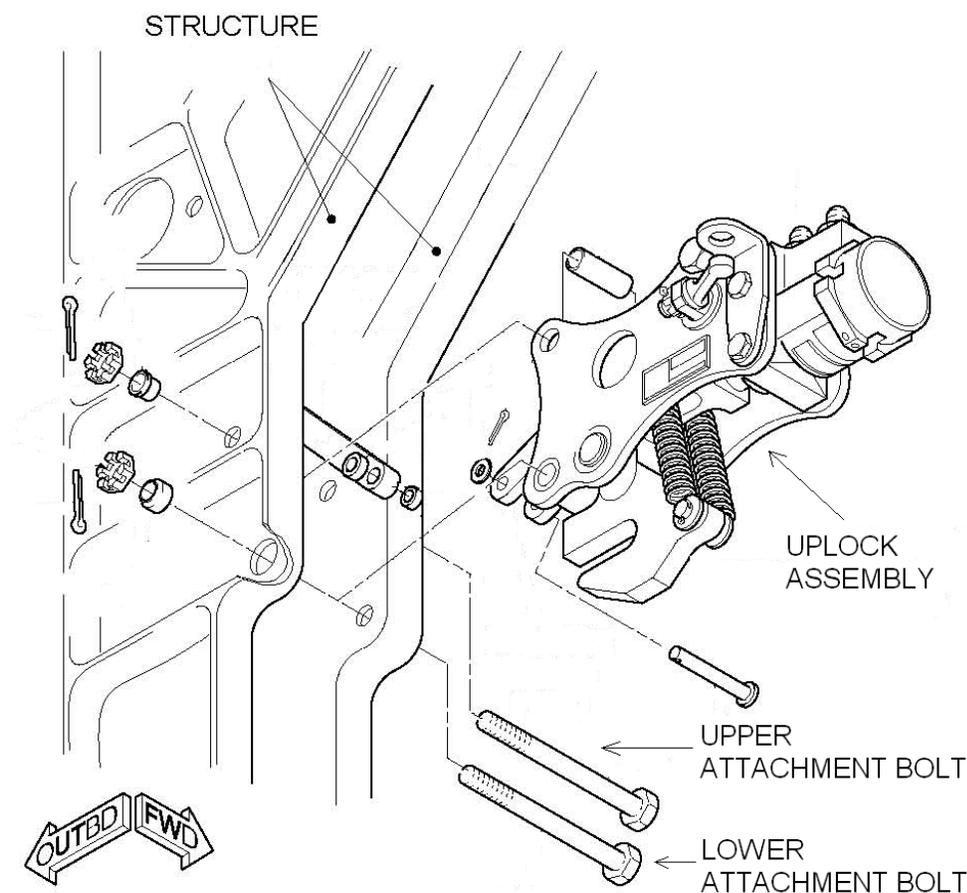
On December 13 and 14, 2008, the incident airplane underwent extensive maintenance at the AWAC maintenance facility at ORF, including the removal, replacement, and visual inspection of the left and right MLG uplock assemblies (see figure).<sup>3</sup> The work order indicated that this task was a required inspection item (RII).<sup>4</sup> Mechanics were only able to work on one assembly at a time due to the confined space in the wheel well, so the work was divided between

two mechanics. The NTSB's investigation revealed that the mechanic who replaced the left uplock assembly (the incident mechanic) had not replaced an uplock assembly prior to working on the incident airplane, had not received on-the-job training (OJT) for this task (it was not required for this task), and was not being supervised during the procedure.<sup>5</sup> In a postincident interview, the incident mechanic stated that he relied on AWAC's General Maintenance Manual (GMM) and the mechanic who was replacing the right uplock assembly for guidance.<sup>6</sup> However, when the incident mechanic replaced the left uplock assembly, the upper attachment bolt, nut, and cotter pin assembly used to mount the left MLG uplock assembly to the structure were installed but did not engage the uplock assembly, which allowed the uplock assembly to pivot about the lower bolt. Because the upper attachment bolt did not engage the uplock assembly, the left MLG remained in the up-and-locked position and did not respond to the pilot's commands to lower prior to landing.

**Figure.** MLG uplock assembly and upper and lower attachment bolts.

The NTSB concludes that the AWAC incident mechanic was not properly trained or supervised when he replaced the uplock assembly on the incident airplane for the first time, which led to the error in installation. Further, the error was not detected by the inspector. The NTSB is concerned that the Federal Aviation Administration (FAA) does not currently require mechanics to receive OJT or be supervised while performing RII tasks for the first time.

The NTSB concludes that the post-maintenance inspections performed by the AWAC incident RII inspector were not adequate to detect the misrigging of the uplock assembly. The incident inspector's lack of training and experience with the removal and installation procedures of the uplock assemblies may have contributed to his failure to detect installation discrepancies. In addition to the inspector's lack of experience, he failed to follow the procedures in the AMM.

<sup>16</sup> The discrepancies were to replace the lower cotter pin, fix a gap measurement, and fix a hydraulic fluid leak. (The upper bolt, nut, and cotter pin assembly did not engage the uplock assembly.)

Require that mechanics performing required inspection item and other critical tasks receive on-the-job training or supervision when completing the maintenance task until the mechanic demonstrates proficiency in the task. (A-10-96)

Require that required inspection item (RII) inspectors receive supervision or on-the-job training on the proper inspection of RII items until the inspector demonstrates proficiency in inspection. (A-10-97)
