National Transportation Safety Board

Safety Recommendation

In reply refer to: A-10-136 through -147

Engine Control Quadrant Design

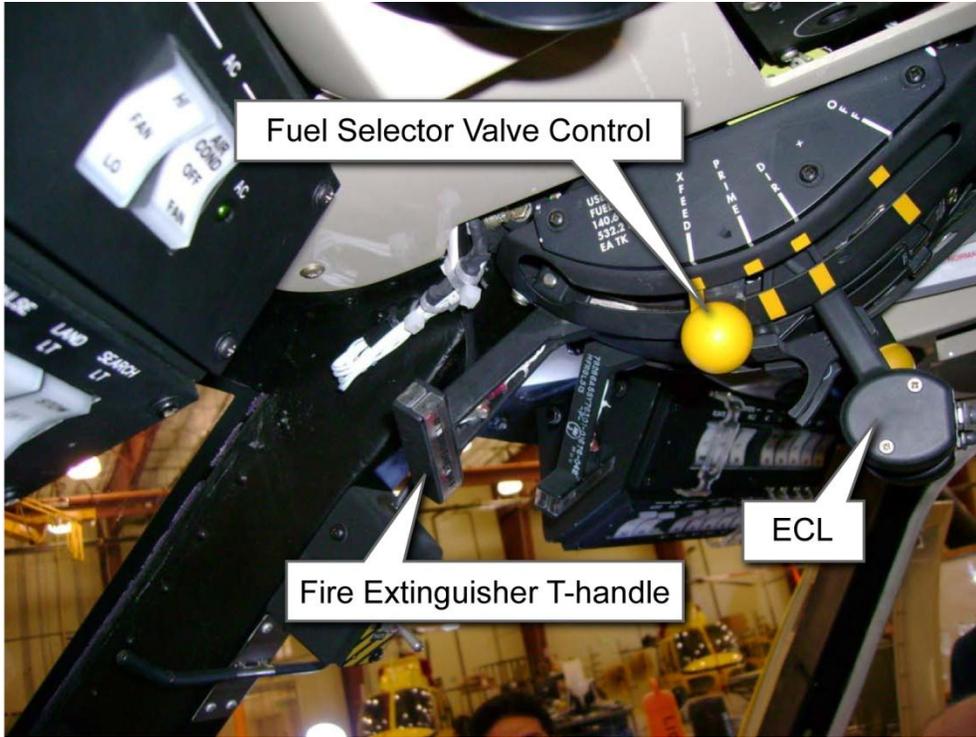
The Sikorsky S-76C++ helicopter has an overhead engine control quadrant that houses two engine fire extinguisher T-handles, two engine power control levers (ECL), two fuel selector valve control levers, and switches for other essential functions (see figure 1). The fire extinguisher T-handles, which are located about 4 inches aft of the captain's and first officer's windshields, are normally in the full-forward position during flight and are held in place by a spring-loaded pin that rests in a detent; aft pulling force is required to move the handles out of their detents (see figure 2). In the event of an in-flight engine fire indication, the flight crew is instructed, in part, to move the affected engine's fire extinguisher T-handle full aft so that a mechanical cam on the T-handle pushes the trigger on the ECL out of the wedge-shaped stop, allowing it to physically move aft with the T-handle (pilot input is required to move the T-handle and ECL aft together); fuel to the affected engine is then reduced. The fuel flow to the engine is eventually shut off as the fire extinguisher T-handle continues aft. The fire extinguisher system is then automatically armed and ready for the pilots to release the fire extinguishing agent into the appropriate engine compartment. Sikorsky S-76C+, S-76D, and S-92A helicopters have engine control quadrant designs similar to the S-76C++ helicopter.

Figure 1. Engine control quadrant on a Sikorsky S-76C++ helicopter.

The NTSB concludes that impact forces on the S-76C++⁶ canopy or windshields near the engine control quadrant and the subsequent movement of T-handles, which may push the ECL triggers out of the stops and allow them to move aft and into or near the flight-idle position, could result in unexpected and substantial loss of engine power. Greater resistance to movement of the fire extinguisher T-handles would ensure that the T-handles do not become dislodged due to impact force on the canopy or windshield and cause unintended movement of the ECLs. The NTSB understands that pilots would then need to use greater force to move the T-handles; however, this resistance can be calculated so that it will not lead to operational problems for the pilots who activate the T-handles when needed and will still provide protection against unintentional movement of the T-handles and ECLs. Therefore, the NTSB recommends that the FAA require that Sikorsky redesign the S-76C++ model helicopter fire extinguisher T-handles and/or engine control quadrant to ensure that the T-handles do not inadvertently dislodge out of their detents due to any external force on the canopy or windshields that could cause unintended movement of the ECLs. The NTSB further recommends that the FAA evaluate other helicopter models with engine control quadrant designs similar to the S-76C++ model helicopter and require modification, as necessary, to ensure that any external force on the canopy or windshields does not cause unintended movement of the ECLs.

Require that Sikorsky redesign the S-76C++ model helicopter fire extinguisher T-handles and/or engine control quadrant to ensure that the T-handles do not inadvertently dislodge out of their detents due to any external force on the canopy or windshields that could cause unintended movement of the engine power control levers. (A-10-136)

Evaluate other helicopter models with engine control quadrant designs similar to the S-76C++ model helicopter and require modification, as necessary, to ensure that any external force on the canopy or windshields does not cause unintended movement of the engine power control levers. (A-10-137)

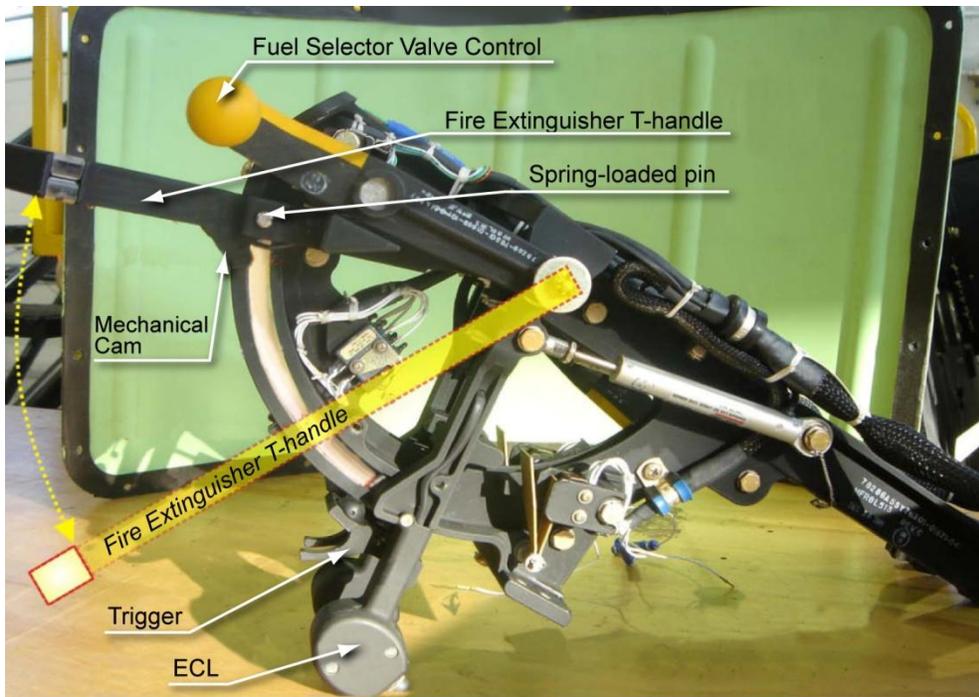
Figure 2. S-76C++ fire extinguisher T-handle and ECL with trigger mechanism.

Based on the impact damage to the canopy, it is likely that the bird impacted the canopy just above the right-side windshield near the fire extinguisher T-handles. As noted, the CVR recorded a loud bang and rushing wind, immediately followed by sounds consistent with a power reduction on both engines; thus, it is likely that the bird impact shattered the windshield and jarred the fire extinguisher T-handles out of their detents and moved them aft. The momentum of the T-handles pushed both ECL triggers out of their stops and allowed them to move aft and into or near the flight-idle position. A similar incident occurred on November 13, 1999, in West Palm Beach, Florida, when a bird struck the windshield of an S-76C+ helicopter, N276TH, operated by Palm Beach County.⁵ The bird did not penetrate the laminated glass windshield, but the impact force of the bird cracked the windshield and dislodged the fire extinguisher T-handles out of their detents; however, in that case, the force was not great enough to move the ECLs.
