National Transportation Safety Board

Safety Recommendation

Date: February 23, 2012

In reply refer to: A-12-1 through -6

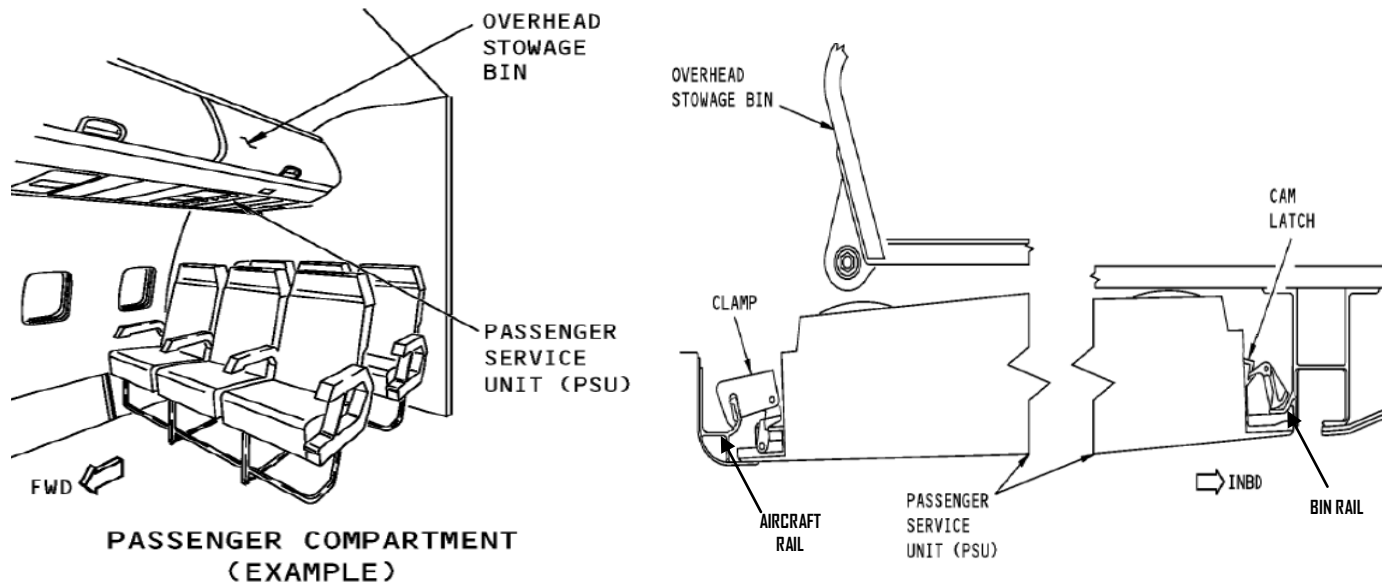
For all of the Boeing 737 accidents cited, the overhead bin and PSU installations were of common design and manufactured, installed, and inspected per Boeing specifications. Two polymer plastic clamps attach the outboard side of the PSU to the aircraft rail and fuselage side wall; two polymer cam latch mechanisms attach the inboard side of the PSU to the bin rail. The bin rail is fastened to the underside of the overhead bin (see figure 1). A maintenance lanyard is connected to the inboard side of the PSU to allow it to hang from the overhead bin for ease of

Figure 1. Diagram of a 737 PSU and overhead bin installation.

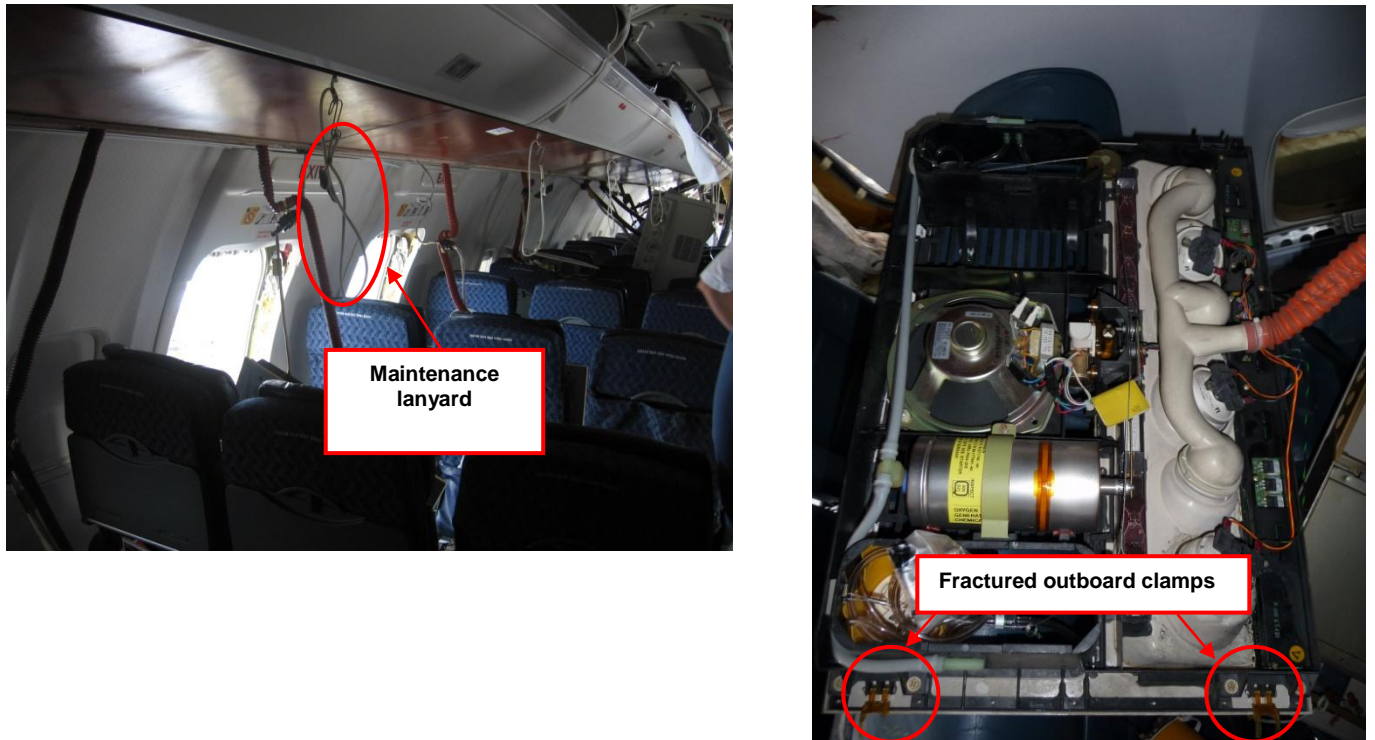
Figure 2. Photographs of a dislodged PSU, showing the maintenance lanyard and fractured outboard clamps.

The airplane wreckage from the Aires flight 8250, American Airlines flight 331, and Continental Airlines flight 1404 accidents were reexamined¹⁶ to further study the releases of the PSUs during an accident, and two potential failure modes were identified. The first was noted as a result of the examination of the American Airlines flight 331 and Aires flight 8250 airplanes. On the flight 331 airplane, overhead bins remained attached, except for the bins in the first-class cabin and at the fuselage breaks; however, the (C) tie rods on many overhead bins were broken, and many of the 9 g tie rods were bent and broken. The outboard aircraft rails remained attached. Similarly, the reexamination of the Aires flight 8250 airplane found that some overhead bin (C) tie rods were broken and 9G tie rods were bent and broken and that the outboard aircraft rails remained attached. To measure the load and rail deflection necessary for the outboard clamps to fail and a PSU to fall, static load tests were conducted by installing an engineering sample PSU (without an oxygen canister) in the flight 331 fuselage. Using chains and a turnbuckle, an inboard load (similar to the directional load that occurred during the accident sequence) was applied to the bin rail. A load cell between the turnbuckle and the chain measured the applied loads as the turnbuckle was tightened. A load of 487 pounds¹⁷ was required to fracture the test PSU outboard clamp. While the NTSB recognizes that this load far exceeds the FAA certification static test requirements of a 3 g side load, or 37.5 pounds,¹⁸ it demonstrates that the forces imposed on the outboard clamps during these accident sequences were greater than the forces present during certification static testing and likely caused them to fail.

Based on this information, it was determined that when the (C) tie rods broke during the accident sequences, overhead bins (and attached bin rails) were allowed to articulate inboard from their upper attachment points to the fuselage, causing increasing separation between the aircraft rails and bin rails. As the bin rails and aircraft rails moved farther apart, the resulting load from the bins was passed on to the PSU outboard clamps causing them to fracture. As the released PSUs dropped, the maintenance lanyards separated from the PSUs during the fall.¹⁹

Require that the installation design for overhead bins and passenger service units (PSU) manufactured by Boeing and installed in Boeing 737NG series airplanes be modified so that the PSUs remain attached to the bins or are captured in a safe manner during survivable accidents. (A-12-2)

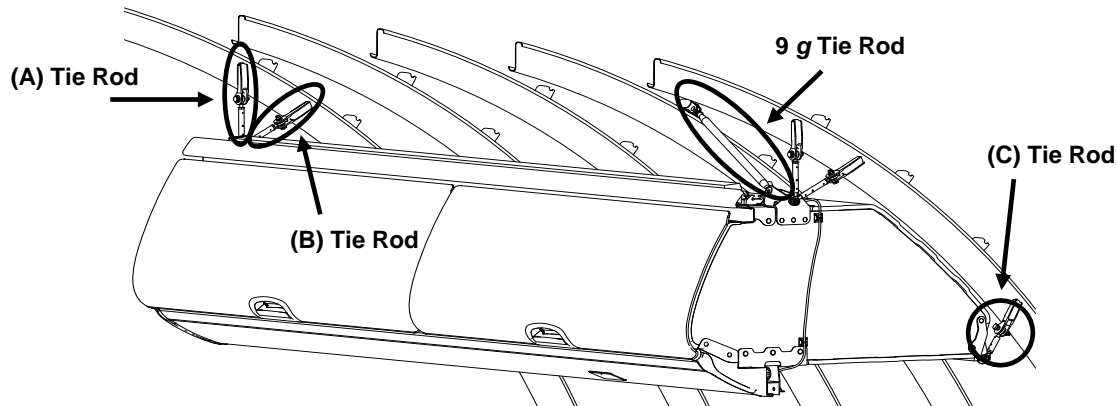
access when conducting maintenance (see figure 2). The overhead bin is suspended from the fuselage ceiling and side walls with the use of tie rods (labeled (A), (B), (C), and 9 g in figure 3).¹¹

Figure 3. Diagram of a 737 overhead bin installation, showing tie rod structural system.

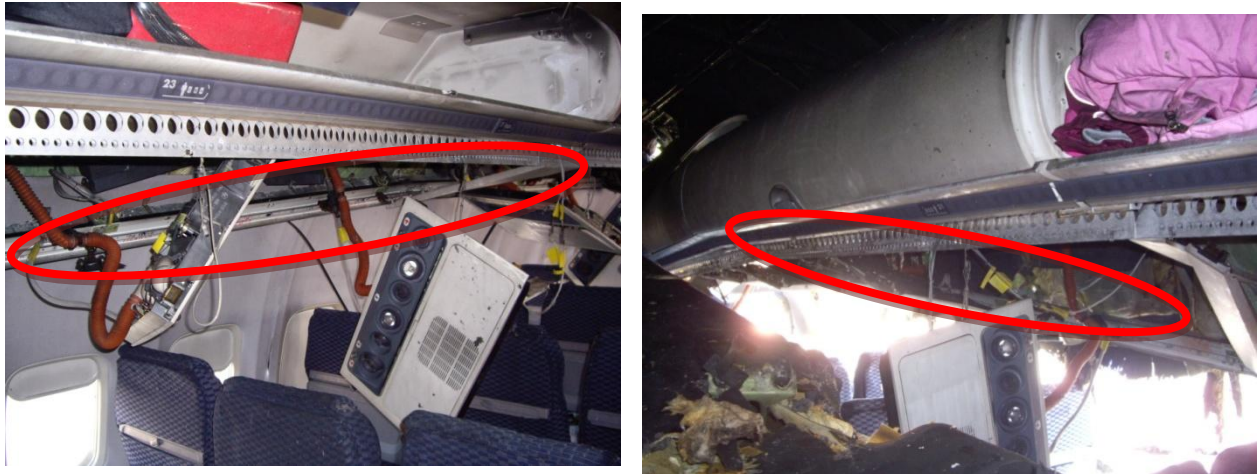
Examination of the Continental Airlines flight 1404 fuselage revealed a second failure mode for PSU detachment. In this accident, all the PSUs in the aft section after the fuselage

break became dislodged because the aircraft rails on both sides of the airplane, though themselves remaining intact, detached from the fuselage aft of row 18 while staying attached to the forward section of the airplane (see figure 4, which shows the detached aircraft rails). As the aft section of the fuselage separated, the relative motion of the outboard aircraft rails remaining with the forward section of the fuselage created high stresses in the PSU outboard clamps, resulting in their failure and release of the PSUs. For either failure mode, the relative motion of the outboard and inboard rails increases the stresses in the clamps well beyond the stresses that would be generated during tests using static forces.

Figure 4. Photographs showing failed aircraft rail on the left and right side of the aft section of Continental Airlines flight 1404.

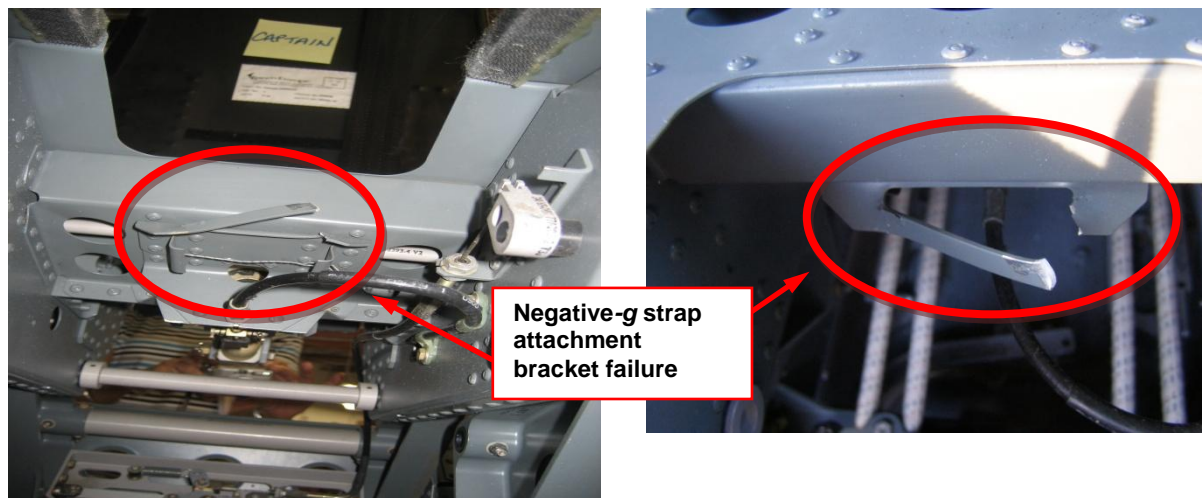
As mentioned previously, the purpose of the negative-*g* strap in a five-point restraint system is to hold the lap belt in a proper position to comply with the dynamic testing requirements of 14 CFR 25.562, "Emergency Landing Dynamic Conditions."²² Specifically, the strap is intended to prevent (1) the pelvis from rotating under the lap belt, thus increasing the loading on the spine and (2) the lap belt from rising into the soft tissue of the abdomen. In performing this function, the strap extends from the buckle to the seat, between the occupant's legs, and is secured by the attachment bracket, which is fixed to the seat. During the accident involving American Airlines flight 331, the captain's negative-*g* strap attachment bracket failed on the left side (the first officer's bracket remained intact);²³ both attachment brackets also failed on the left side for the captain and first officer of Continental Airlines flight 1404²⁴ (see figure 5). The three flight crewmembers suffered from either serious (compression fractures) or minor (pain) back injuries, which are consistent with, and possibly a result of, the occupants bouncing in their seats.

Figure 5. Photographs showing broken negative-*g* strap attachment bracket on American Airlines flight 331 captain's seat.

Ipeco, Inc. designed, tested, and manufactured the seats that were installed at the captain and first officer positions in both airplanes; however, the negative-*g* attachment brackets were of two different manufacturer designs. One bracket, designed by Ipeco, consists of 0.063-inch thick sheet aluminum that is riveted to the seat. A loop stitched onto the strap is inserted through the bracket, and a rod is inserted through the loop behind the bracket to keep the strap in place. This design was installed at all three crew positions where the bracket failed. The other bracket, designed by AmSafe Aviation, consists of 0.093-inch thick aluminum that is bolted to the seat, and the strap is looped through the bracket then stitched. The thicker bracket, used on the first officer's seat on flight 331, did not fail.

As part of the investigation of the flight 331 accident, the strength of the negative-*g* attachment bracket was evaluated by the JCAA, NTSB, Ipeco, and a biomedical engineer from the FAA Civil Aerospace Medical Institute. The evaluation considered the captain's weight,²⁵ the occupant motion (an estimation of body contact points and relationship to injury causation, seated position, and seat belt loading),²⁶ and typical seat deformation observed during seat sled testing for certification purposes. During the evaluation, Ipeco determined that damage to the seat was comparable to damage observed for seats that passed the 16.7 *g* pulse used during sled testing. The evaluation determined, however, that the lateral loading to the occupant and seat, as well as multiple impacts during the accident sequence would likely induce additional loading into the bracket. As a result, the evaluation suggested that the forces imposed on the bracket during the accident were greater than demonstrated during certification testing, even though the overall loading to the seat appeared to be equivalent to the 16 *g* test requirements.

Require that negative-g strap attachment brackets manufactured by Ipeco be retrofitted with stronger brackets. (A-12-6)
