National Transportation Safety Board

Safety Recommendation

Date: May 18, 2012

In reply refer to: A-12-18 through -20

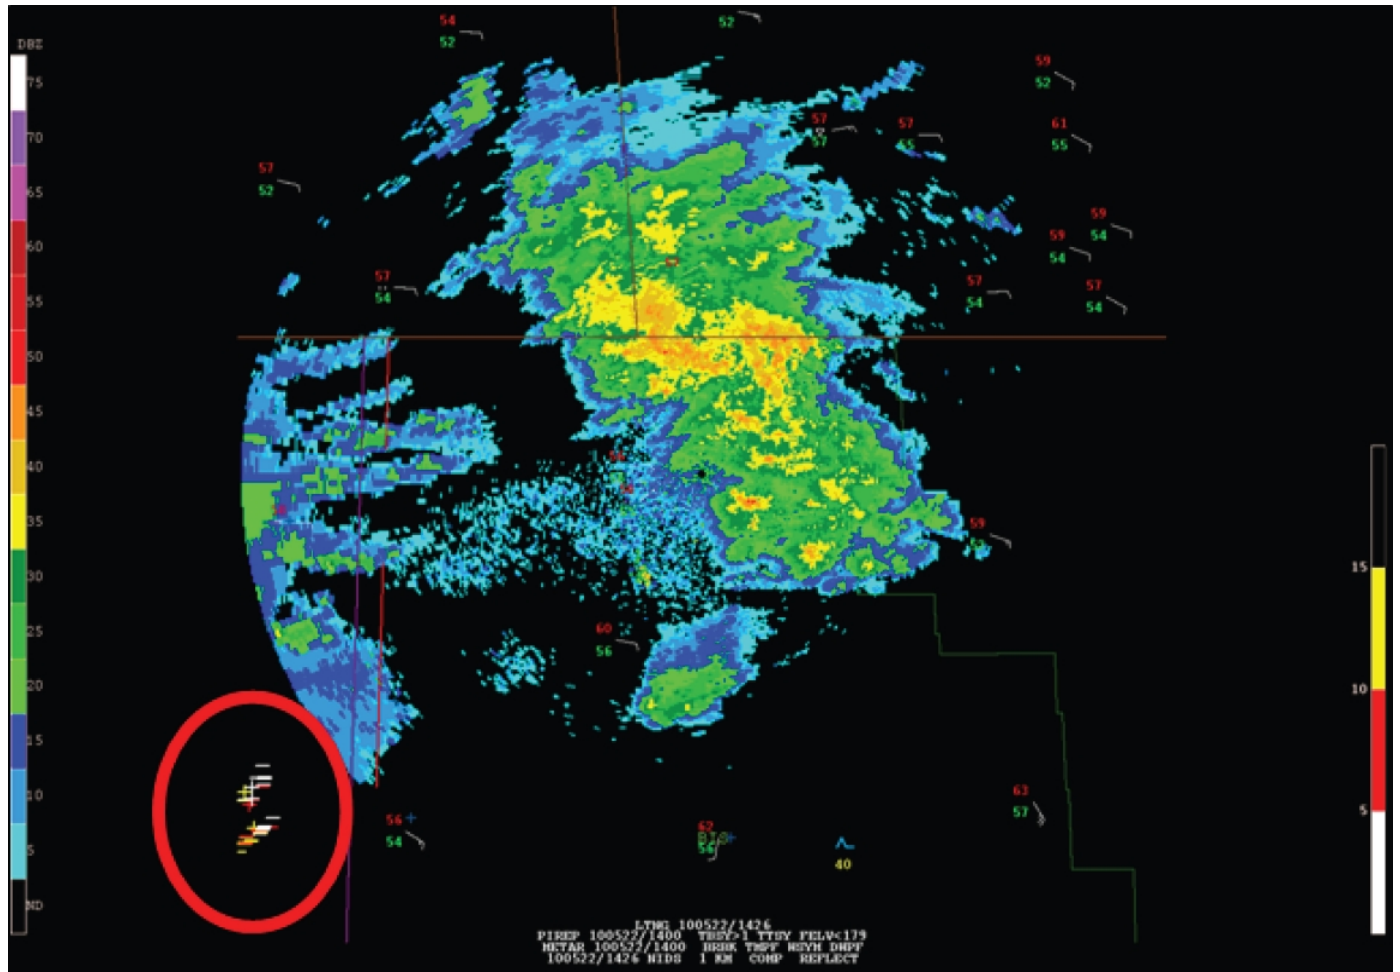
thunderstorm identification in regions of the National Airspace System where weather radar data are unavailable, such as parts of the Gulf of Mexico and portions of the western continental United States (see figure 1). In addition, lightning information is an important supplement to weather radar data because it can identify regions of airspace conducive to hazardous events even where precipitation returns from weather radar do not appear to be significant. For example, in 2002, a Chautauqua Airlines Embraer 145 regional jet descending through 13,000 feet near Windsor Locks, Connecticut, was struck by lightning,⁴ resulting in two of its four elevator cables being severed. No thunderstorm-related precipitation had been detected by weather radar in the vicinity of the airplane.

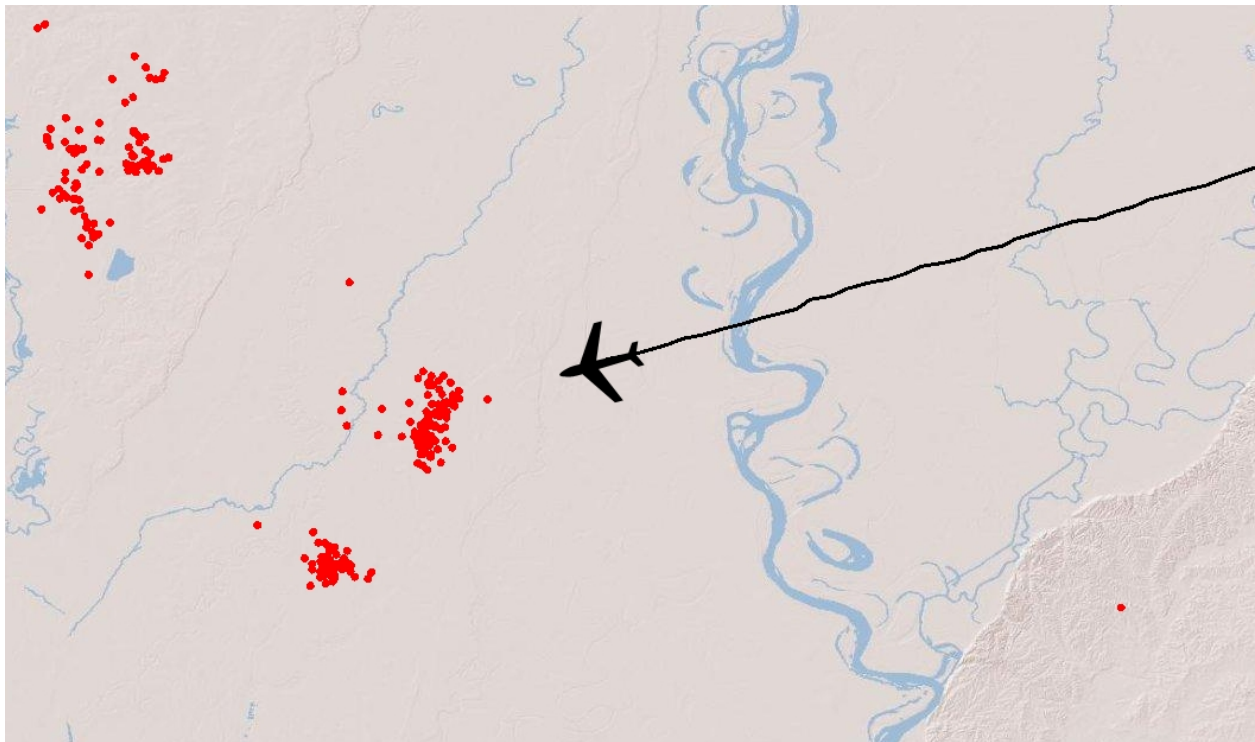
An NTSB review of recorded air traffic control (ATC) weather information along the airplane’s flightpath showed that an area of extreme intensity precipitation returns existed at the accident location and had been present for at least 15 minutes before the airplane encountered

severe turbulence. Review of ATC communications revealed that the air traffic controllers handling the flight did not advise the pilot of the precipitation ahead, as required by Federal Aviation Administration (FAA) Order 7110.65, *Air Traffic Control*.⁹ When interviewed, the controllers handling flight 3224 stated that their displays did not show any precipitation at the accident location.¹⁰

An NTSB meteorologist also reviewed commercially available archived lightning data (from the Earth Networks Total Lightning Network [ENTLN]¹¹) for the area and noted that substantial lightning activity had been recorded at the accident location. Figure 2 shows the airplane's position immediately before the accident, along with the locations of lightning strokes detected during the preceding 20 minutes. The lightning detected by the ENTLN was a strong indication of the presence of a thunderstorm immediately in front of the airplane. The captain stated in postaccident interviews that if he had been aware that there was a thunderstorm ahead, he would have asked ATC for a course change because American Eagle's policy instructed pilots to avoid thunderstorms by 20 miles.

Figure 2. American Eagle flight 3324 flightpath (black line) immediately before the accident 1751 central daylight time. Red dots indicate total lightning detected between 1731 and 1750.

Study the technical feasibility of presenting, through the use of the weather and radar processor system or other means, real-time total lightning data on controller displays at both air route traffic control centers and terminal radar approach control facilities, and, if feasible, incorporate real-time total lightning data on controller displays and in associated weather products for current and future display systems. (A-12-18)

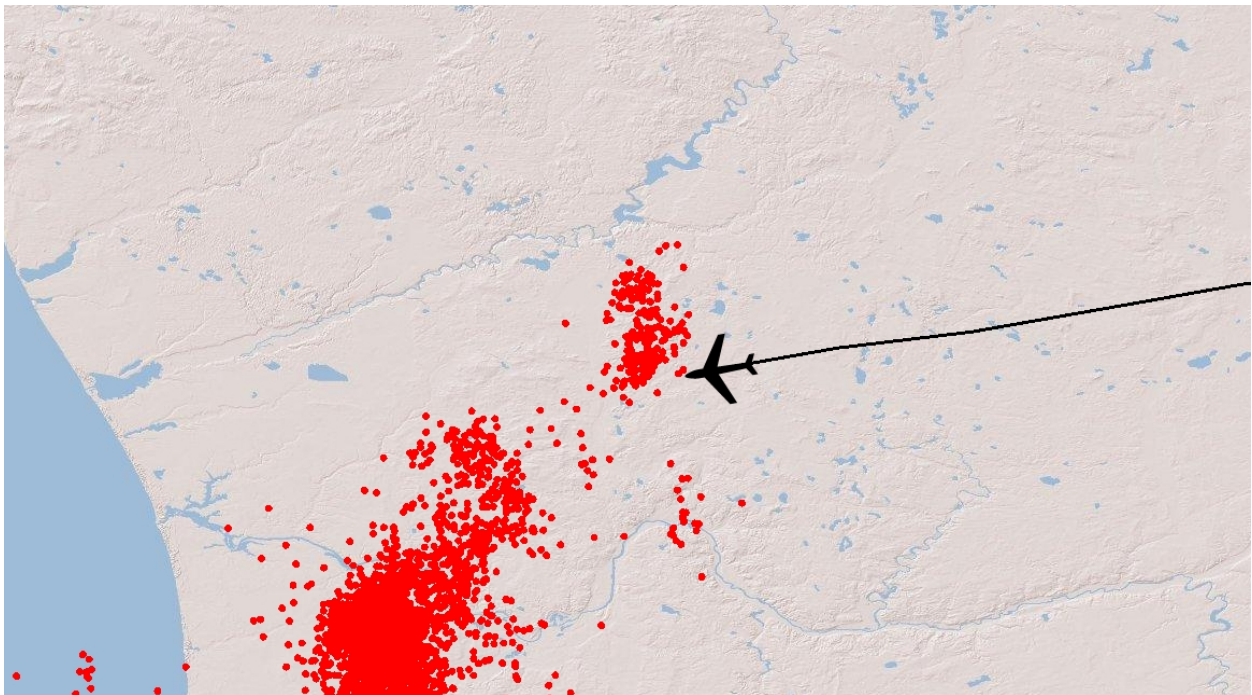
Plots of the airplane's position along with lightning data (see figure 3) indicated that the airplane penetrated an area of dense lightning activity. Analysis of ground-based weather radar data indicated that a convective cell collocated with the lightning activity may have contained hail up to 2 inches in diameter. Figure 3 depicts the flightpath of flight 4018 immediately before the hail encounter and shows that lightning activity was present during the previous 20 minutes at the event location. Review of ATC communications indicated that the crew was not advised of any detected precipitation, and, according to information provided by Pinnacle, the flight crew did not recall seeing any precipitation on their airborne radar display.

Figure 3. Pinnacle Airlines flight 4018 flightpath (black line) at 1226 central daylight time. Red dots indicate total lightning detected between 1206 and 1225 central daylight time.

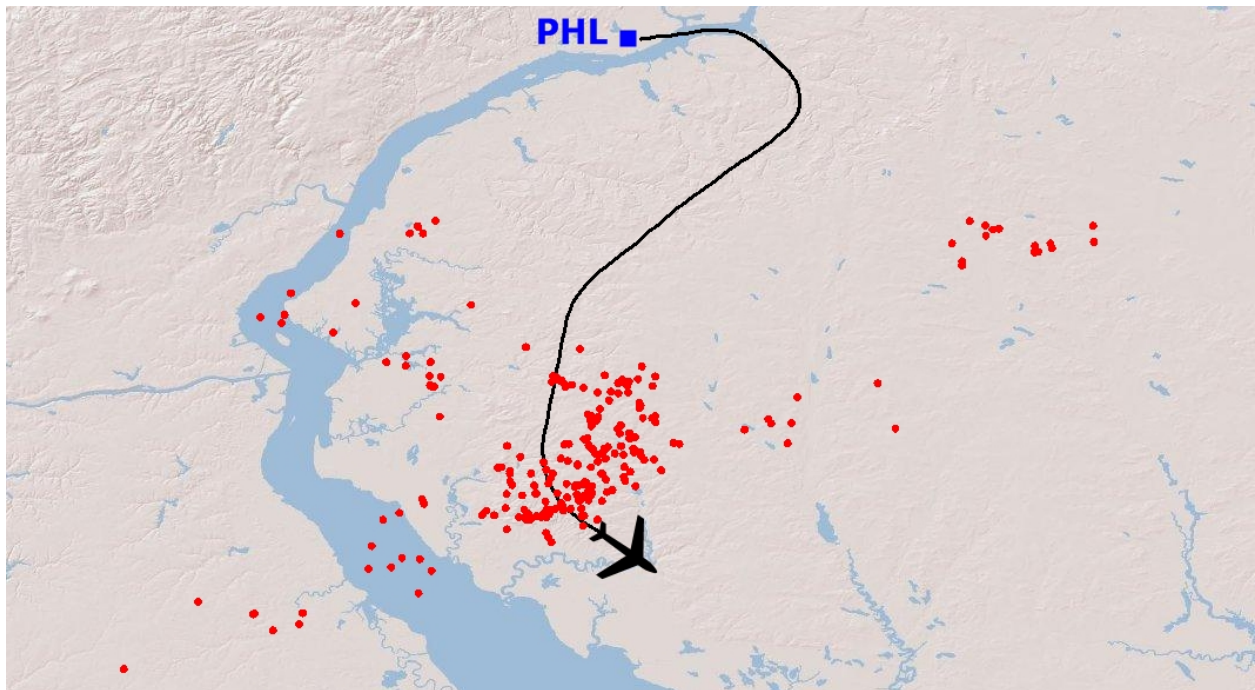
emergency, and diverted to Baltimore, Maryland, where the airplane landed without further incident. At the time of the incident, the flight was under control of the Washington ARTCC. When the pilot first contacted the center, the controller advised of moderate rain and turbulence along the airplane's route. About 3 minutes later, the pilot reported that the airplane had sustained a lightning strike and requested to return to Philadelphia "with priority," later changing the destination to Baltimore. The pilot added that the airspace the flight had just traversed contained "...moderate to possible severe..." turbulence, with multiple cloud-to-cloud lightning strokes. Figure 4 depicts the position of the airplane about the time that the pilot reported the lightning strike, along with the locations of lightning strokes detected in the area during the 15 minutes before the event.

Figure 4. US Airways flight 1209 flightpath (black line) about 1015 eastern daylight time. Red dots indicate total lightning detected between 1000 and 1015.

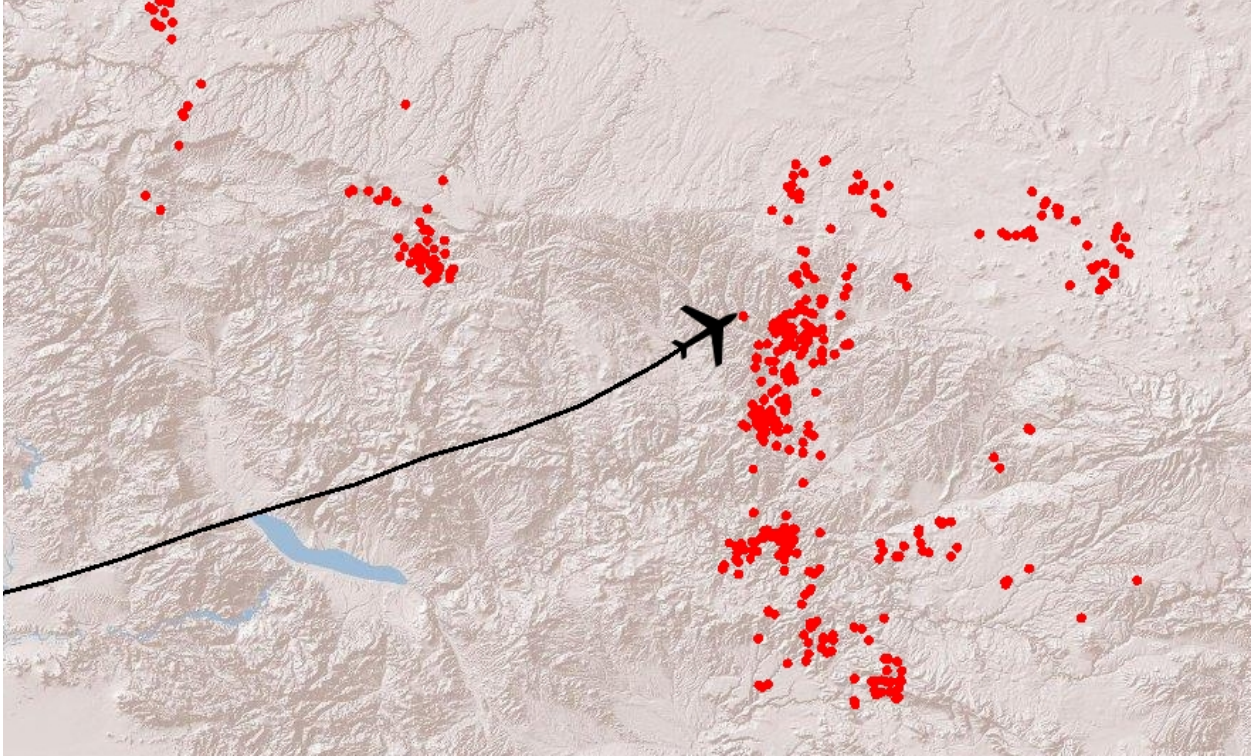
On August 18, 2011, about 1442 mountain daylight time, the flight crew of American Airlines flight 1894, a McDonnell-Douglas MD-83 en route from Phoenix, Arizona, to Dallas/Fort Worth, Texas, declared an emergency after encountering severe icing conditions at 33,000 feet near Show Low, Arizona. The crew diverted to Albuquerque, New Mexico, where the airplane landed without further incident. Severe icing events at these altitudes are rare and are normally associated with convective activity that can be readily detected by ground-based weather radar. Review of radar data recorded along the airplane's flightpath suggested the presence of convective activity in the area but only moderate precipitation returns at the location of the reported icing. However, as shown in figure 5, there was significant lightning detected in the area of the incident for at least 20 minutes before. If this information had been available to the crew, it would have alerted the pilots to potential hazards associated with convective activity well before they entered the area.

Figure 5. American Airlines flight 1894 flightpath (black line) at 1540 mountain daylight time. Red dots indicate total lightning detected between 1520 and 1539.

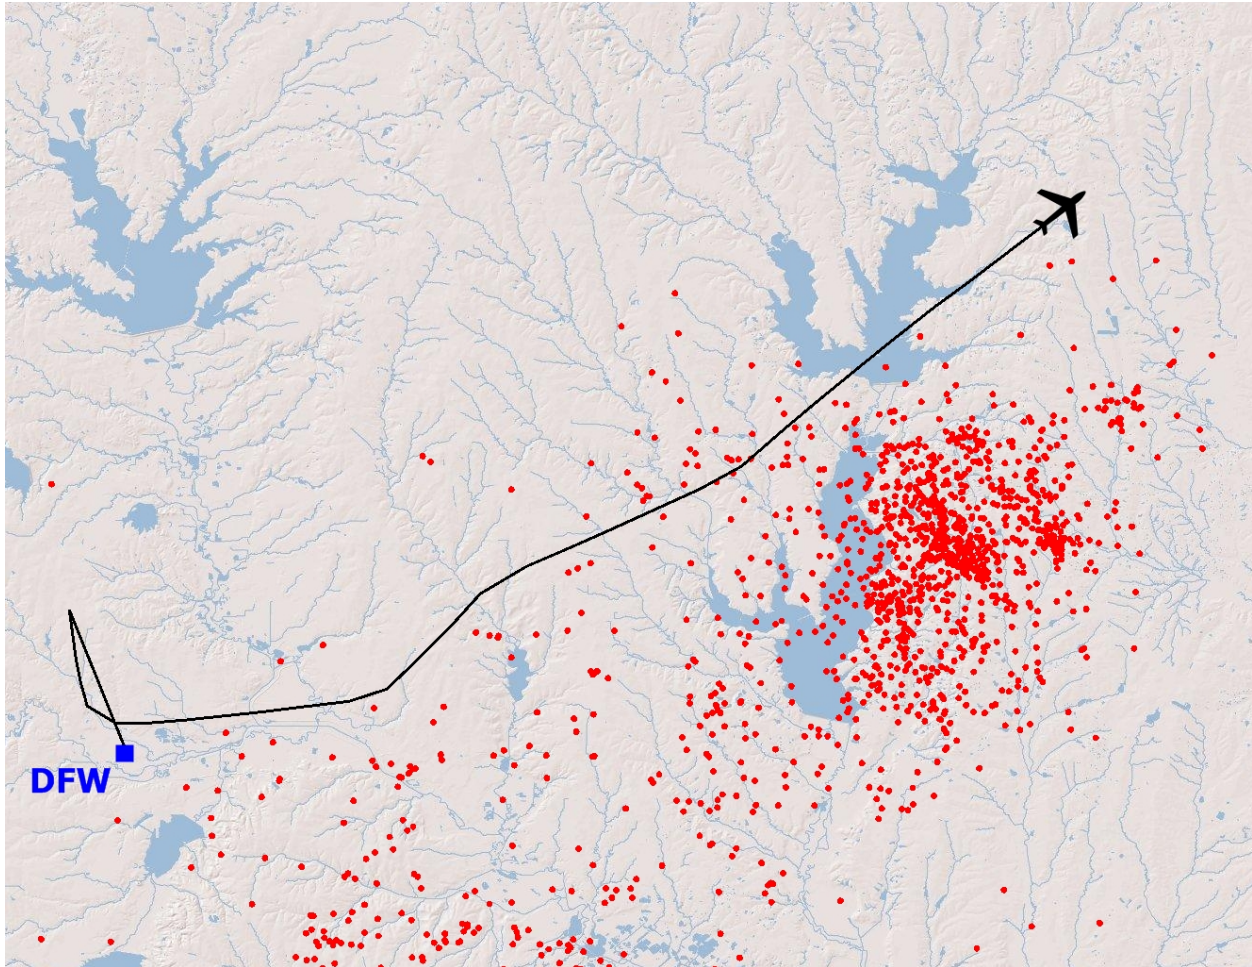
On January 24, 2012, about 1927 central standard time, the flight crew of American Eagle flight 3376, an Embraer 145 regional jet en route from Dallas/Fort Worth, Texas, to Madison, Wisconsin, declared an emergency after sustaining a lightning strike at about 17,500 feet near Farmersville, Texas. The crew immediately requested to divert to Little Rock, Arkansas, where the airplane landed without further incident. Review of weather radar data recorded along the airplane's flightpath showed convective activity in the immediate region; however, the aircraft had not penetrated any area of extreme precipitation returns. Although the aircraft successfully avoided the most dense area of lightning, significant lightning was detected along the aircraft's actual flightpath for at least 15 minutes before the emergency declaration (see figure 6). During postincident interviews, the controllers involved in the incident stated that the ability to depict lightning data on ATC displays would be useful in assisting pilots to avoid areas of hazardous weather.

Figure 6. American Eagle flight 3376 flightpath (black line) at 1927 central daylight time. Red dots indicate total lightning detected between 1912 and 1927.
