National Transportation Safety Board

Safety Recommendation

In reply refer to: A-12-50 and -51

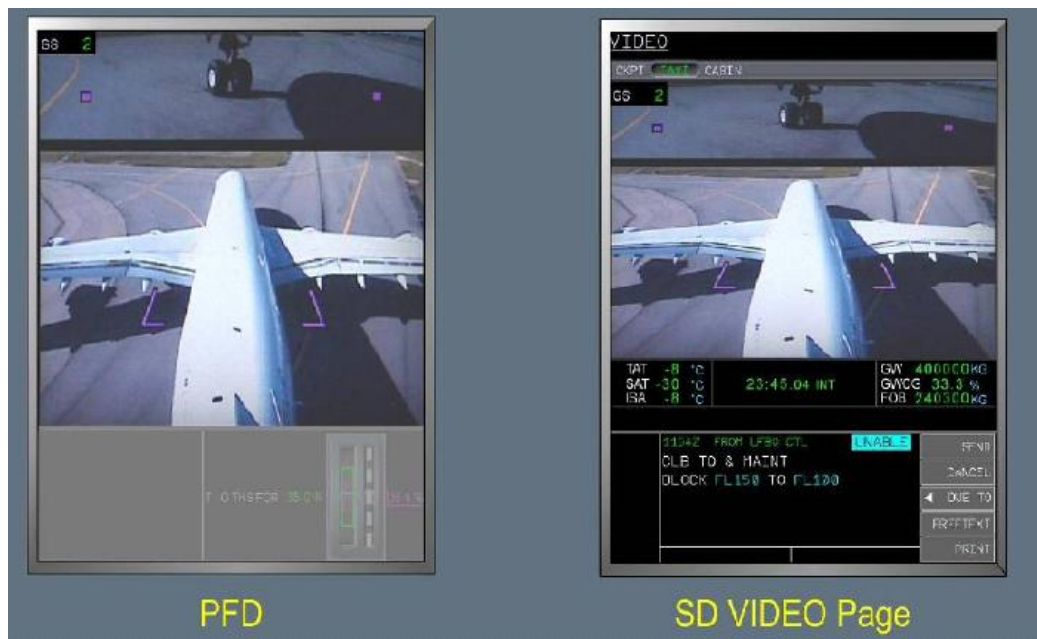
The live views from these cameras can be displayed on either primary flight displays (PFD) or on the system display (SD) when the airplane is on the ground and below 60 knots.⁸ The figure shows the view from the A380's BTACS and FTAC as shown on the PFD and SD.

Figure. Live camera views on an A380 as shown on the PFD and SD.

The NTSB notes that the A380 and other large airplanes do not currently have camera systems that display wingtips or wingtip paths. The NTSB is concerned that pilots of large airplanes where the wingtips are not visible from the cockpit may have difficulty determining wingtip clearance and path. The NTSB concludes that an anti-collision aid, such as a camera system that displays the airplane's wingtips, would give pilots of large airplanes a clear

Require the installation of an anti-collision aid, such as a camera system, on all newly manufactured and newly type-certificated large airplanes and other airplane models where the wingtips are not easily visible from the cockpit to provide a cockpit indication that will help pilots determine wingtip clearance and path during taxi. (A-12-50)

Require all existing large airplanes and other airplane models where the wingtips are not easily visible from the cockpit to be retrofitted with an anti-collision aid, such as a camera system, to provide a cockpit indication that will help pilots determine wingtip clearance and path during taxi. (A-12-51)
