National Transportation Safety Board

Safety Recommendation

Date: July 1, 2013

In reply refer to: A-13-024

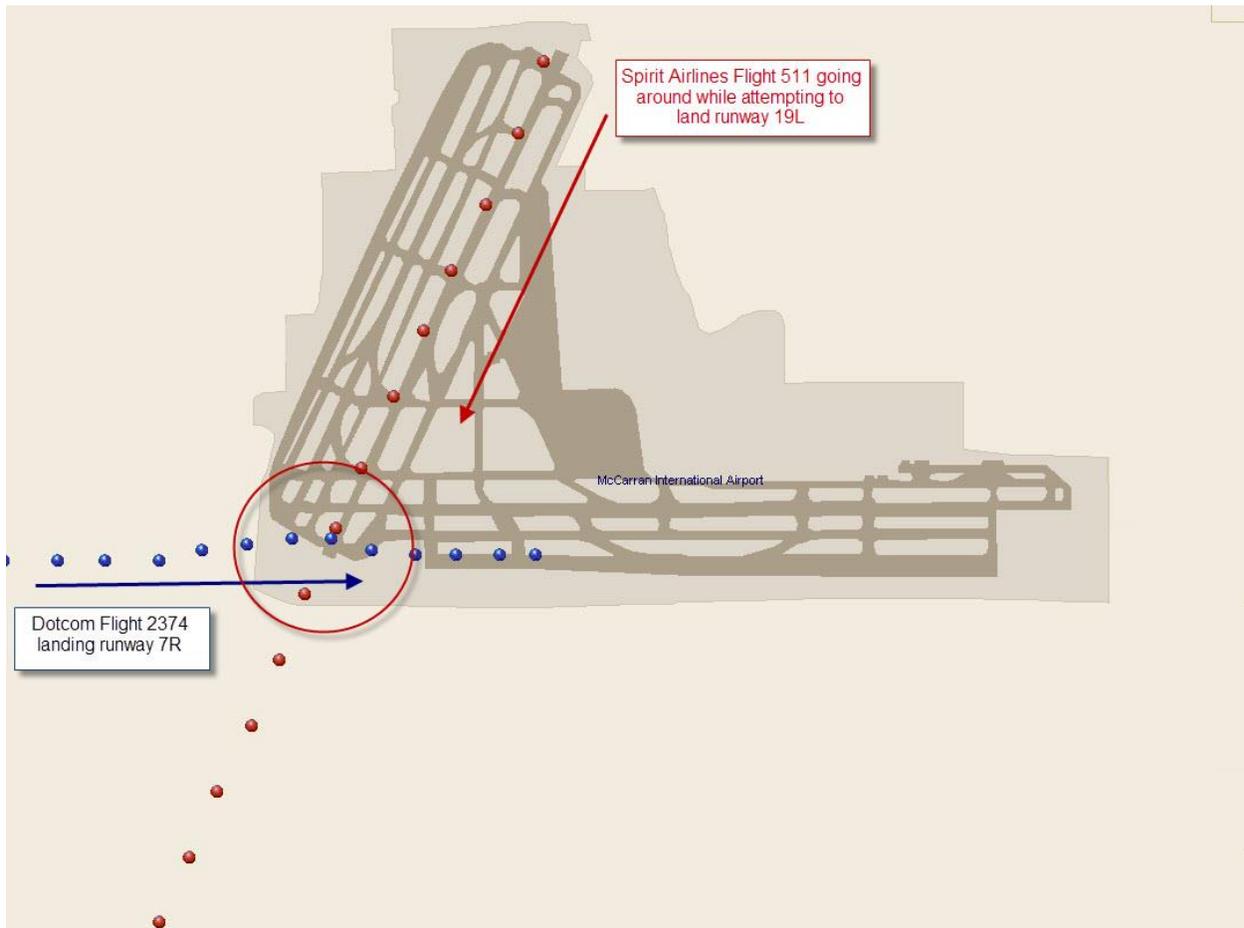
On July 30, 2012, about 1944 coordinated universal time (UTC), two airplanes came within hazardous proximity of one another at Las Vegas-McCarran International Airport (LAS), Las Vegas, Nevada,² when Spirit Airlines flight 511, an Airbus Industries A319, was executing a go-around from runway 19L and Dotcom flight 2374, a Cessna Citation 510, was landing on runway 7R (see figure 2). Runways 19 L/R and 7L intersect and may not be operated independently of one another. Runway 7R is located approximately 1,000 feet south of runway 7L and does not intersect any other landing surface, permitting controllers to conduct arrival and departure operations independently of all other runways; however, the flightpath of runway 19L intersects the flightpath of runway 7R. The airplanes were being controlled by separate LAS ATC tower controllers operating on different frequencies. The pilot of Spirit Airlines flight 511 announced that the airplane was “on the go,” and the air traffic controller immediately responded with “traffic ahead and to your right landing 7R is a Citation out of 2600 off your right.” The transmission was not acknowledged, and the controller

instructed Spirit Airlines flight 511 to “expedite your climb.” The pilot of Spirit Airlines flight 511 never reported Dotcom flight 2374 in sight.

When the controller responsible for Dotcom flight 2374 recognized that Spirit Airlines flight 511 was executing a go-around, he notified the Dotcom flight 2374 pilot of the position of Spirit Airlines flight 511 but did not provide any control instructions to ensure that the airplanes avoided one another. According to recorded radar data, the pilot of Dotcom flight 2374 turned the airplane off of the final approach course to the left to pass behind Spirit Airlines flight 511, then turned back to the runway and landed on runway 7R. Spirit Airlines flight 511 passed in front of and slightly above Dotcom flight 2374 on short final. The reported closest proximity was 0.21 nautical miles (nm) laterally and 100 feet vertically. There were no injuries reported to passengers or flight crew and no damage reported to either airplane.

Figure 2. Spirit Airlines flight 511 (red dots) executed a go-around while attempting to land on runway 19L. Dotcom flight 2374 (blue dots) was simultaneously landing on runway 7R.

Amend Federal Aviation Administration Order 7110.65, "Air Traffic Control," to establish separation standards similar to the provisions of paragraph 3-9-8 between an arriving aircraft that goes around and any combination of arriving or departing aircraft operating on runways where flightpaths may intersect. (A-13-024)

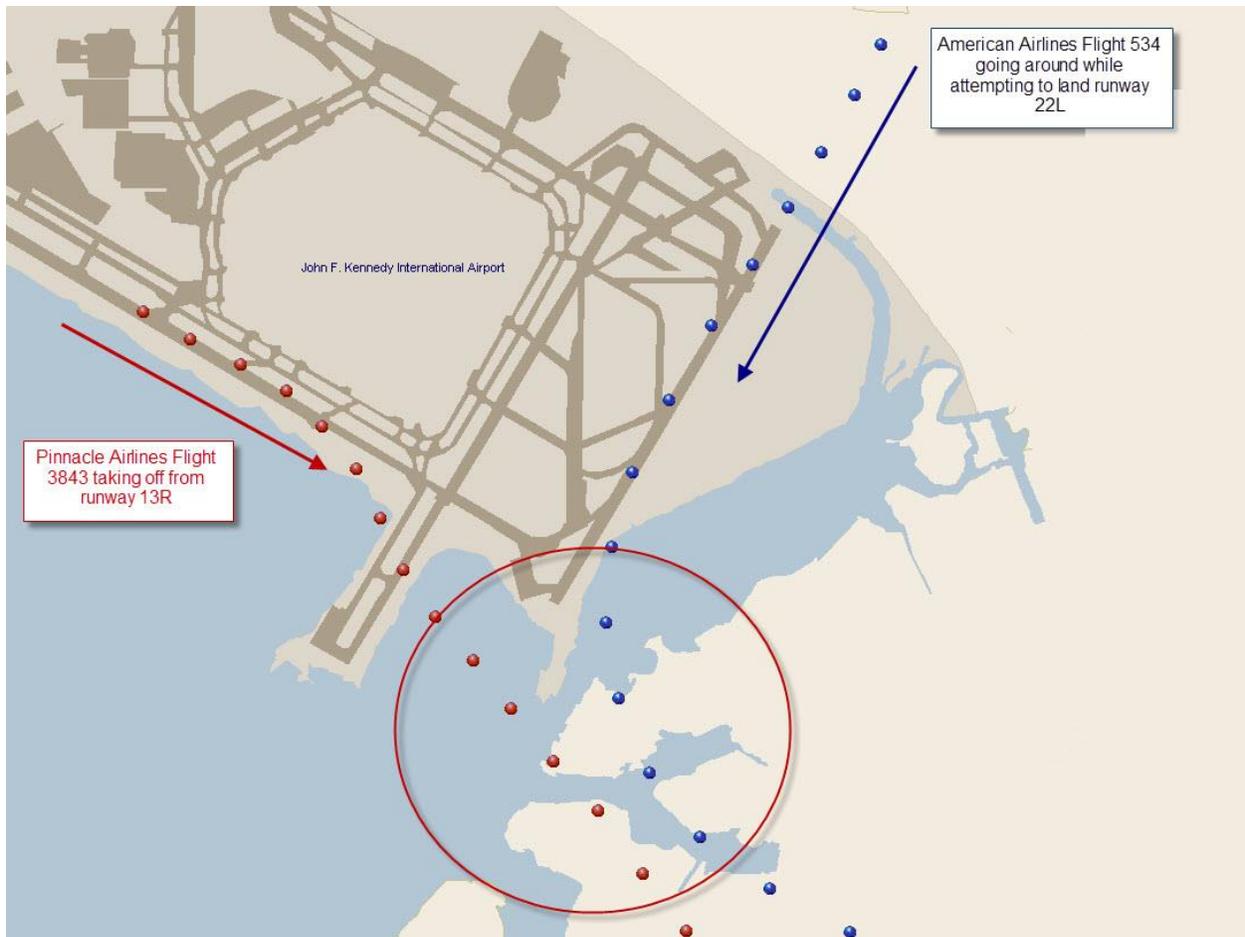
on runway 22L and Pinnacle Airlines flight 3843, a Bombardier CRJ 200 regional jet (RJ), was departing from runway 13R (see figure 3). Runway 13R does not intersect runway 22L; however, the flightpath of runway 13R intersects runway 22L. The airplanes were being controlled by separate JFK ATC tower controllers operating on different frequencies. When the pilot of American Airlines flight 534 notified ATC of the go-around, the controller instructed the pilot to “climb and maintain 2000 feet, traffic off to your left is an RJ turning southbound, turn left immediately heading 130.” The pilot responded and began the maneuver. The controller asked the pilot of American Airlines flight 534 if Pinnacle Airlines flight 3843 was in sight, and the pilot responded “We’re turning as tightly as we can.” When the controller asked the pilot of American Airlines flight 534 about the assigned altitude of 2,000 feet, the pilot responded “Negative, we are trying not to hit this aircraft off our right.” The controller responsible for Pinnacle Airlines flight 3843 had transferred communications to New York Departure Control and was no longer able to provide the pilot with control instructions or traffic advisories. American Airlines flight 534 returned for landing, and Pinnacle Airlines flight 3843 continued to its destination. There were no injuries reported to passengers or flight crew and no damage reported to either airplane.

Because of previous conflicts similar to the situation involving American Airlines flight 534 and Pinnacle Airlines flight 3843, JFK had been the subject of an FAA review of the runway configuration by the FAA Flight Standards Office, AFS-450, in 2009 that resulted in the establishment of an arrival/departure window (ADW) on the runway 22L final approach course. The ADW is an imaginary box including the area between 1 and 3 nm from the runway threshold. The intent of the ADW was to prevent conflicts between runway 13R departures and runway 22L arrivals by requiring the departure aircraft from runway 13R to be rolling for takeoff before the runway 22L arrival aircraft entered the ADW. Pinnacle Airlines flight 3843 was cleared for takeoff when American Airlines flight 534 was about 3.7 nm away from the runway 22L threshold. However, Pinnacle Airlines flight 3843 did not begin the takeoff roll until American Airlines flight 534 was inside the ADW. Consequently, the separation intended to be ensured through use of the ADW procedures was not ensured. Under the circumstances, the tower controller should have canceled the takeoff clearance for Pinnacle Airlines flight 3843 but did not do so. The two airplanes came within 0.3 nm laterally and 300 feet vertically following the evasive maneuvers by American Airlines flight 534.

Figure 3. American Airlines flight 534 (blue dots) executed a go-around while attempting to land on runway 22L. Pinnacle Airlines flight 3843 (red dots) was simultaneously cleared for takeoff from runway 13R.

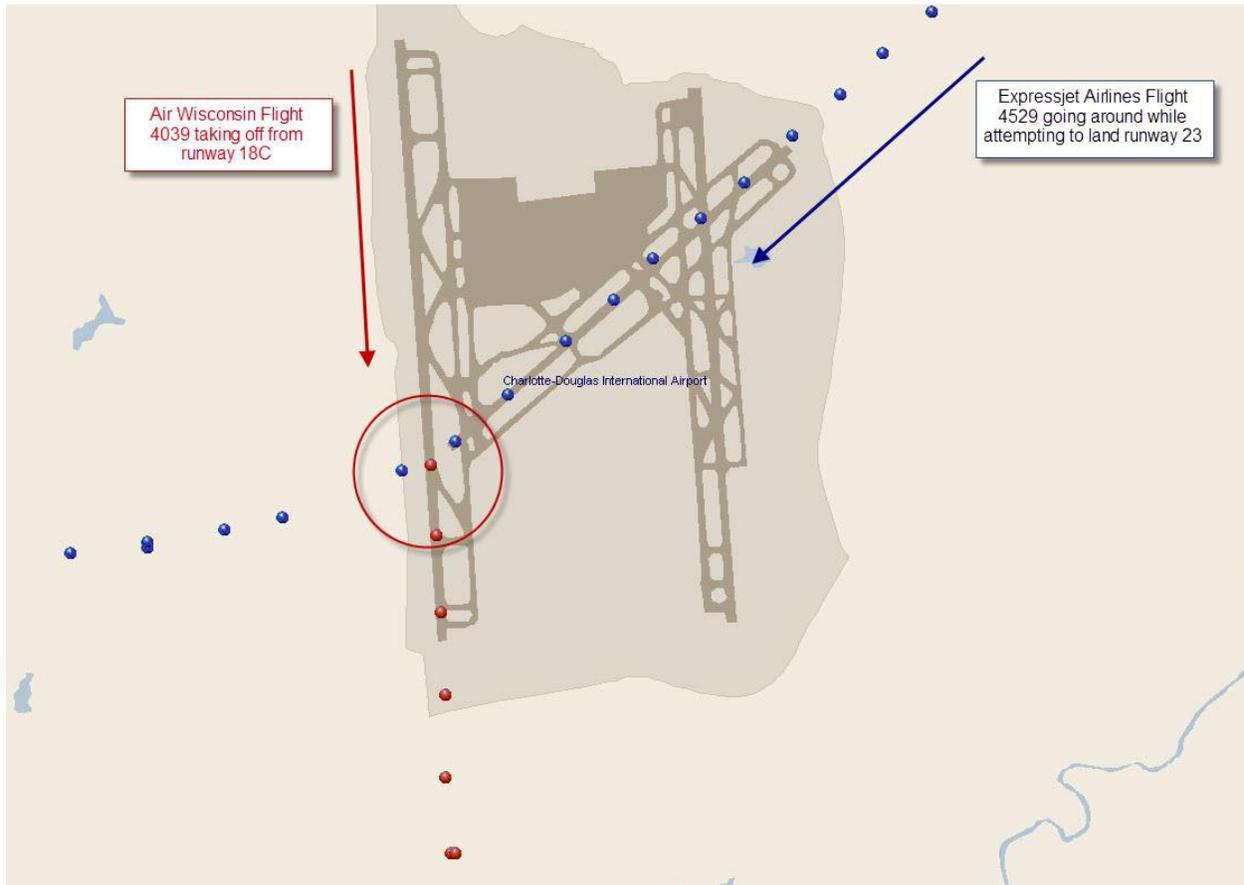
On July 14, 2012, about 1544 UTC, two airplanes came within hazardous proximity of one another at Charlotte International Airport (CLT), Charlotte, North Carolina, when Expressjet flight 4529, an Embraer 145 RJ, was executing a go-around while attempting to land on runway 23 and Air Wisconsin flight 4039, a Canadair RJ, was simultaneously departing from runway 18C (see figure 4). Runway 18C does not intersect runway 23; however, the flightpath of runway 23 intersects runway 18C. The airplanes were being controlled by separate CLT ATC tower controllers operating on different frequencies. When the pilot of Expressjet flight 4529 indicated that he was going around, the air traffic controller instructed the pilot to “Fly heading 270, climb and maintain 4000, traffic departing runway 18C beneath you.” The pilot of Expressjet flight 4529 did not confirm the transmission and never reported the conflicting departure in sight. The controller handling Air Wisconsin flight 4039 provided the pilot with a traffic advisory about Expressjet flight 4529 but issued no control instructions to resolve the conflict. The two airplanes passed within 0.16 nm laterally and 400 feet vertically of each other as Expressjet flight 4529 approached runway 18C. Expressjet flight 4529 returned for landing,

and Air Wisconsin flight 4039 continued to its destination. There were no injuries reported to passengers or flight crew and no damage reported to either airplane.

Figure 4. Expressjet flight 4529 (blue dots) executed a go-around while attempting to land on runway 23. Air Wisconsin flight 4039 (red dots) was simultaneously cleared for takeoff from runway 18C.

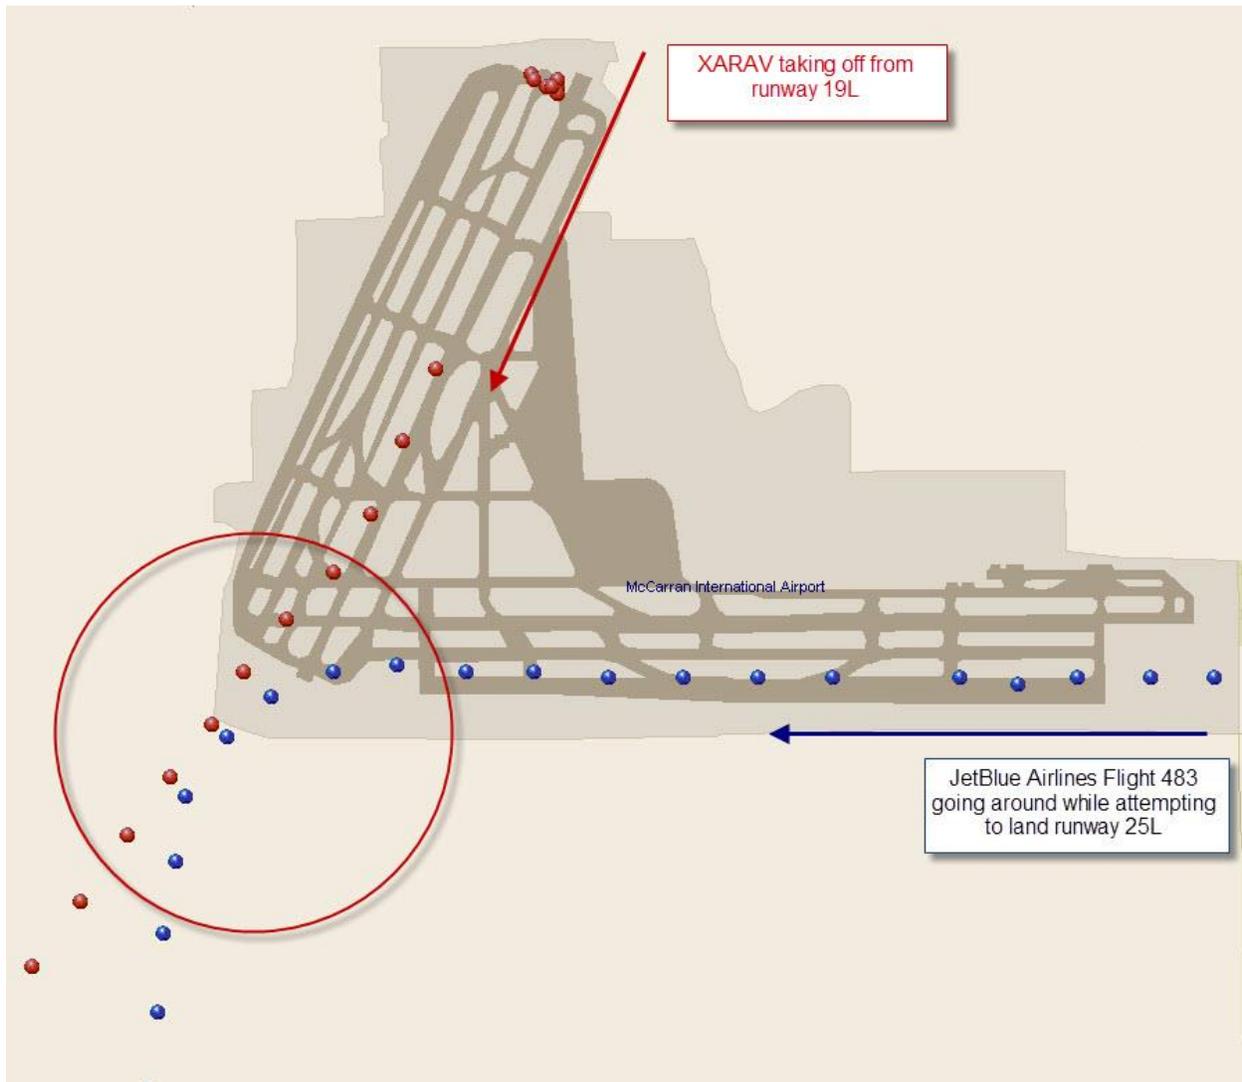
On April 26, 2012, about 1825 UTC, two airplanes came within hazardous proximity of one another at LAS when Jet Blue flight 483, an Airbus Industries A320, executed a go-around while attempting to land on runway 25L and XARAV, a Mexican-registered Bombardier Learjet 60, was departing from runway 19L (see figure 5).³ Runway 19L does not intersect runway 25L; however, the flightpath of runway 19L intersects the flightpath of runway 25L. Both pilots were communicating with separate LAS ATC controllers operating on different frequencies. During the go-around, Jet Blue flight 483 turned left to avoid XARAV. The pilot of XARAV saw Jet Blue flight 483 approaching from his left and initiated a rapid climb in an attempt to establish and maintain vertical separation. Review of recorded radar data for XARAV showed that the airplane's climb rate was as high as 6,000 feet per minute immediately after

departure. In radio transmissions from the pilot, the airplane's stick shaker⁴ can be heard in the background, warning the pilot of an imminent aerodynamic stall. The only separation instruction that ATC issued to XARAV was for the pilot to "go low," but by the time the instruction was issued, the airplane was climbing at a high rate and the pilot was unable to comply. The two airplanes' closest proximity was 0.30 nm laterally and 100 feet vertically. There were no injuries reported to passengers or flight crew and no damage reported to either airplane.

Figure 5. Jet Blue flight 483 (blue dots) executed a go-around from runway 25L. XARAV (red dots) was simultaneously departing from runway 19L.

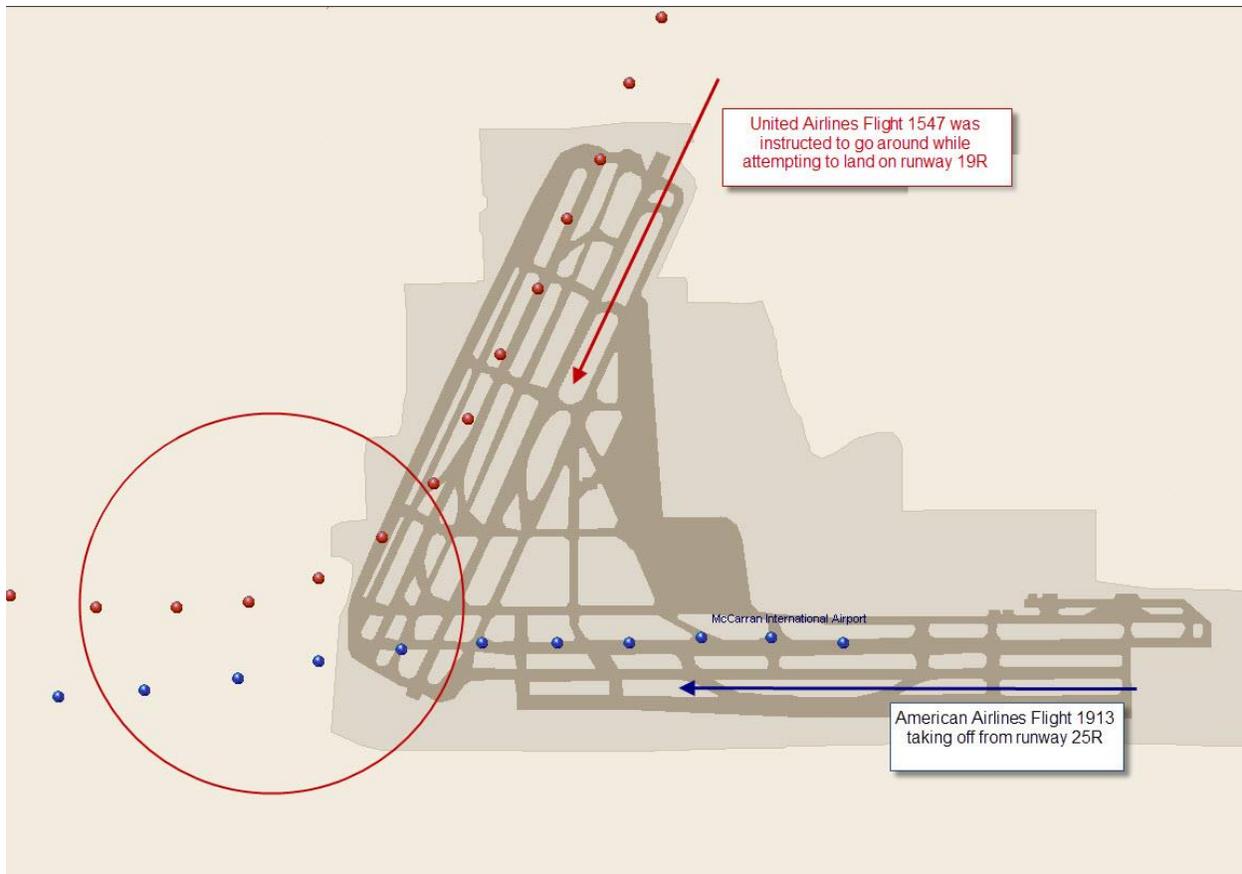
On January 27, 2006, about 0044 UTC, a near mid-air collision occurred at LAS when United Airlines flight 1547, an Airbus Industries A320, was attempting to land on runway 19R

but was instructed to go around by ATC to prevent a conflict with a Beechcraft BE200 crossing the runway. During the go-around, United Airlines flight 1547 nearly collided with American Airlines flight 1913, a Boeing 757 that was departing from runway 25R (see figure 6).⁵ Runway 19L did not intersect runway 25R; however, the flightpath of runway 19L intersected the flightpath of runway 25R. Both airplanes were in communication with separate LAS ATC tower controllers operating on different frequencies. When the controller handling United Airlines flight 1547 became aware of the conflict, he issued a safety alert to the pilot about the conflicting departure and instructed the pilot to "...turn at your discretion." During a postincident interview, the controller stated that he did not issue a specific direction to turn because wake turbulence separation rules did not permit him to have the Airbus A320 turn left immediately behind the departing Boeing 757, and a right turn might have been too slow as well as rendering the United Airlines flight 1547 flight crew unable to see the conflicting departure. The controller stated that he "...wanted the pilot-in-command to decide what to do." United Airlines flight 1547 made an evasive turn to the right to avoid a potential collision, reportedly banking as much as 40 degrees to avoid crossing American Airlines flight 1913's flightpath. American Airlines flight 1913 made a slight left turn and was instructed by the controller to "stay low." United Airlines flight 1547 returned for landing, and American Airlines flight 1913 continued to its destination. There were no injuries reported to passengers or flight crew and no damage reported to either airplane. In postincident statements, the United Airlines flight 1547 flight crewmembers stated that the tower controllers did not seem to have clear procedures for separating aircraft in the event of a go-around and may not have had the same perception of an impending collision that they did.

Figure 6. United Airlines flight 1547 (red dots) executed a go-around while attempting to land on runway 19R. American Airlines flight 1913 (blue dots) was simultaneously cleared for takeoff from runway 25R.
