National Transportation Safety Board

Safety Recommendation

In reply refer to: A-14-001

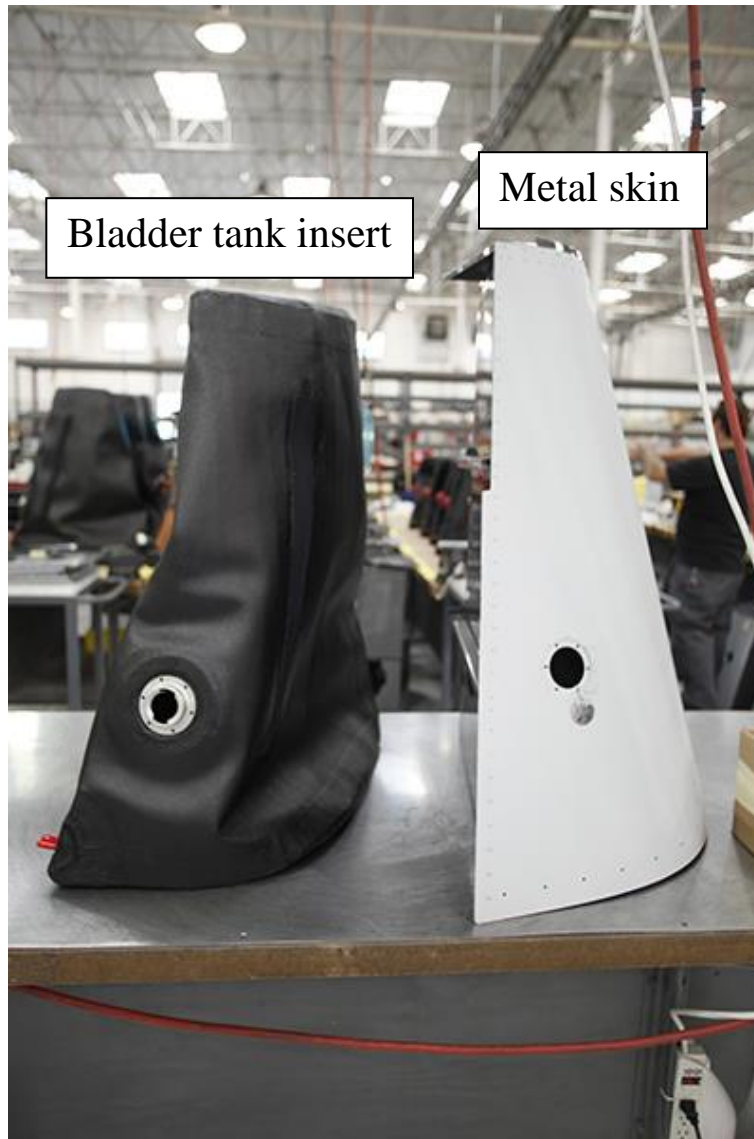
On December 20, 2010, Robinson Helicopter Company issued Service Bulletin SB-78, which advised owners, operators, and maintenance personnel of R44 helicopters with all-aluminum main and auxiliary fuel tanks to retrofit those helicopters with bladder-type tanks to improve the R44 fuel system's resistance to a postaccident fuel leak.⁶ The bladder-type fuel tank, as shown in the figure (on page 3), was designed to contain fuel and prevent it from spilling out of the tank after a survivable impact. Fuel might still leak out through vent lines, supply lines, or other fuel system components; however, in that situation, the fuel would leak out at a much slower rate than it would if a fuel tank ruptured, which would allow helicopter occupants time to escape.

Figure. R44 main fuel bladder and outer skin.

Require owners and operators of existing R44 helicopters to comply with the fuel tank retrofit advised in Robinson Helicopter Company Service Bulletin SB-78B to improve the helicopters' resistance to a postaccident fuel tank leak. (A-14-001)
