# National Transportation Safety Board

## Safety Recommendation

**In reply refer to:** A-14-69 and -70

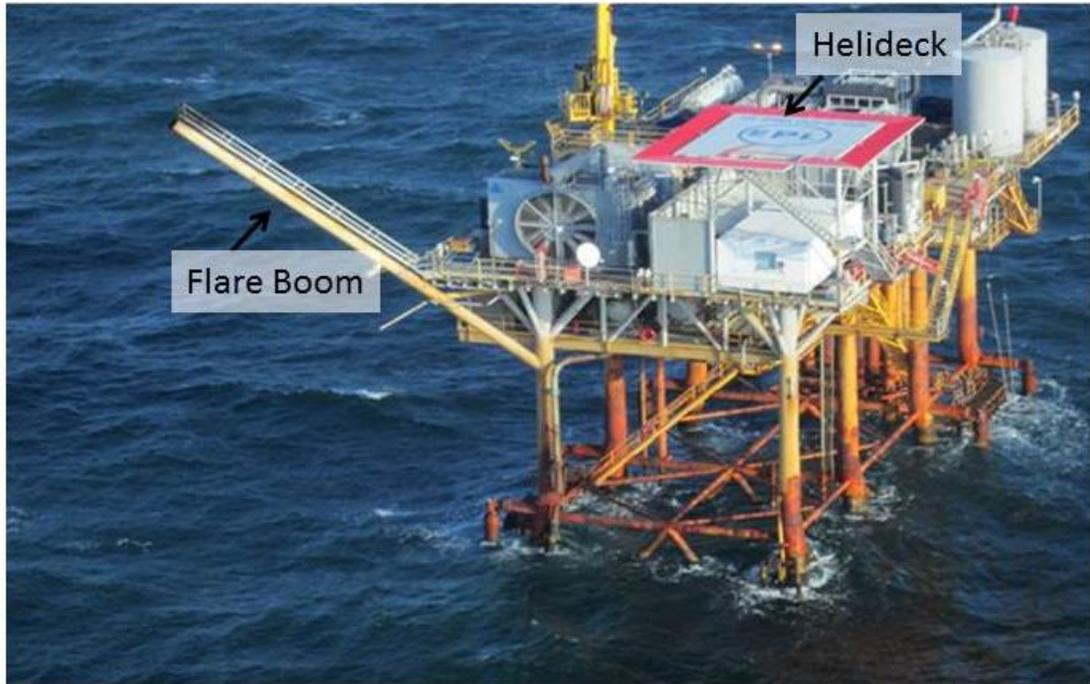
The NTSB's investigation of the 2013 accident is ongoing. Preliminary analysis of data from the helicopter's full authority digital electronic control system indicated an engine surge condition just after takeoff. After about 1 second of the abnormally high engine operating condition, engine power dropped and an engine flameout occurred. Power to the rotor system was regained about 4 seconds later, but there was not sufficient altitude available for the pilot to recover.

The pilot later reported that before departure, he brought the helicopter into a stationary hover in the middle of the helideck and made a "left pedal turn into the wind and in a direction to avoid the flare boom." According to a monthly gas flaring and venting volume summary provided by the platform operator, the volume of methane vented on the day of the accident was the highest of the month and about 20 times the volume of the second highest day. The pilot was not aware before departing that methane gas was being vented. While a wind sock is located on the platform to assist pilots in determining the prevailing wind direction, as recommended in industry guidance, the platform does not have a system visible to pilots indicating when gas is venting; such a system is particularly helpful since methane gas is colorless and odorless and pilots are not able to discern its presence. The following figure shows SS208H with its helideck and flare boom.

**Figure.** SS208H showing the helideck and flare boom.

methane, by helicopters operating in the vicinity of offshore oil platforms. (A-14-69)

After appropriate mitigations are developed as recommended in Safety Recommendation A-14-69, require mobile offshore oil platform operators to implement these systems and procedures. (A-14-70)
