# National Transportation Safety Board

## Safety Recommendation

**In reply refer to:** A-00-104

In this letter, the National Transportation Safety Board recommends that the Federal Aviation Administration (FAA) take action to address a safety issue concerning uncontained engine failures<sup>1</sup> as a result of cracking and rupture of high pressure compressor (HPC) stage 3-9 spools in General Electric (GE) CF6-50 and -80 series engines. The Safety Board identified this safety issue during its participation in the Brazilian Centro de Investigação e Prevenção de Accidentes Aeronauticos' (CENIPA) investigation<sup>2</sup> of an uncontained engine failure that occurred at São Paulo, Brazil, on June 7, 2000. Although the investigation is continuing, information gathered thus far has raised serious concerns that warrant immediate action by the FAA.

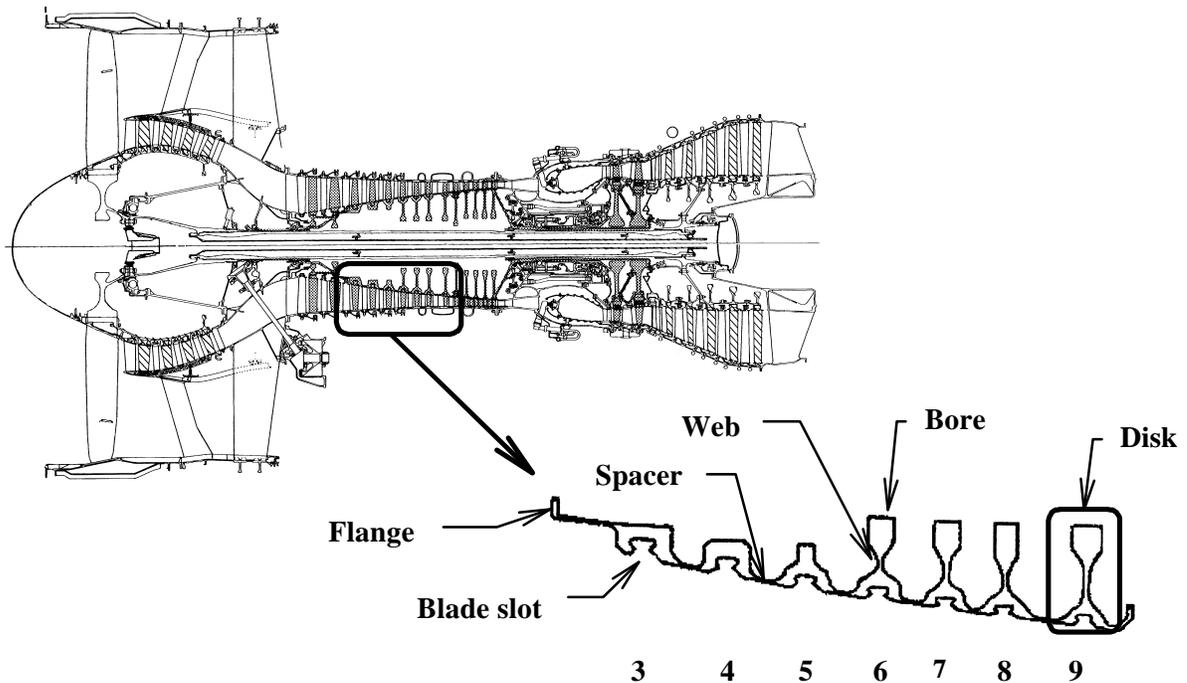
**Figure 1. CF6-80C2 Engine and HPC Stage 3-9 Spool in Cross Section**

The ruptured HPC stage 3-9 spool is a rotor one-piece component machined from a single forging<sup>4</sup> of Ti-6-2-4-2 titanium alloy and composed of disks joined together with integral spacer segments and end flanges (see figure 1). According to Varig Airlines' maintenance records, the ruptured HPC stage 3-9 spool, part number 9380M28P05 and serial number VOL02558, had accumulated 37,755 hours and 9,948 cycles since new (CSN). Varig's maintenance records also show that, on September 22, 1997, at 8,907 hours and 2,375 cycles before the rupture, the entire spool underwent a fluorescent penetrant inspection (FPI)<sup>5</sup> and the disk bores underwent an ultrasonic inspection<sup>6</sup> at Varig Brasil Airlines' engine shop.<sup>7</sup> No defects were noted during those inspections.

Metallurgical examination<sup>9</sup> of the Varig 3-9 spool revealed a fracture that originated in the stage 7 web from a 0.12 by 0.04-inch subsurface area of quasi-cleavage (rather than a specific point of origin).<sup>10</sup> From the origin area, the fracture propagated in a combination of low cycle fatigue and quasi-cleavage radially inward toward the bore and outward toward the rim and dovetail blade slots, reaching an overall length of about 2.6 inches, before the spool separated. Metallographic examination of the web near the area of the fracture's origin and the bore revealed that the microstructure was comprised of about 75 percent primary alpha with 25 percent transformed beta grains.<sup>11</sup> The microstructure of the rim (under the blade slots) was a 50/50 mix of primary alpha and transformed beta grains.

Electron backscatter diffraction<sup>12</sup> of the origin region revealed colonies of primary alpha grains aligned such that their basal planes<sup>13</sup> were nearly perpendicular to the hoop stress.<sup>14</sup> The scanning electron microscope (SEM) examination of the fracture surface further revealed that the morphology of the fracture away from the origin was predominately quasi-cleavage with random patches of classical fatigue striations. The quasi-cleavage fracture features observed on the fracture surface during metallurgical examination and the highly aligned primary alpha crystal structure are indicative of dwell-time fatigue (DTF).<sup>15</sup>

The examination of the fracture surface with the SEM revealed approximately 18,000 striations from the origin area to the end of the progressive growth region.<sup>16</sup> On the basis of the metallurgical examination, it was determined that the crack had broken through the surface and was estimated to be about 0.3 to 0.6 inch long on the stage 7 web surface at the time of the last FPI but had not been detected.

Immediately issue an airworthiness directive (AD) to require the expeditious removal from service of CF6-50 and -80 series engines with high pressure compressor stage 3-9 spools that are most at risk of rupturing and inspect those spools in accordance with AD 99-24-15 and engine manual instructions. (Class 1, Urgent Action) (A-00-104)
