# National Transportation Safety Board

## Safety Recommendation

**In reply refer to:** A-02-20 through -23

On November 20, 2000, about 1222 eastern standard time, a flight attendant/purser was killed during an emergency evacuation of American Airlines flight 1291, an Airbus Industrie A300B4-605R (A300), N14056, at Miami International Airport (MIA), Miami, Florida. The airplane was pressurized until the flight attendant/purser opened the left front (1L) emergency exit door; he was then forcibly ejected from the airplane. There were 133 persons on board. During the emergency evacuation, in addition to the 1 flight attendant/purser who was killed, 3 passengers sustained serious injuries; 18 passengers and 1 flight service director<sup>1</sup> sustained minor injuries; and the 2 pilots, 6 flight attendants, 1 off-duty flight attendant, 1 flight service director, and the remaining 100 passengers reported no injuries. The airplane sustained minor damage.<sup>2</sup>

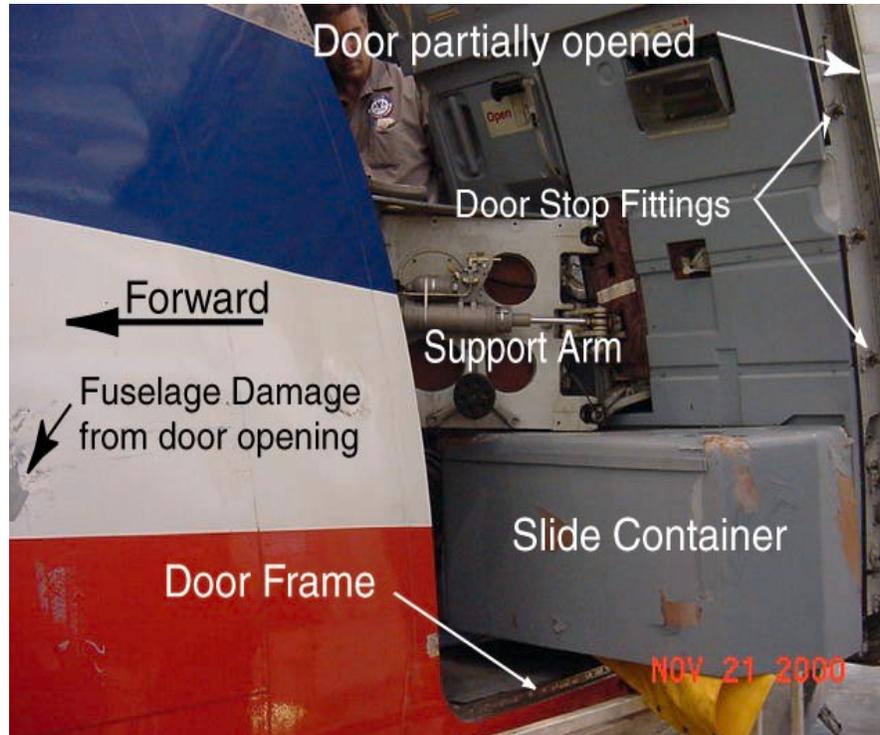
**Figure 1. November 20, 2000, Accident Airplane's (Airbus A300) Emergency Exit Door.**

connecting links attach a support arm to the door. The lower connecting link, a lifting lever, moves the emergency exit door up and over the fuselage stop fittings, and the door opens. Guide arms keep the door parallel to the fuselage. A damper/emergency operation cylinder powered by a gas bottle, which is mounted inside the emergency exit door's support arm, assists the forward movement of the door and slows its momentum so that it does not damage the adjacent fuselage when it opens. According to Airbus, a person of the same size and stature (183 pounds and 5 feet 10 inches tall) as the flight attendant/purser could exert enough force on the handle to open the emergency exit door even if the airplane is overpressurized. Airbus A300 emergency exit doors do not have built-in systems to relieve pressure before the door is opened.

During its investigation of the November 20, 2000, accident, the Safety Board found that the 1L emergency exit door's lower guide arm was fractured and its support arm was cracked, consistent with the door bursting open because of excess pressure. The investigation also revealed that a section of each of the emergency exit door's aft eight door stop fitting pins was flattened, consistent with them having been forced up and over the fuselage stop fittings before the door burst open.

Require that all newly certificated transport-category airplanes have a system for each emergency exit door to relieve pressure so that they can only be opened on the ground after a safe differential pressure level is attained. (A-02-20)

For those transport-category airplane emergency exit doors that can be opened on the ground when the airplane is overpressurized, require air carriers to provide specific warnings near the emergency exit doors (such as lights, placards, or other indications) that clearly identify the danger of opening the emergency exit doors when the airplane is overpressurized. (A-02-21)
