# National Transportation Safety Board

## Safety Recommendation

**Date:** August 28, 2006

**In reply refer to:** A-06-60 through -64

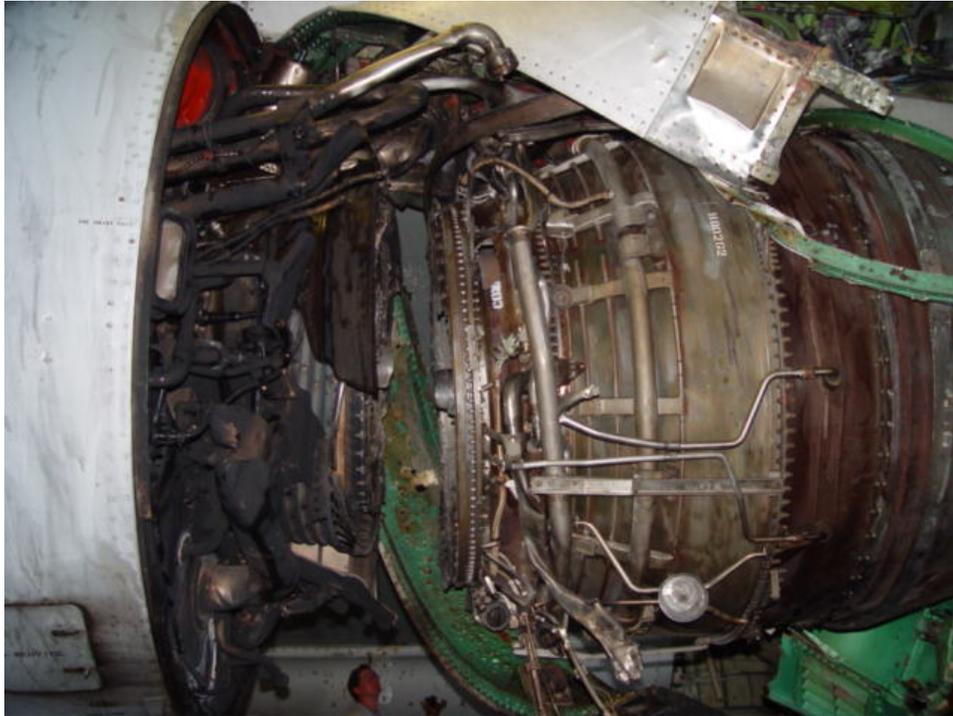
Postincident examination of the No. 1 engine revealed that the HPT stage 1 disk had ruptured and completely split the engine (see figure 2) with the fan, booster, high pressure compressor, and combustor hanging from the forward-engine mount and the low pressure turbine and exhaust hanging from the rear-engine mount. The HPT stage 1 disk separated from the shaft at the conical section of the shaft and was completely missing from the engine. The recovery of the pieces of the ruptured disk revealed that it had broken into three approximately equal-sized pieces, as well as a fourth triangular-shaped piece and several smaller fragments. One piece of the disk, which initially bounced off of the ground before penetrating the airplane, completely severed the airplane's left-hand keel beam and partially severed the right-hand keel beam before exiting the airplane and becoming lodged in the No. 2 engine's exhaust duct. A second piece of the disk was found in the airplane embedded in an air duct. A third piece of the disk was found about 2,500 feet away from the airplane against an airport perimeter fence after crossing two active runways and taxiways.<sup>5</sup> The fourth triangular-shaped piece of the disk was found embedded in the engine pylon.

**Figure 2.** View of the left side of the No. 1 engine showing the engine split in two.

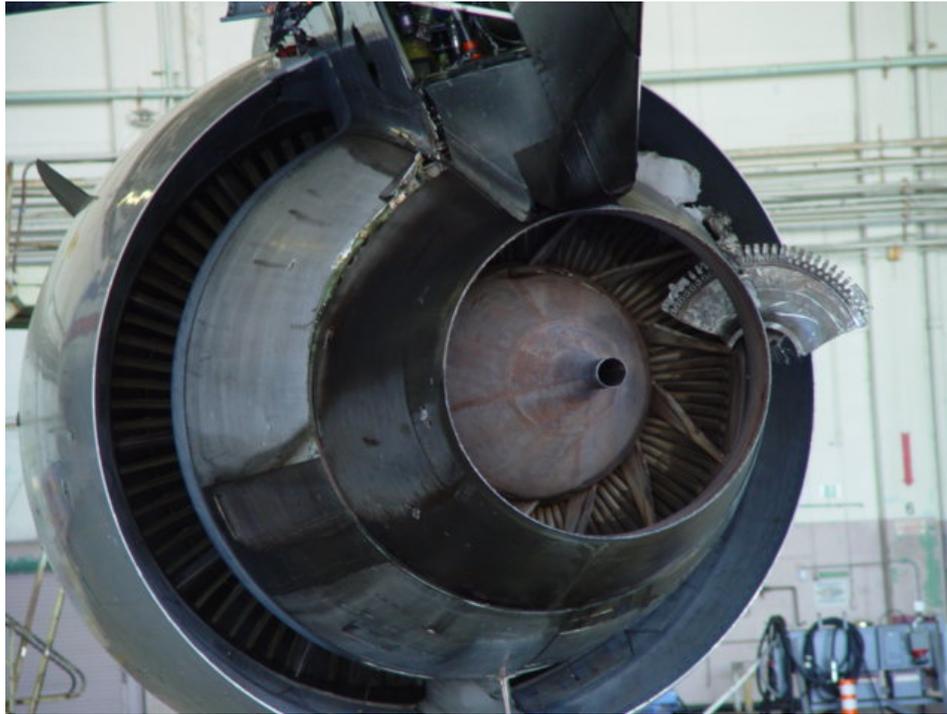
Examination of the No. 2 engine revealed that the left side of the engine's nacelle was peppered with holes and impact marks from debris from the No. 1 engine in addition to the piece of the HPT stage 1 disk that had gone through the exhaust duct and was protruding from the right side of the engine (see figure 3). The examination of the airplane revealed numerous holes in the left and right wing's fuel tanks where fuel leaked out, feeding the ground fire that burned the left wing and the fuselage aft of the wing.<sup>6</sup>

**Figure 3.** View of the exhaust of No. 2 engine showing piece of HPT stage 1 disk protruding from the right side of the engine exhaust duct.
