# National Transportation Safety Board

## Safety Recommendation

**In reply refer to:** A-06-60 through -64

On June 2, 2006, an American Airlines Boeing 767-223(ER), N330AA, equipped with General Electric (GE) CF6-80A engines experienced an uncontained failure<sup>1</sup> of the high pressure turbine (HPT) stage 1 disk<sup>2</sup> in the No. 1 (left) engine during a high-power ground run for maintenance at Los Angeles International Airport (LAX), Los Angeles, California (see figure 1 for a diagram of a GE CF6-80A engine). The three maintenance personnel on board the airplane as well as the observer on the ground were not injured. Both engines and the airplane sustained substantial damage.<sup>3</sup>

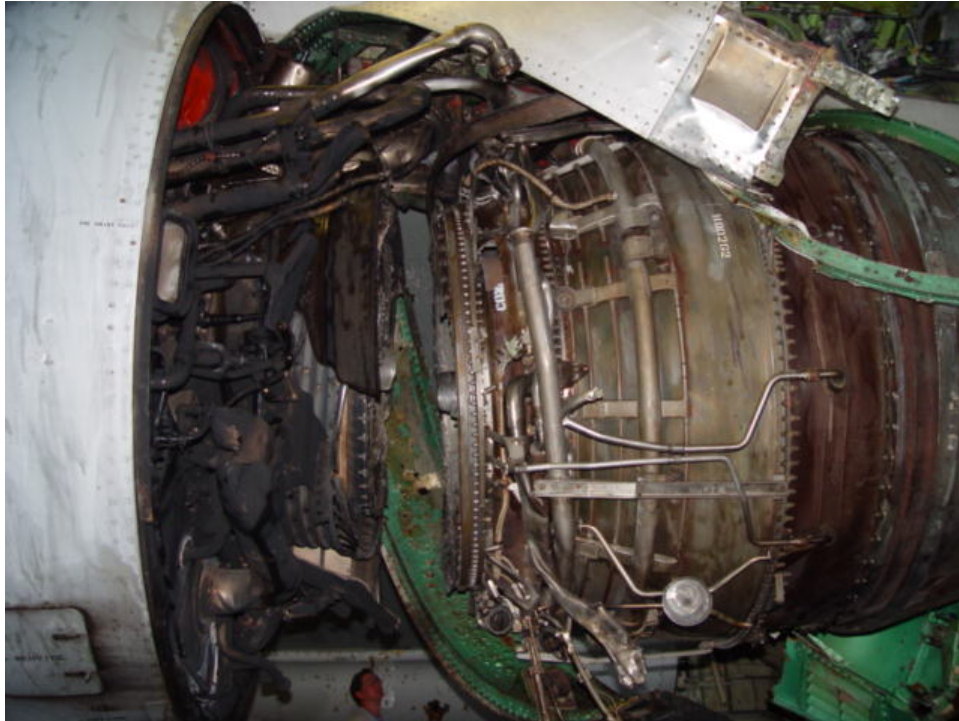
Postincident examination of the No. 1 engine revealed that the HPT stage 1 disk had ruptured and completely split the engine (see figure 2) with the fan, booster, high pressure compressor, and combustor hanging from the forward-engine mount and the low pressure turbine and exhaust hanging from the rear-engine mount. The HPT stage 1 disk separated from the shaft at the conical section of the shaft and was completely missing from the engine. The recovery of the pieces of the ruptured disk revealed that it had broken into three approximately equal-sized pieces, as well as a fourth triangular-shaped piece and several smaller fragments. One piece of the disk, which initially bounced off of the ground before penetrating the airplane, completely severed the airplane's left-hand keel beam and partially severed the right-hand keel beam before exiting the airplane and becoming lodged in the No. 2 engine's exhaust duct. A second piece of the disk was found in the airplane embedded in an air duct. A third piece of the disk was found about 2,500 feet away from the airplane against an airport perimeter fence after crossing two active runways and taxiways.<sup>5</sup> The fourth triangular-shaped piece of the disk was found embedded in the engine pylon.

**Figure 2.** View of the left side of the No. 1 engine showing the engine split in two.

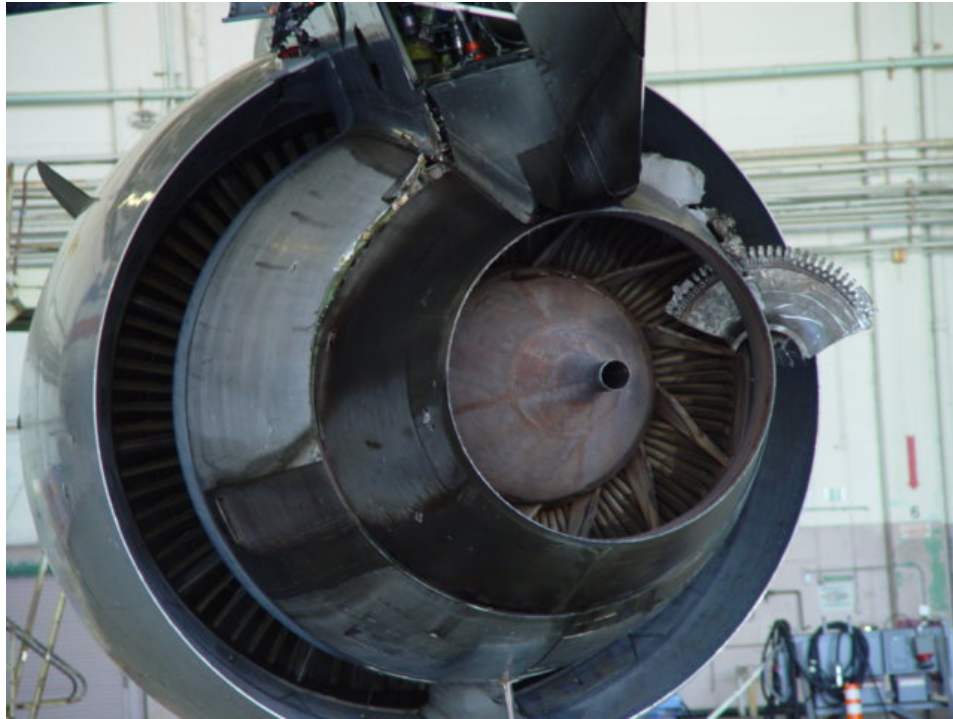
Examination of the No. 2 engine revealed that the left side of the engine's nacelle was peppered with holes and impact marks from debris from the No. 1 engine in addition to the piece of the HPT stage 1 disk that had gone through the exhaust duct and was protruding from the right side of the engine (see figure 3). The examination of the airplane revealed numerous holes in the left and right wing's fuel tanks where fuel leaked out, feeding the ground fire that burned the left wing and the fuselage aft of the wing.<sup>6</sup>

**Figure 3.** View of the exhaust of No. 2 engine showing piece of HPT stage 1 disk protruding from the right side of the engine exhaust duct.
