# National Transportation Safety Board

## Safety Recommendation

**In reply refer to:** A-06-83 and -84

On August 27, 2006, about 0607 eastern daylight time,<sup>1</sup> Comair flight 5191, a Bombardier CL-600-2B19 (CRJ-100), N431CA, crashed during takeoff from Blue Grass Airport (LEX), Lexington, Kentucky. The airplane had been cleared by air traffic control (ATC) for takeoff on runway 22, which is 7,003 feet long; however, the crew mistakenly taxied onto runway 26, which is 3,500 feet long, and attempted to take off. The airplane ran off the end of runway 26, impacted the airport perimeter fence and trees, and crashed. Of the 47 passengers and 3 crewmembers on board the airplane, 49 were killed, and 1 received serious injuries. The airplane was destroyed by impact forces and postcrash fire. The flight was operating under the provisions of 14 *Code of Federal Regulations* (CFR) Part 121 and was en route to Hartsfield-Jackson Atlanta International Airport, Atlanta, Georgia.

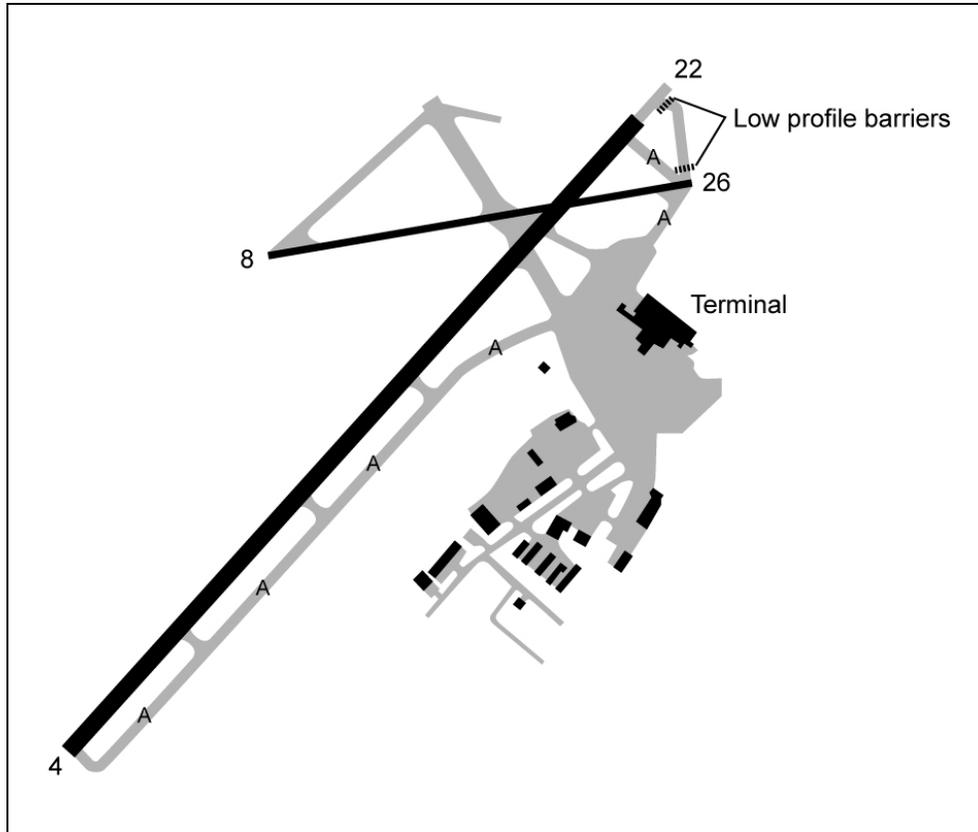
**Figure 1.** Lexington airport diagram.

Runway 26 is 3,500 feet long and painted to indicate 75 feet of usable width.<sup>5</sup> The runway is used for general aviation aircraft, has no precision runway markings (that is, threshold bars, fixed distance markers, etc.) and no operational edge lights, and is not authorized for use at night.<sup>6</sup> In contrast, runway 22 is 7,003 feet long with 150 feet of usable width and has precision markings and operating edge lights.<sup>7</sup> At the time of the accident, both runways had appropriate

<sup>6</sup> According to airport officials, the runway 26 edge lights were disabled because they were considered nonstandard (that is, not consistent with the usable width of the runway) after the usable runway width was reduced from its original 150 feet to 75 feet via the painting of edge lines inboard of the actual runway edge. After they were disabled, the edge lights could not be turned on by tower personnel.
