National Transportation Safety Board

Safety Recommendation

Date: March 11, 2009

In reply refer to: A-09-17 (Urgent) and -18

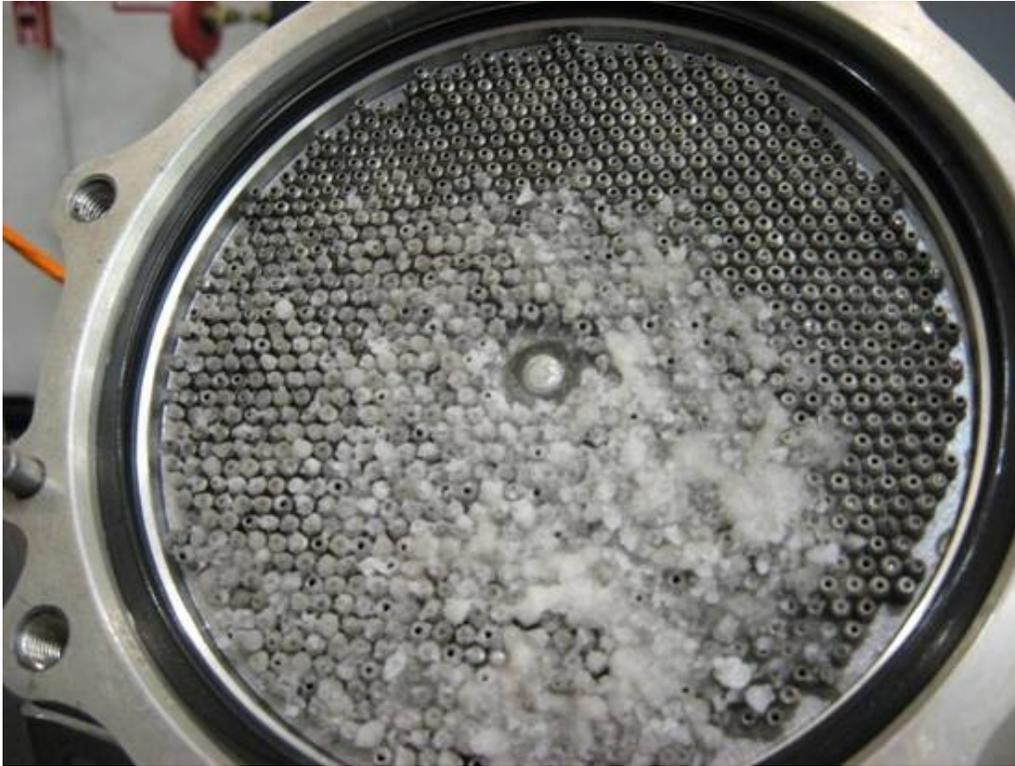
AAIB-directed laboratory testing at Boeing confirmed that at fuel temperatures between -5° C and -20° C, ice crystals tend to form and adhere to fuel component surfaces. The British Airways thrust rollbacks occurred at about -22° C. Tests showed that ice crystals formed solely from entrained water can restrict fuel passages and that, under certain conditions, substantial amounts of ice will accumulate on the inner surfaces of the fuel feed system. This ice can be released during high fuel flows, such as those that occurred during the final approach of the British Airways flight. When a sufficient amount of ice is released, ice can enter the engine fuel system and collect in a mass on the inlet face of the FOHE. (See the following figure.) The testing demonstrated that, after high fuel flows, the FOHE can be presented with ice concentrations well beyond the amounts for which the engine fuel system was certified to withstand. Further, ice in sufficient concentrations could block a large enough portion of the FOHE inlet face to restrict fuel flow so that the thrust demanded could not be supported and a rollback could occur.

Figure. Ice on the inlet face of a Rolls-Royce RB211 Trent 800 series FOHE.

Testing also found that reducing the volume of the fuel flow through the FOHE can clear ice from the face of the FOHE within a few seconds. A reduced fuel flow through the FOHE reduces the amount of fuel available for oil-to-fuel heat transfer in the FOHE, and this causes more heat from the oil to be retained. Heat from the oil then spreads further up the FOHE tubes to the face and to the ends of the tubes protruding from the face, melting the ice collected on the face and tubes. In fact, fuel volume tests showed that temporarily reducing fuel flows by moving the power levers to minimum idle will melt ice that may be blocking the FOHE.

Require that Rolls-Royce redesign the RB211 Trent 800 series engine fuel/oil heat exchanger (FOHE) such that ice accumulation on the face of the FOHE will not restrict fuel flow to the extent that the ability to achieve commanded thrust is reduced. (A-09-17) (Urgent)

Once the fuel/oil heat exchanger (FOHE) is redesigned and approved by certification authorities, require that operators of Boeing 777-200 airplanes powered by Rolls-Royce RB211 Trent 800 series engines install the redesigned FOHE at the next scheduled maintenance opportunity or within 6 months after the revised FOHE design has been certificated, whichever comes first. (A-09-18)
