National Transportation Safety Board

Safety Recommendation

In reply refer to: A-09-19 (Urgent) and -20

Boeing 777/Trent 800 Series Fuel Delivery and Control System

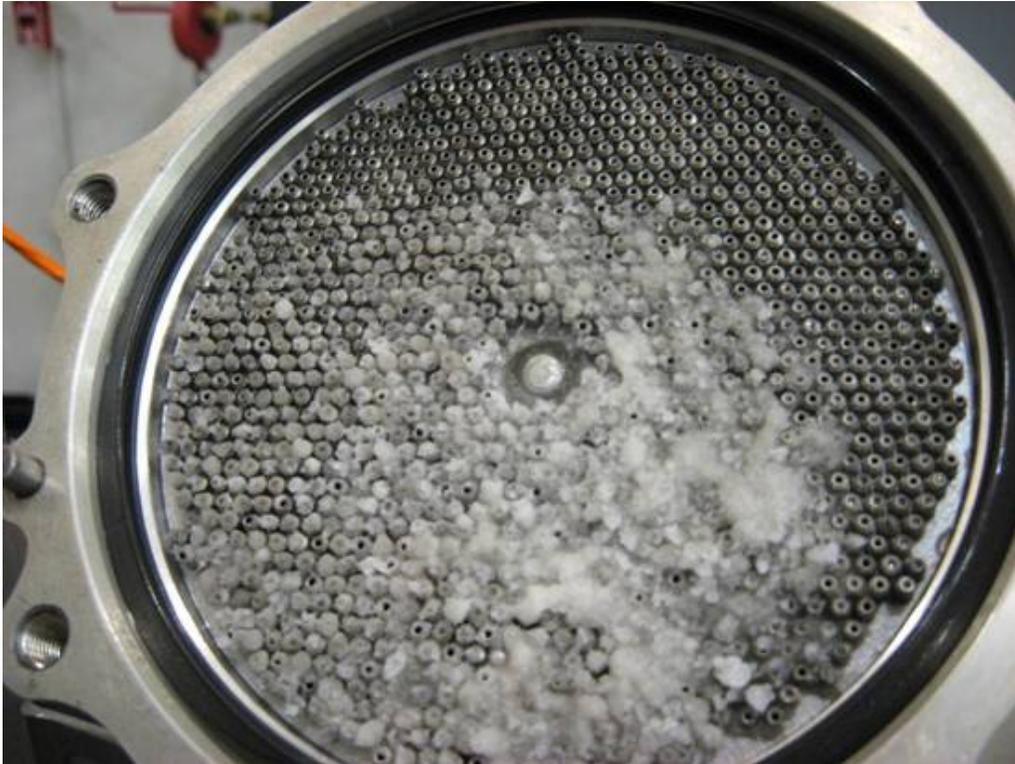
AAIB-directed laboratory testing at Boeing confirmed that at fuel temperatures between -5° C and -20° C, ice crystals tend to form and adhere to fuel component surfaces. The British Airways thrust rollbacks occurred at about -22° C. Tests showed that ice crystals formed solely from entrained water can restrict fuel passages and that, under certain conditions, substantial amounts of ice will accumulate on the inner surfaces of the fuel feed system. This ice can be released during high fuel flows, such as those that occurred during the final approach of the British Airways flight. When a sufficient amount of ice is released, ice can enter the engine fuel system and collect in a mass on the inlet face of the FOHE. (See the following figure.) The testing demonstrated that, after high fuel flows, the FOHE can be presented with ice concentrations well beyond the amounts for which the engine fuel system was certified to

withstand. Further, ice in sufficient concentrations could block a large enough portion of the FOHE inlet face to restrict fuel flow so that the thrust demanded could not be supported and a rollback could occur.

Figure. Ice on the inlet face of a Rolls-Royce RB211 Trent 800 series FOHE.

Require that Rolls-Royce redesign the RB211 Trent 800 series engine fuel/oil heat exchanger (FOHE) such that ice accumulation on the face of the FOHE will not restrict fuel flow to the extent that the ability to achieve commanded thrust is reduced. (A-09-19) (Urgent)

Once the fuel/oil heat exchanger (FOHE) is redesigned and approved by certification authorities, require that operators of Boeing 777-200 airplanes powered by Rolls-Royce RB211 Trent 800 series engines install the redesigned FOHE at the next scheduled maintenance opportunity or within 6 months after the revised FOHE design has been certificated, whichever comes first. (A-09-20)
