# National Transportation Safety Board

## Safety Recommendation

**Date:** July 17, 2009

**In reply refer to:** A-09-55 through -60

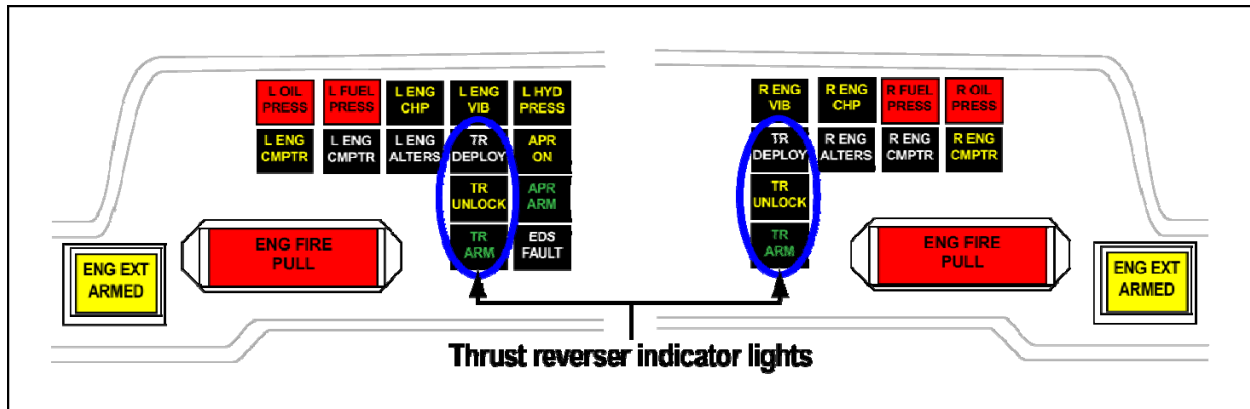
Normally, six lights<sup>7</sup>—three for each engine—will illuminate on the forward instrument panel to indicate the status of the thrust reversers (see figure). Each bottom light (TR ARM) is green and indicates that prerequisites for reverse thrust exist, such as the availability of hydraulic pressure to deploy the engine thrust reversers. Two of the conditions that trigger the TR ARM lights and that would be apparent to the pilots were that (1) the squat switches sense that the aircraft is in ground mode, and (2) the engine power levers are in the idle positions. The TR ARM lights denote that the reverse levers can be moved upward if the pilot elects. Because these lights are normally on when the engines are at the idle position on the ground and go out whenever the engine power levers are moved to and from idle, the pilot can become conditioned to these lights going on and off during normal taxi.

When the reverse levers are raised to the DEPLOY position, hydraulic pressure unlocks the engine thrust reverser doors, and, subsequently, two amber lights (TR UNLOCK) will illuminate to indicate that both thrust reverser doors are unlocked. When the amber TR UNLOCK lights illuminate, the green TR ARM lights extinguish. After the engine thrust reverser doors are fully deployed, two white lights (TR DEPLOY) illuminate, and the amber TR UNLOCK lights extinguish.

**Figure.** Diagram of a Learjet 60's lights on the main annunciator panel.

If, during a rejected takeoff, there were an inadvertent thrust reverser stowage due to loss of the requirements for maintaining reverse thrust, the following indications would occur:

- The white TR DEPLOY light(s) would extinguish,
- The amber TR UNLOCK light(s) would illuminate momentarily, and
- The green TR ARM light(s) would blink momentarily.<sup>8</sup>

The only indication available to the pilots that the cockpit reverse levers and engine thrust reversers were not in agreement would be the pilots' comprehension that neither of the TR DEPLOY lights was illuminated while the reverse levers were in the positions normally associated with reverse thrust. The NTSB concludes that, during a rejected takeoff, which requires quick and concentrated pilot actions, it may be difficult for a pilot to recognize the significance of the absence of reverse thrust indicator lights.

Require Learjet to develop and install improved aural or visual cues on future-manufactured Learjet 60 airplanes that would allow pilots to recognize an inadvertent thrust reverser stowage in a timely manner. (A-09-57)

Once improved aural or visual cues are developed per Safety Recommendation A-09-57, require Learjet 60 operators to install those cues on existing Learjet 60 airplanes. (A-09-58)
