DEPARTMENT OF TRANSPORTATION
NATIONAL TRANSPORTATION SAFETY BOARD
WASHINGTON, D.C. 20591

SB-1-96

During our investigation of the midair collision between Beech Baron, N6127, and TWA DC-9, N1063T, near Urbana, Ohio, a series of photographs were taken for us by your NAFEC facilities from inside the cockpit of a TWA DC-9 and an FAA Beech Baron. In reviewing the photographs of the Beech Baron, it was noted that a considerable portion of the window area can be blanked out by the sun visor.

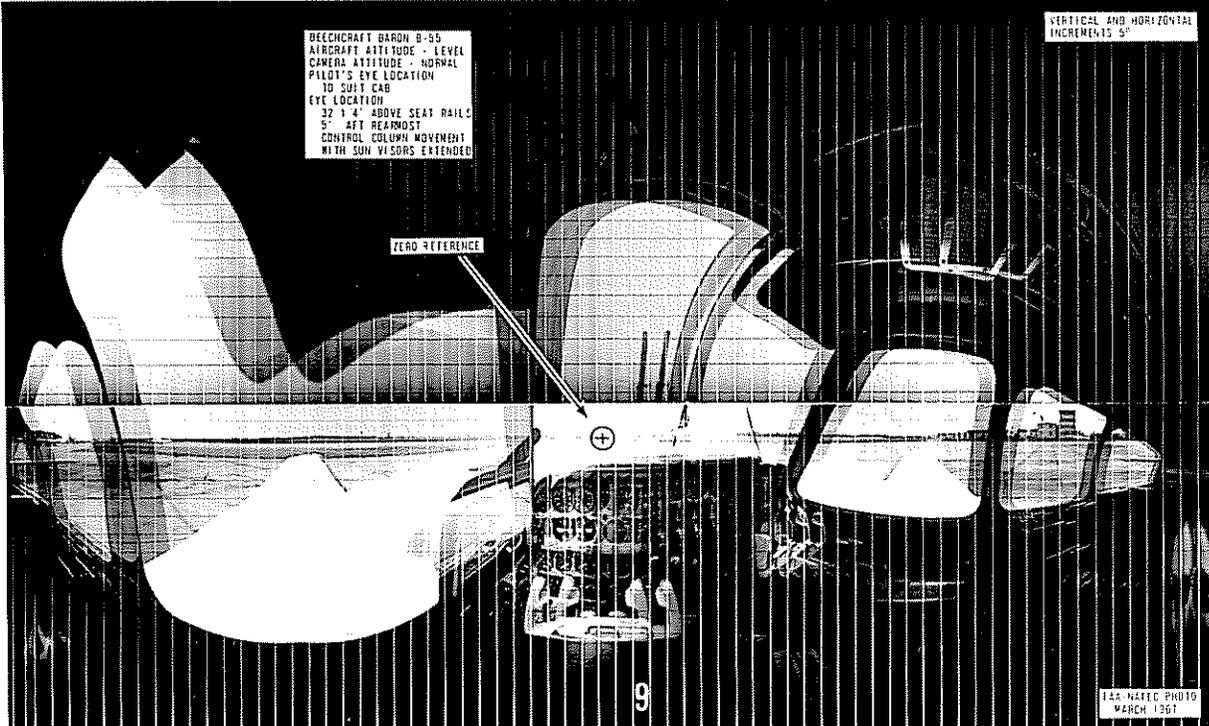
BEECHCRAFT BARON B-55
 AIRCRAFT ATTITUDE - LEVEL
 CAMERA ATTITUDE - NORMAL
 PILOT'S EYE LOCATION TO SUIT CAB
 EYE LOCATION
 32 1/4" ABOVE SEAT RAILS
 5" AFT REARMOST CONTROL COLUMN MOVEMENT WITH SUN VISORS EXTENDED

We recommend, therefore, that the Federal Aviation Administration survey the types of general aviation airplanes equipped with solid type visors to determine the extent of the resultant vision impairment. Where it is found that they severely hinder the pilot's vision, the solid visor should be replaced by a see-through type. Additionally, we recommend that, if this survey shows the solid type visors adversely affect the visibility from the aircraft, Part 23 be amended to provide

that when a sun visor is installed on future airplanes, it be a see-through type if it can be positioned so that it extends into the area of vision necessary for collision avoidance.

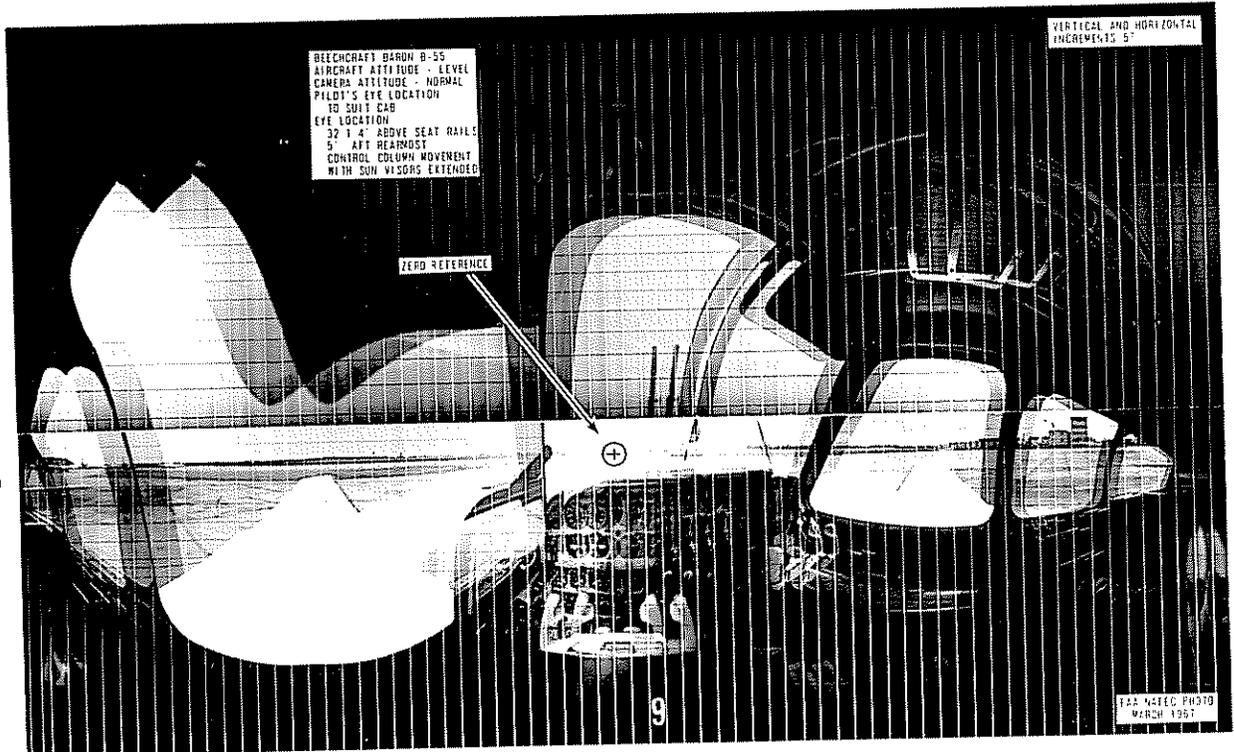
BEECHCRAFT BARON B-55
 AIRCRAFT ATTITUDE - LEVEL
 CAMERA ATTITUDE - NORMAL
 PILOT'S EYE LOCATION TO SUIT CAB
 EYE LOCATION
 32 1/4" ABOVE SEAT RAILS
 5" AFT REARMOST CONTROL COLUMN MOVEMENT WITH SUN VISORS EXTENDED
