# National Transportation Safety Board

Washington, D.C. 20594  
Safety Recommendation

In reply refer to: A-96-174 through -177

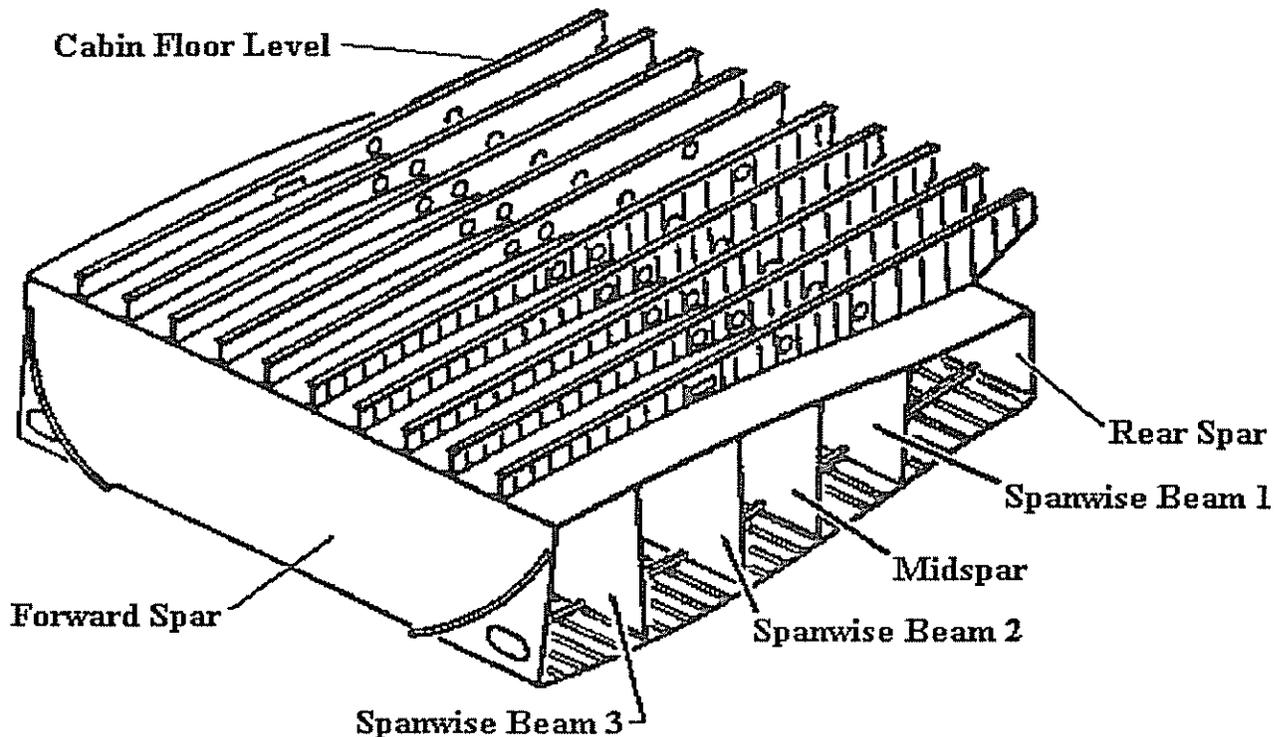
**Figure 1. Center Wing Fuel Tank**

A substantial portion of the airplane wreckage has been recovered from the ocean floor. Among the debris found along the first part of the wreckage path were CWT parts from spanwise beam Nos. 2 and 3, the forward spar, and debris from beneath and forward of the center wing section (see Figure 1). The cockpit of the airplane and pieces of the forward fuselage were found in a second debris field that was more than 1 mile from the beginning of the wreckage path. Fragmented wing and aft fuselage parts were recovered from a third debris field farther along the wreckage path.

Portions of the airplane have been reconstructed, including the CWT, the passenger cabin above the CWT, and the air conditioning packs and associated ducting beneath the CWT. The reconstruction thus far shows outward deformation of the CWT walls and deformation of the internal components of the tank that are consistent with an explosion originating within the tank. Airplane parts<sup>2</sup> from in and around the CWT recovered and identified to date contain no evidence
