# National Transportation Safety Board

## Safety Recommendation

**In reply refer to:** H-15-10 and -11

### **Davis, Oklahoma, crash**

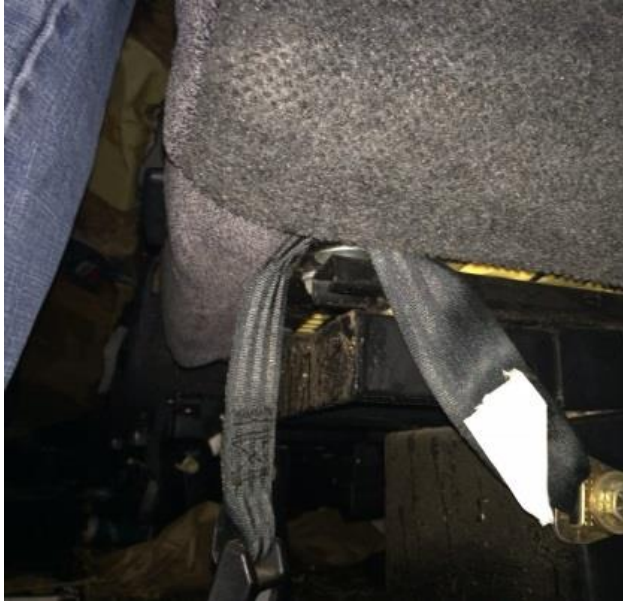
**Seat belts.** The medium-size bus was also equipped with lap belts at all passenger seating positions.<sup>6</sup> After the crash, many aisle-side belts were found with their webbing trapped by the side-slide track (see figure 1), which compromised the belt load path.<sup>7</sup> Further, two belts showed fraying and tears (see figure 2) in locations on the webbing similar to those where other belts were trapped. Most likely, the damage to the belt webbing resulted from previous entrapment by the side-slide track. Although the passengers in the Davis crash were not using the seat belts, both trapped seat belts and frayed/torn seat belt webbing would negatively affect the survivability of belted passengers, due to the reduced load capacity of trapped or damaged belts.

**Figure 1.** Seat belt webbing pinched by the side-sliding seat track.

The design of the Freedman side-slide seat did not provide a mechanism to protect the belt webbing from becoming pinched or trapped by the side-slide track. The NTSB is aware that a large number of buses have been sold with the Freedman side-slide seat option. Some of these buses were originally equipped with passenger lap belts. Other buses may have been equipped with belts as an after-market feature, as was the case with the medium-size bus involved in the Davis crash. Further, Freedman is not the only manufacturer of bus seats with a side-slide design. Several US seating manufacturers design seats that provide the option of flexible lateral seat positioning. The NTSB is concerned that these side-sliding seat designs do not protect the seat belt from becoming trapped by the sliding seat track. This entrapment can result in a compromised load path and damage to the belt webbing. As a result, the NTSB recommends that NHTSA determine whether the design of side-slide seats leads to seat belt entrapment that could result in reduced load capacity due to trapped belts or damage to belt webbing, and, if appropriate, open a defect investigation to address this issue.

Determine whether the design of side-slide seats leads to seat belt entrapment that could result in reduced load capacity due to trapped belts or damage to belt webbing; if appropriate, open a defect investigation to address this issue.

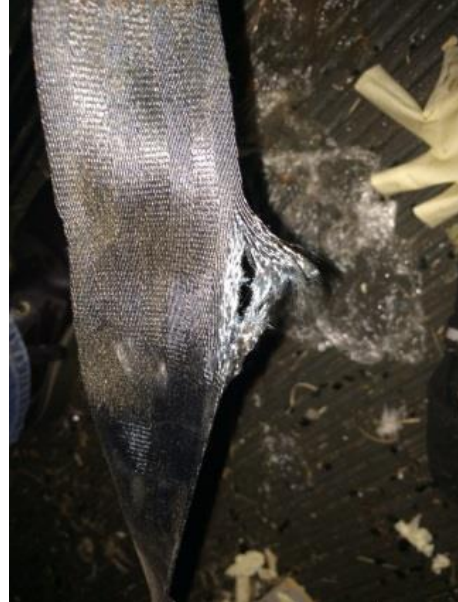
**Figure 2.** Seat belt with webbing torn in a location similar to where other belts were trapped.
