National Transportation Safety Board

Safety Recommendation

In reply refer to: R-14-74

The Accident

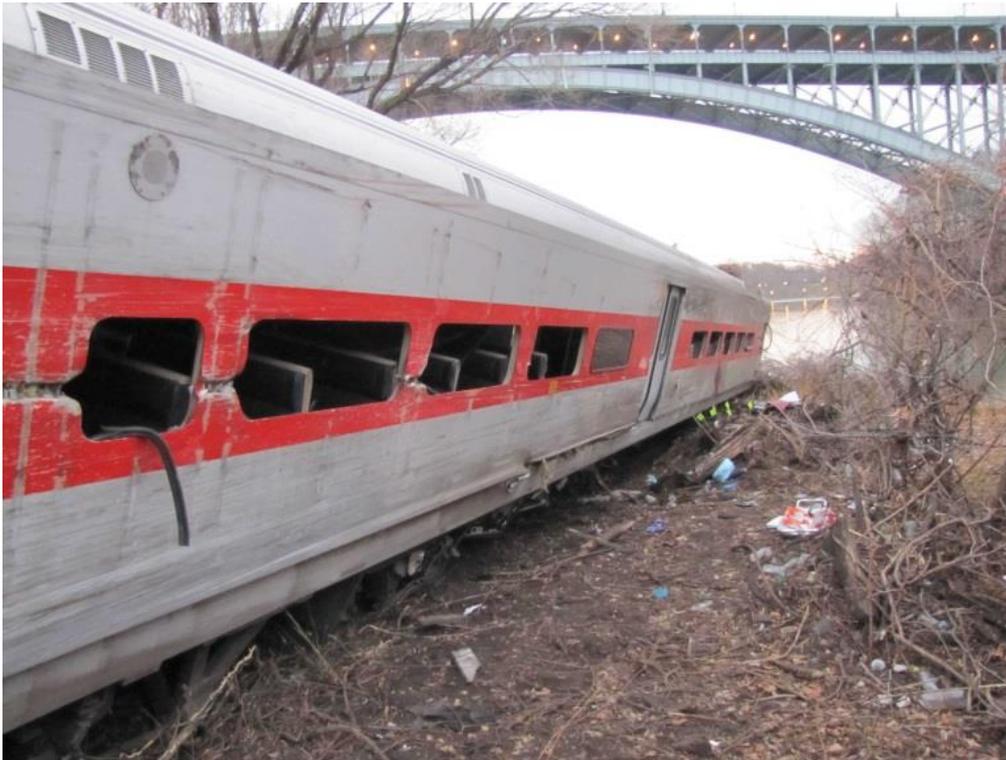
the right sides of the first three cars. Specifically, in the first and second cars, 9 right-side windows were missing in each car (see figure 2); in the third car, all 12 of the right-side windows were missing. NTSB investigators considered if the windows may have been removed by occupants or responders to exit or enter the cars. However, investigators discounted this possibility because the second and third cars came to rest on their right sides, allowing no usable exit or entry routes on the right sides. The first car had usable car body doors on the left side and both ends of the car for entry or egress, so window exit or entry was not needed. NTSB investigators examined the windows (glazing and gaskets) that remained in the train and found that the windows were intact; however, several other types of failures were observed, including the window/glazing partially separated from its surrounding structure, torn gaskets, and zip-strips that partially separated from the gasket.

Figure 2. The right side of the first car.

The four passengers who were ejected from the train were killed and were found under or adjacent to the first three cars. They were ejected from the cars through the window openings that resulted from the loss of the windows/glazing. Two of the seriously injured passengers were partially ejected and sustained injuries consistent with making contact with the ground outside of the train while it slid along the ballast. The passengers and crew who remained in the train survived the accident. Had the windows remained secured in the cars, the four passengers who were killed would not have been ejected and likely would have survived the accident.

Develop a performance standard to ensure that windows (e.g., glazing, gaskets, and any retention hardware) are retained in the window opening structure during an accident and incorporate the standard into 49 *Code of Federal Regulations* (CFR) 238.221 and 49 CFR 238.421 to require that passenger railcars meet this standard.
