National Transportation Safety Board

Safety Recommendation

In reply refer to: R-14-75 and -76

The National Transportation Safety Board (NTSB) urges the Federal Railroad Administration (FRA) to take action on the safety recommendations issued in this letter. The recommendations address defining specific allowable limits for combinations of track conditions to ensure detection and remediation of measured varying track deviations, which by themselves do not exceed specific track geometry limits, but in combination pose a risk to safe train operations. The recommendations are derived from the NTSB's investigation of the CSX Transportation (CSX) train Q70419 derailment on Metro-North Railroad (Metro-North) track in The Bronx, New York (DCA-13-FR-009). Information supporting this recommendation is discussed below.

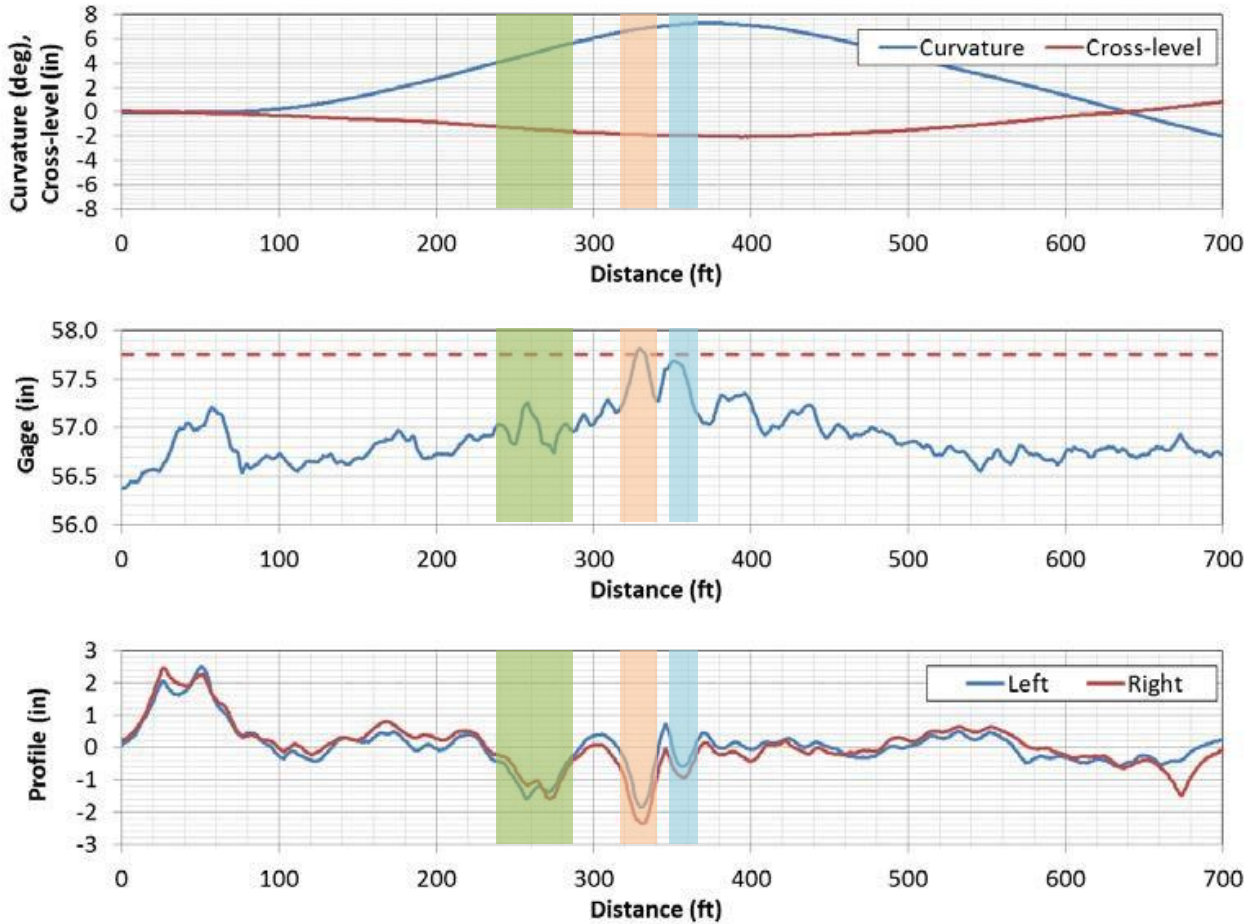
Figure 1. FRA DOTX220 geometry car inspection charts.

The NTSB determined that the probable cause of the accident was excessive track gage due to a combination of fouled ballast, deteriorated concrete ties, and profile deviations resulting from Metro-North's decision to defer scheduled track maintenance.

The NTSB investigator’s review of the data strip chart from the geometry car in the derailment area revealed a gage measurement of 57.81 inches and a profile measurement of —2 inches (a 2-inch dip) in both rails (see figure 1). Deviations in track geometry are symptoms of underlying track defects that can vary over time.

As shown in figure 1 below, the track at the POD (shaded orange) had a gage measurement slightly above the FRA limit in combination with a substantial (but allowable) profile deviation. Whereas the other two fouled ballast zones shown shaded in blue and green had either gage or profile deviation, but not both simultaneously. The combined geometry deviation with fouled ballast presented a risk of derailment.

Revise Title 49 *Code of Federal Regulations* Part 213 to define specific allowable limits for combinations of track conditions, none of which individually amounts to a deviation from Federal Railroad Administration regulations that requires remedial action, but, which when combined, require remedial action.

Once you have completed the actions specified in Safety Recommendation R-14-75, program your geometry inspection vehicles to detect combinations of conditions that require remedial action.
