# National Transportation Safety Board

## Safety Recommendation

**In reply refer to:** R-14-75 and -76

The National Transportation Safety Board (NTSB) urges the Federal Railroad Administration (FRA) to take action on the safety recommendations issued in this letter. The recommendations address defining specific allowable limits for combinations of track conditions to ensure detection and remediation of measured varying track deviations, which by themselves do not exceed specific track geometry limits, but in combination pose a risk to safe train operations. The recommendations are derived from the NTSB's investigation of the CSX Transportation (CSX) train Q70419 derailment on Metro-North Railroad (Metro-North) track in The Bronx, New York (DCA-13-FR-009). Information supporting this recommendation is discussed below.

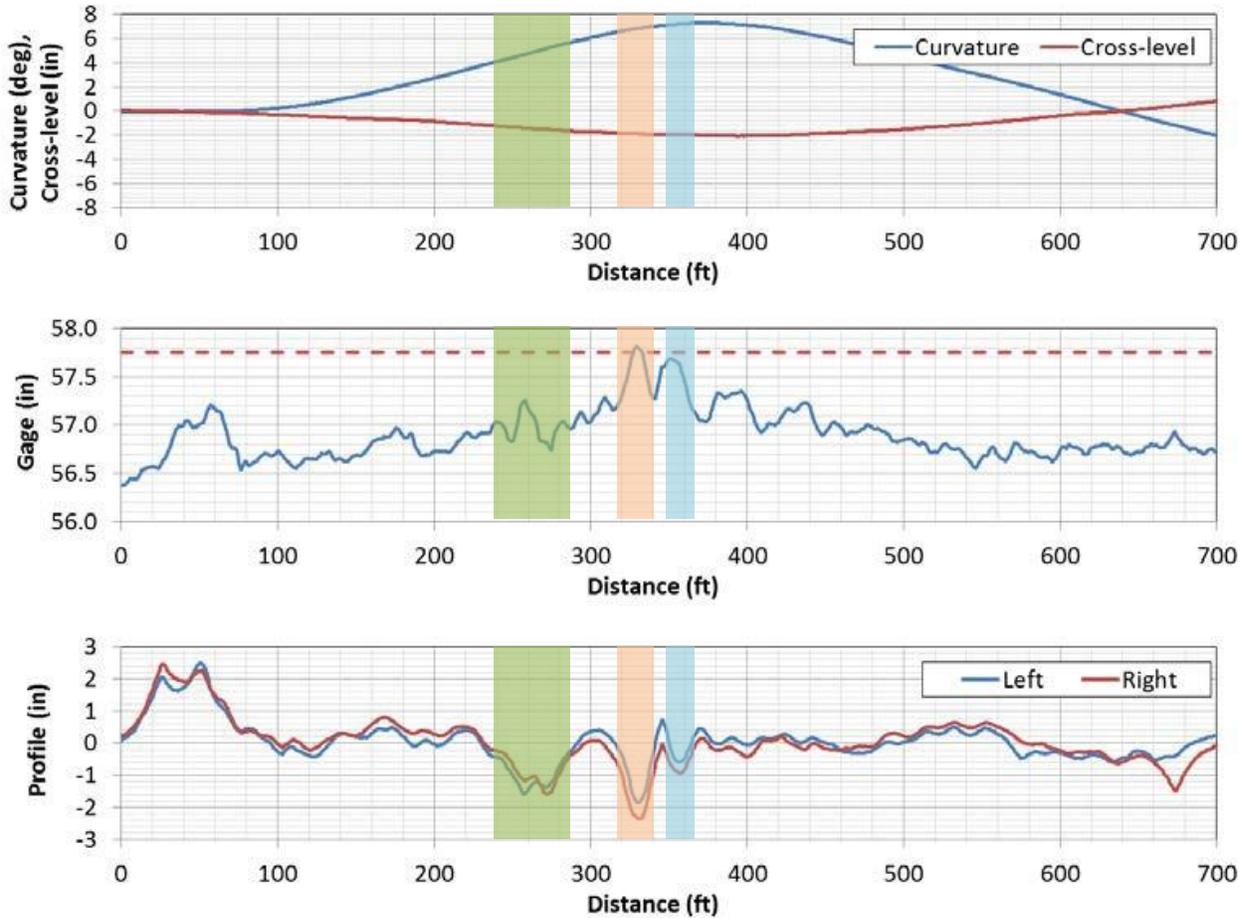
**Figure 1.** FRA DOTX220 geometry car inspection charts.

The NTSB investigator’s review of the data strip chart from the geometry car in the derailment area revealed a gage measurement of 57.81 inches and a profile measurement of —2 inches (a 2-inch dip) in both rails (see figure 1). Deviations in track geometry are symptoms of underlying track defects that can vary over time.

As shown in figure 1 below, the track at the POD (shaded orange) had a gage measurement slightly above the FRA limit in combination with a substantial (but allowable) profile deviation. Whereas the other two fouled ballast zones shown shaded in blue and green had either gage or profile deviation, but not both simultaneously. The combined geometry deviation with fouled ballast presented a risk of derailment.

Revise Title 49 *Code of Federal Regulations* Part 213 to define specific allowable limits for combinations of track conditions, none of which individually amounts to a deviation from Federal Railroad Administration regulations that requires remedial action, but, which when combined, require remedial action.

Once you have completed the actions specified in Safety Recommendation R-14-75, program your geometry inspection vehicles to detect combinations of conditions that require remedial action.
