National Transportation Safety Board

Safety Recommendation

Date: February 2, 2015

In reply refer to: R-15-01 and -02

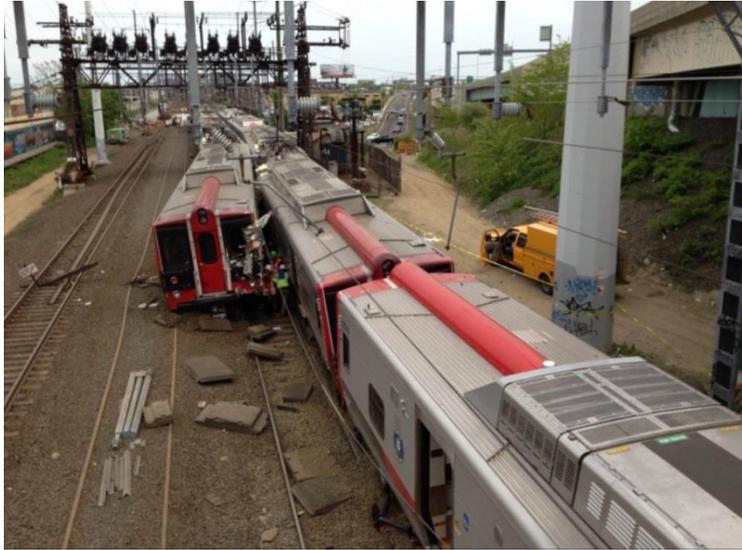
On Friday, May 17, 2013, at 6:01 p.m. eastern daylight time, eastbound Metro-North passenger train 1548, which had departed Grand Central Terminal, New York, toward New Haven, Connecticut, derailed at milepost (MP) 53.25 from main track 4 of the New Haven line subdivision 7 in Bridgeport, Connecticut, and was struck by westbound Metro-North passenger train 1581, which had departed New Haven bound for Grand Central Terminal. In the collision, the forward (F-end) or leading end of a passenger railcar of passenger train 1581 struck the trailing or back end (B-end) of a passenger railcar of passenger train 1548. (See Figure 1.) As a result of the collision, 63 passengers, 2 engineers, and 1 conductor were injured. Metro-North estimated that about 250 passengers were on each train at the time of the accident.

The NTSB determined that the probable cause of the derailment was an undetected broken pair of compromise joint bars on the north rail of track 4 on the Metro-North New Haven subdivision at MP 53.25 resulting from: (1) the lack of a comprehensive track maintenance program that prioritized the inspection findings to schedule proper corrective maintenance; (2) the regulatory exemption for high-density commuter railroads from the requirement to traverse the tracks they inspect; and (3) Metro-North's decisions to defer scheduled track maintenance.

Figure 1. View of the accident between Metro-North passenger trains 1548 (right) and 1581 (left).

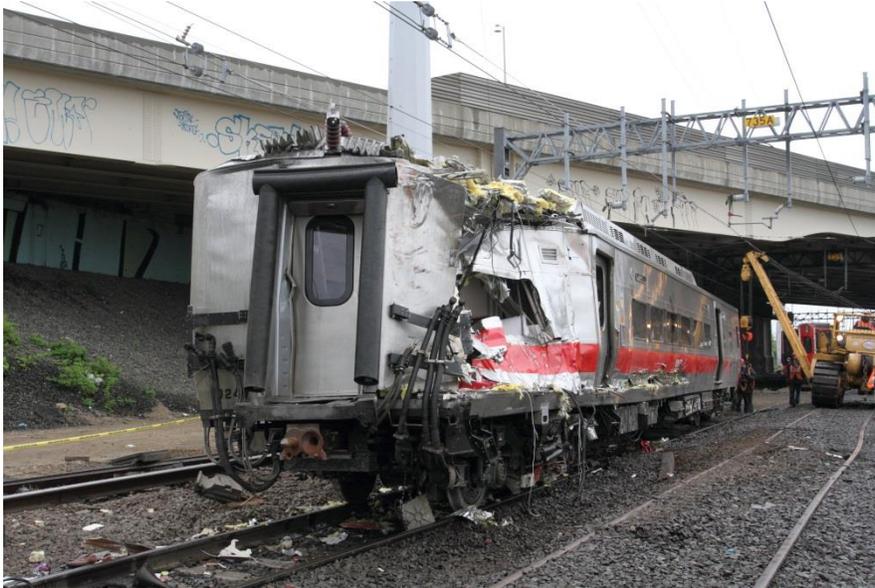
The mechanical strength requirements in 49 CFR 238.213(a)(1) for the B-end corner posts are less than one-half of those in 49 CFR 238.213(b)(2) and (b)(3) for the F-end corner posts of passenger railcars.

This train collision provides compelling evidence that the B-end strength requirement for passenger railcars needs revision. The accident sequence involved a common type of collision—a sideswipe or raking collision; specifically, the stronger F-end of passenger railcar 9193 impacted the weaker B-end of passenger railcar 9247. The damage to the B-end of passenger railcar 9247 was significant and posed significant risk to passengers; whereas, the damage to the F-end of passenger railcar 9193 was not significant from an intrusion point of

view. (See Figure 2.) This evidence indicates that the F-end corner posts provided adequate protection from accidents, but that the B-end corner posts were not sufficiently robust to ensure passenger safety.

Figure 2. Photograph of B-end of Metro-North passenger railcar 9247 after the collision.

Revise Title 49 *Code of Federal Regulations* (CFR) 238.213 to require the existing forward-end corner post strength requirements for the back-end corner posts of passenger railcars. (R-15-01)
