National Transportation Safety Board

Safety Recommendation

In reply refer to: R-15-4 and -5 (Urgent)

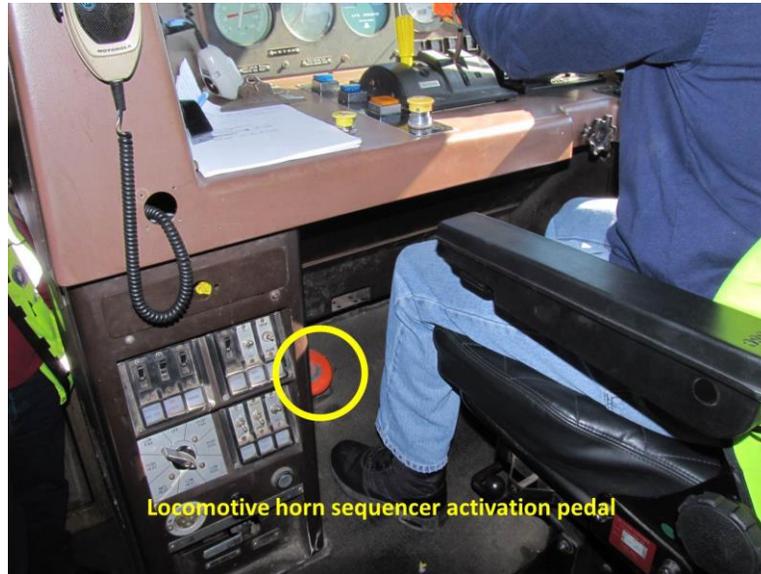
The lead locomotive in the southbound train, UP 9707, was equipped with a horn sequencer that is designed to sound the "long, long, short, long" highway-rail grade-crossing horn cadence. NTSB investigators asked the UP about the operating characteristics of the horn sequencer system to understand its functionality. The UP stated that the system is activated by pressing a pedal on the floor inside the cab of the locomotive on the engineer's side (the right side) under the control console. (See figure 1.) Documentation provided by the UP indicated that the pedal is pressed once and released to activate the system. The pedal is pressed again to deactivate the system.

Figure 1. Locomotive horn sequencer pedal from exemplar UP locomotive.

- The horn sequencer was activated with a single push of the sequencer foot pedal located under the engineer’s control console at several speeds ranging from 20 mph to 75 mph.
- The sequencer sounded the standard grade-crossing horn cadence (long, long, short, long) repeatedly at all speeds until the sequencer foot pedal was again depressed, which silenced the horn.

Based on examination of the Lococam data and the operating characteristics of the horn sequencer, we determined that the southbound train’s horn sequencer was active for a 4-minute 6-second period before the accident.

Review your existing regulations and your motive power and equipment compliance manual, and revise them as needed to prohibit automatic systems from resetting the locomotive alerter.

Immediately notify railroads of the circumstances of this accident and the risks posed by automated inputs that reset alerter cycles. Urge railroads to assess all controlling locomotive alerter systems to (1) identify and document any system inputs that reset the alerter cycle without manual intervention by crewmembers and (2) determine ways to eliminate such resets.
