**STUDY OF
LESSONS TO BE LEARNED
FROM ACCIDENTS
ATTRIBUTED TO TURBULENCE**

ADOPTED: DECEMBER 15, 1971

**NATIONAL TRANSPORTATION SAFETY BOARD
Washington, D. C. 20591
REPORT NUMBER: NTSB-AAS-71-1**

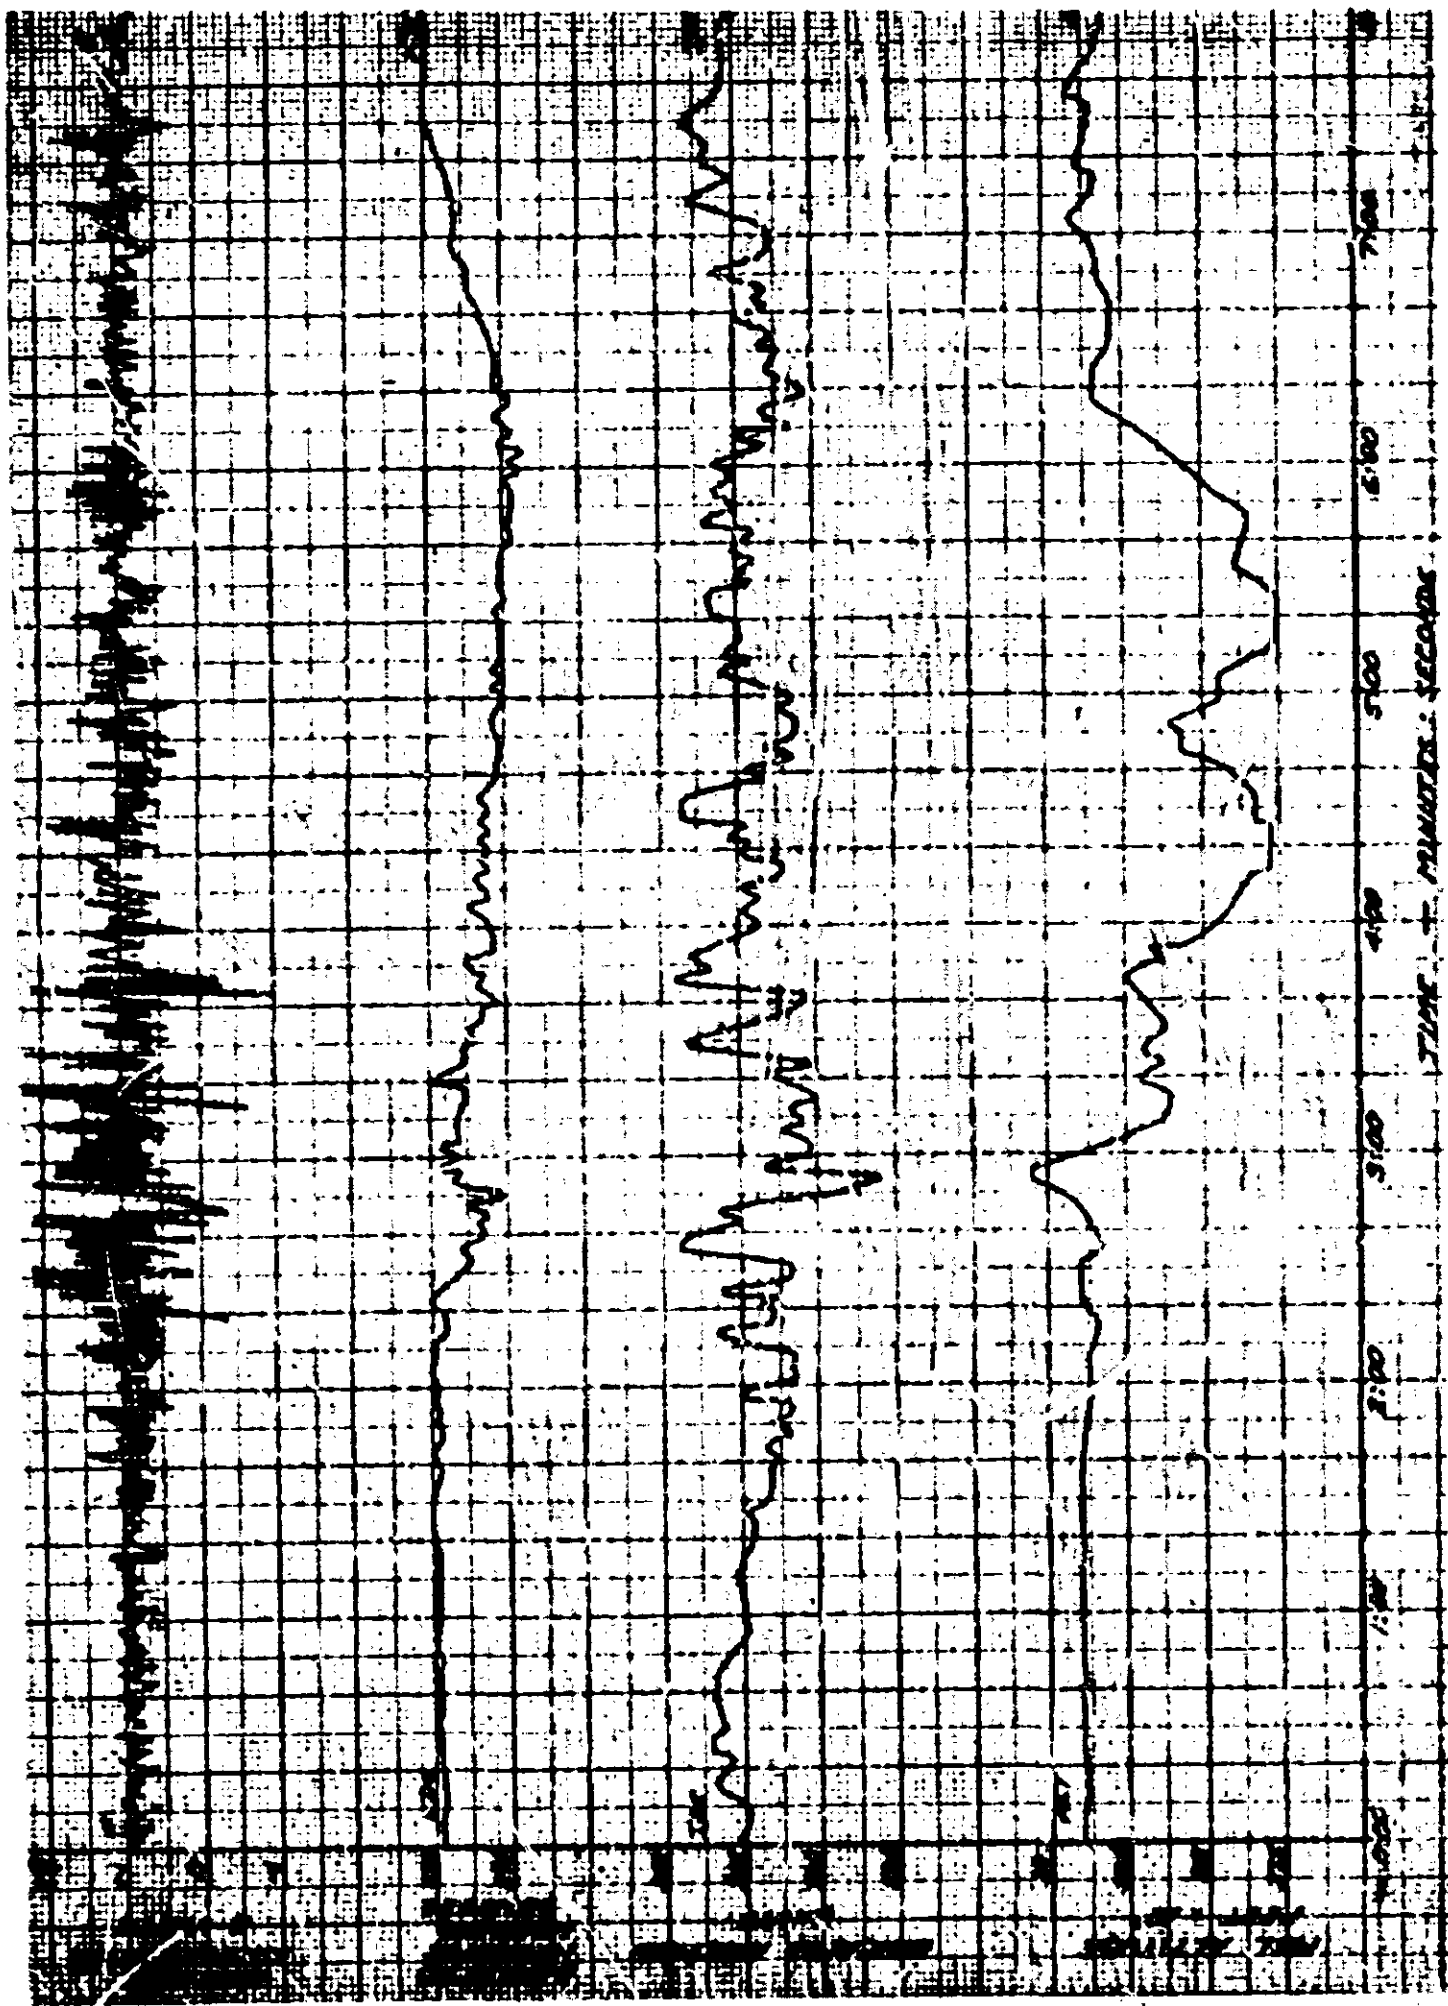
Figure 4 FLIGHT DATA RECORDER GRAPH
THUNDERSTORM PENETRATION

One such case involved a regularly scheduled air carrier flight of a DC-8 which encountered severe turbulence and hail upon penetration of a thunderstorm during cruise westbound over the central United States at Flight Level 390. Six passengers were injured, two of them seriously, and the aircraft was damaged as follows: Nos. 2 and 4 heat exchangers damaged, all four engine chin scoops cracked at island, No. 1 engine PT2 probe damaged and bent, left cabin heat exchanger door damaged, fuselage skin just aft of radome lifted, radome damaged - replaced, splitter between Nos. 3 and 4 compressors damaged, left wingtip window cracked, numerous static wicks missing, five seat tables damaged, hole in right aft lavatory ceiling, isolation band on vertical stabilizer damaged and right horizontal stabilizer damaged.

Fig. 4 is a reproduction of a portion of the flight data recorder graph associated with this accident. It can be seen that the maximum variance in vertical acceleration was from + 2.23 g's to -0.99 g or an incremental peak variation of 3.22 g's, while several variations of more than 2 g's are noted. During the worst of the encounter, airspeed fluctuated as much as 52 knots, the heading varied 20° and there were two successive altitude losses of almost 1,000 ft. Although the turbulence in this case has been categorized as severe, the variations in the parameters above, particularly the variation in vertical acceleration, meet the criteria for extreme turbulence.
