Railroad Special Investigation Report

**Two Rear-End Collisions
Involving Chicago Transit Authority
Rapid Transit Trains
at Chicago, Illinois
June 17 and August 3, 2001**

**NTSB/SIR-02/01
PB2002-917006
Notation 7488
Adopted September 5, 2002**

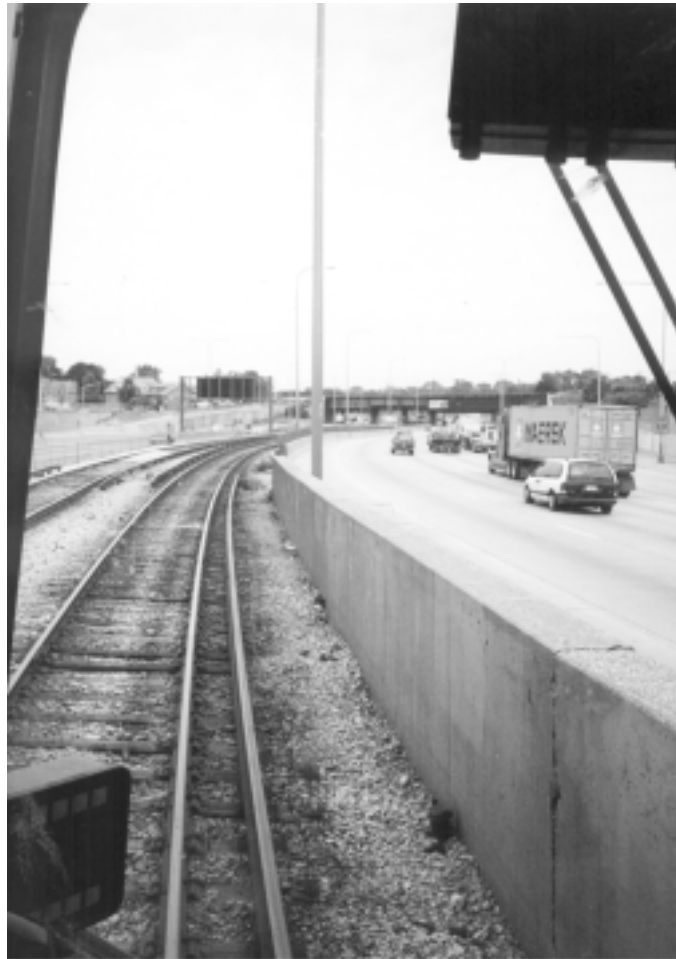
Figure 3. Operator's view as train approaches June 17 accident location.

The Safety Board does not find this part of her account credible. The Safety Board identified no mechanical condition or malfunction that would have prevented the train from stopping had the brakes been applied appropriately. Sight distance tests indicated that the standing train was visible from 800 feet away. At a train speed of 10 mph, the operator had more than 50 seconds to see the train ahead and bring her own train to a stop, without the need to resort to emergency braking. The Safety Board concludes that the operator in the June 17 accident had ample time to see the train ahead and bring her train to a safe stop; however, for unexplained reasons, she failed to do so.

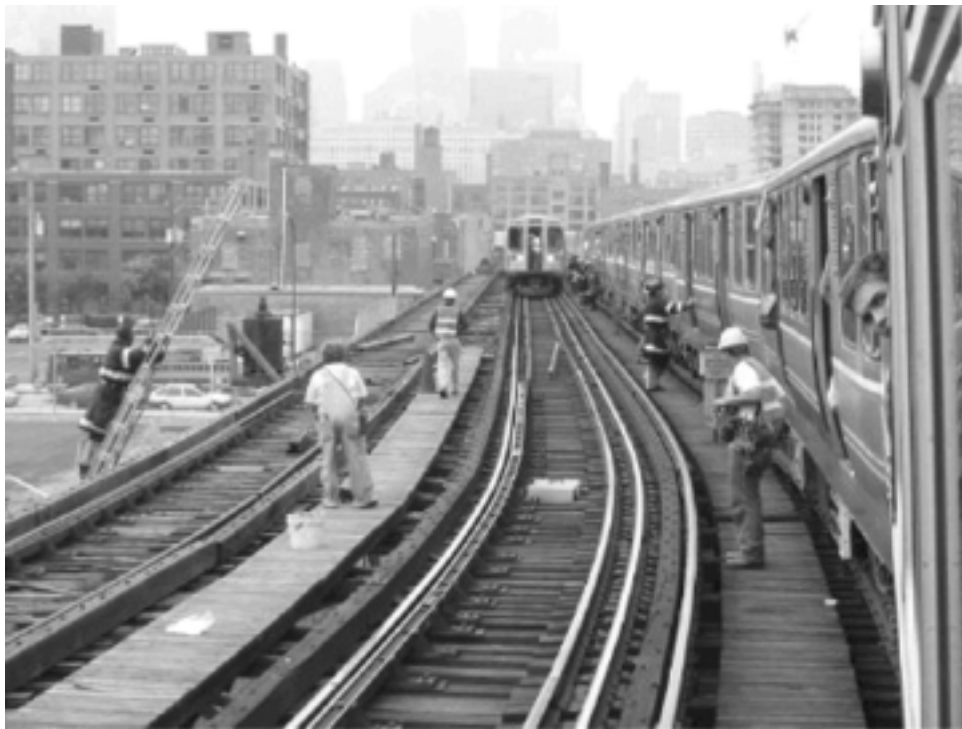
**Figure 5.** Emergency response personnel at accident scene.

Equipment damage consisted of damaged couplers, anti-climbers, and electronics, as well as buckled flooring and broken windows. Buckled flooring on train 505 prevented car-end doors from opening or closing properly throughout the train consist. All end doors on train 416 functioned. The CTA estimated the cost of damage repair at \$136,138.

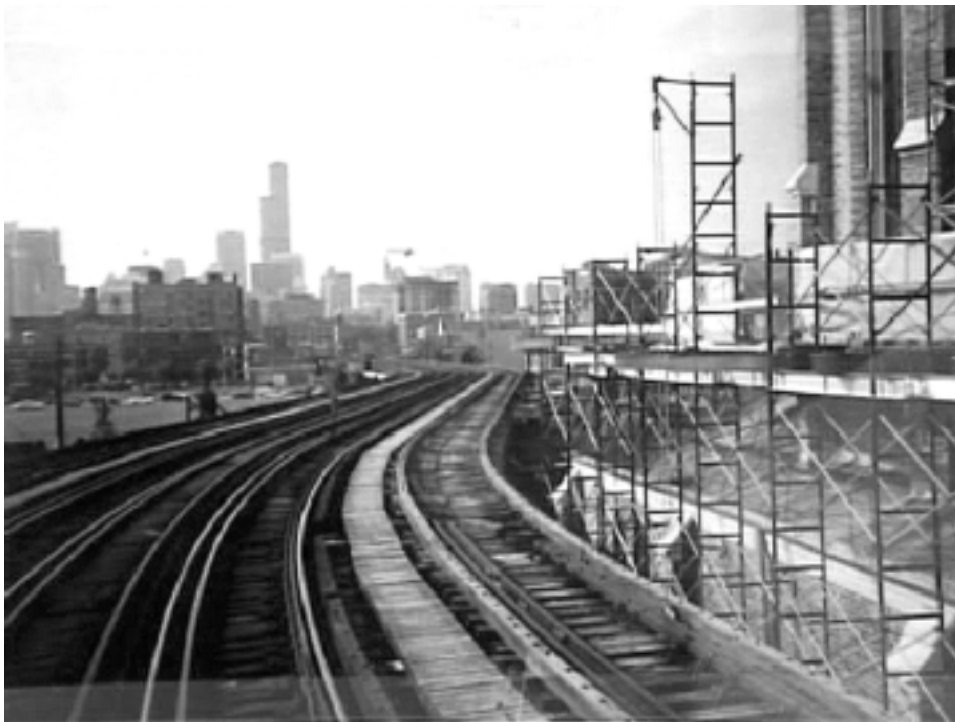
Figure 6. Operator's view as train rounds Church Curve.

Sight Distance. Investigators determined that the side of a train standing at the point of impact could first be glimpsed by a following train from a distance of about 373 feet as the following train exited Church Curve. The view of the rear of the train was unobstructed from about 345 feet (see figure 6).

The Safety Board could not find any mechanical reasons why the operator failed to stop train 416 short of the standing train. Sight distance tests indicated that the standing train was visible from 373 feet away which, at 13 mph (the speed indicated on the accident train's maintenance data logger), would have given the operator 18 seconds or more to see the standing train and activate braking to safely stop and avoid an accident. But according to the maintenance logger data, the operator did not activate emergency braking until 1 1/2 seconds before impact.

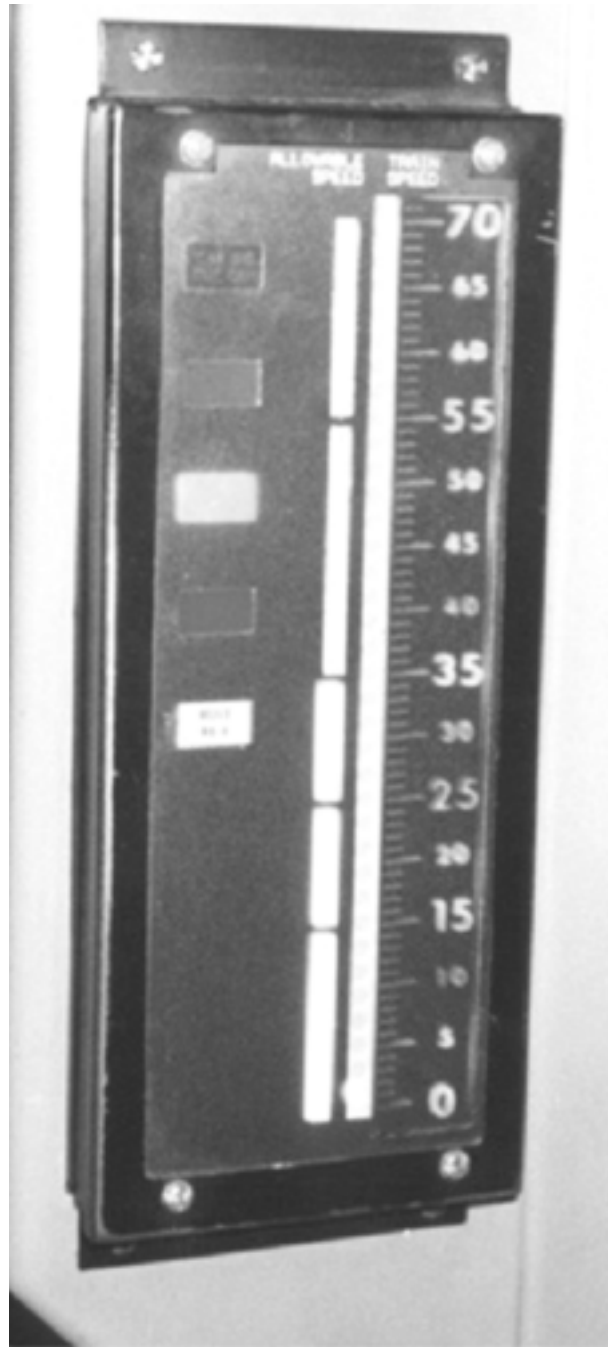
Figure 7. Cab signal aspect display unit.

The cab signal system picks up speed codes from the track circuits through an antenna and displays them to the operator on an aspect display unit in the cab (see figure 7). An operator may operate up to the indicated speed. If the indicated speed is exceeded, an alarm sounds, and the train must be put into braking position 2 or 3 and slowed to the proper speed. If the operator's response to an alarm is not timely, train braking will initiate automatically after 1 1/2 seconds, and the train will be brought to a complete stop. The system is designed such that, provided cab signaling is cut in, the absence of a speed code in the track circuit is interpreted as a stop signal, which is covered by rule R6.4 (discussed below).

At the transition from cab signal territory to block signal territory on the Blue Line, the cab signal system must be cut out; otherwise, trains will be brought to a stop because of the absence of the required speed code. The system is cut out through use of a signal card in the wayside equipment. At the transition back to cab signal territory from block signal territory, the cab signal system is designed to cut back in as soon as any speed code is detected. If a train does not detect a speed code, the cab signal system will not cut in. As
