SPECIAL INVESTIGATION REPORT

**SEARCH AND RESCUE PROCEDURES AND
ARMING OF EMERGENCY LOCATOR TRANSMITTER:**

**AIRCRAFT ACCIDENT NEAR MICHIGAN CITY,
INDIANA,**

NTSB-SIR-81-2

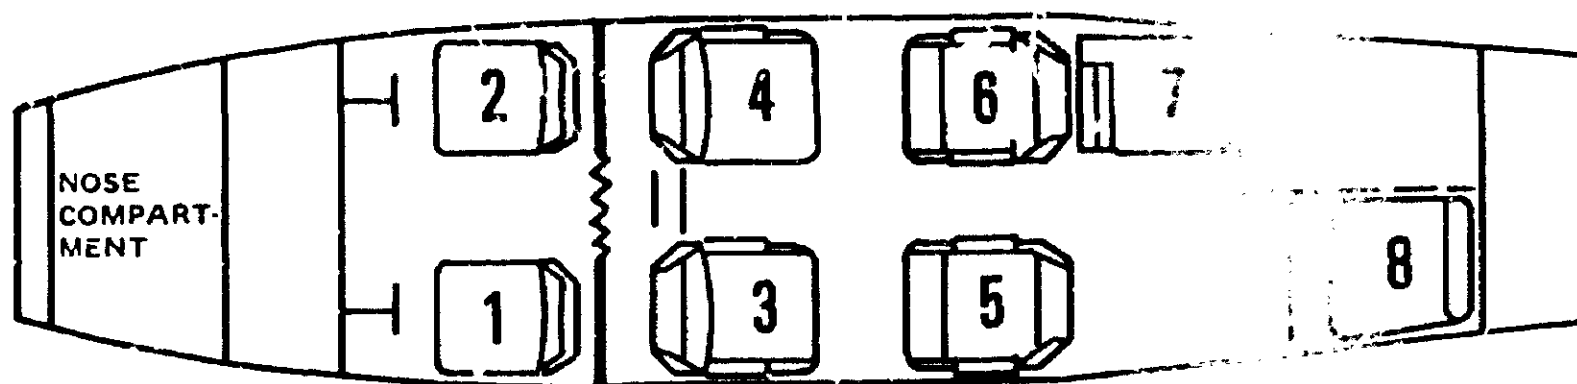
Figure 2.--Interior and exterior of N2181L.

The cabin and cockpit areas were undamaged--there was no loss of occupiable space because of crushing. The cabin interior revealed no evidence of smoke or burned upholstery. The passengers' luggage was stored in the aft compartment. The sliding door was partially opened. There were eight seats in the aircraft, including the cockpit. (See figure 2.) All seats and restraint systems were essentially undamaged.

Examination of the aircraft wreckage before and after it was recovered from the lake indicated this was a survivable crash. The cockpit and cabin areas were practically undamaged, there was no loss of occupiable space due to crushing, and there was no evidence of material or section rebound. The seatbelts were not damaged and all seats, except the left forward facing seat, were attached to the floor tracks.

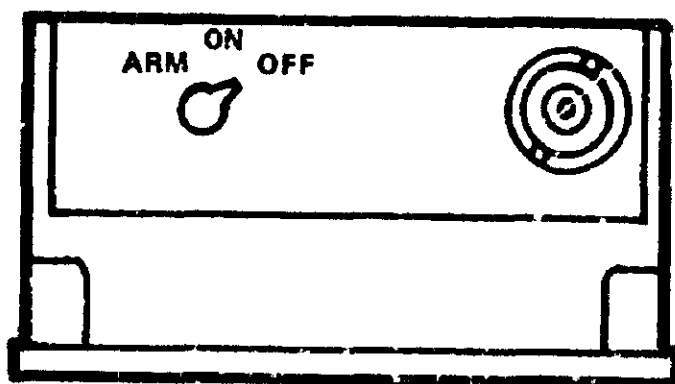
Figure 3.—Emergency locator transmitter.

The ELT is an electronic signaling device that can be used in conjunction with homing devices to determine the position of aircraft or personnel in distress. N2181L was required under 14 CFR Part 135 to be equipped with an operational ELT. A CIR-11-2 Emergency Locator System, including the TR70-13/13A/16 ELT was installed on N2181L. The ELT is water resistant and should operate submerged for up to 20 hours. However, the transmitting range of the ELT is severely reduced if the unit is submerged. Under normal temperatures and with a fully charged battery, the ELT will emit signals for at least 48 hours, although not at full output power. (See figure 3.)

The Collins CIR-11-2 ELT unit installed on N2181L was mounted inside the aft section of the fuselage on the right side. The position of the transmitter function switch on the ELT could not be seen through the inspection hole. The aircraft operator is responsible for ensuring that the ELT is armed and functioning.

Investigation of the wreckage disclosed that the ELT antenna was connected and the unit was secured in the bracket. The transmitter function switch on the ELT was found in the OFF position.

The remote switch on N2181L was accessible through a spring loaded, 1 1/8 inch diameter inspection hole which was located on the right side of the fuselage below the leading edge of the horizontal stabilizer. The remote switch had three positions as shown on the placard on the side of the fuselage just below the inspection hole. (See figure 3.) The placarded remote switch positions on N2181L read from left to right, "ARM", "OFF", "ON". The remote switch, when moved to the left toward the ARM position, was spring loaded so that the switch would return to the center OFF position.

The ELT on board N2181L had been installed on October 15, 1980, by the pilot who was flying N2181L when it crashed. It is possible that, from installation until the crash, the ELT transmitter function switch had been in the OFF position and would not have been automatically activated under any condition. Or, the operator may have incorrectly assumed that the ELT was properly armed by turning the remote switch to ARM.

Examination of N2181L revealed that the remote switch for the ELT was located in the rear section of the aircraft. When the ELT was tested and the wiring diagram was checked, the ARM position on the remote switch actually acted as a reset when the ELT impact switch was activated. Further testing of the remote switch revealed that a signal could be transmitted through the ELT, regardless of the position of the transmitter function switch on the ELT. Thus, a CIR-11-2 ELT unit can be installed with the transmitter function switch in the OFF position and a normal test signal will be radiated by momentarily placing the remote switch to the ON position. With the transmitter function switch on the ELT unit in the OFF position, the emergency, or automatic "g" function of the unit, is eliminated. The possibility of confusion of the operators on these functions was recognized and responded to (1) by Collins General Aviation Division when it issued Service Information Letter 1-81, "Supplemental Information on ELT Remote Functions" dated July 15, 1981, and updated the ELT owner's manual and by (2) Beech Aircraft when it provided a modification kit for all Beech aircraft equipped with the CIR-11-2 ELT.

Since this accident, the ELT owners manual, Document 350012, has been updated to include supplementary information regarding the function of the remote switch, and Beech Aircraft has designed a modification consisting of a bracket which will not allow the remote switching plugs to be plugged into the unit unless the ELT transmitter function switch is in the ARM position. The expanded description of the ELT remote switch functions and the modification, which includes new labeling of the remote switch, should reduce misunderstanding of its use. The modification insures that the remote switch is only operational when the ELT transmitter function switch is in the ARM position. As a result, the problem of testing the ELT by turning the remote switch to ON and generating a positive test signal with the ELT transmitter function switch OFF should be eliminated. For example, the old label read "ARM-OFF-ON", which may have suggested to some operators that activation of the remote switch to the ARM position would arm the ELT. The new label reading "REARM-ARM-XMIT" should make the remote switch function clearer to operators. This modification, Beech Kit No. 101-3062-1, applies to all Beech aircraft which have this ELT installed; however, installation of the modification is not required.

Issue an Airworthiness Directive to require that Beech Kit No. 101-3062-1 be installed on all Beech aircraft which have the remote ELT switch installed. (Class II, Priority Action) (A-81-90)
