HAZARDOUS MATERIALS SPECIAL INVESTIGATION REPORT
RELEASE OF OLEUM DURING WRECKAGE-CLEARING FOLLOWING
DERAILMENT OF SEABOARD SYSTEM RAILROAD TRAIN EXTRA
8294 NORTH, CLAY, KENTUCKY, FEBRUARY 5, 1984

National Transportation Safety Board
Washington, DC

Apr 85

NTSB/SIR-85/01

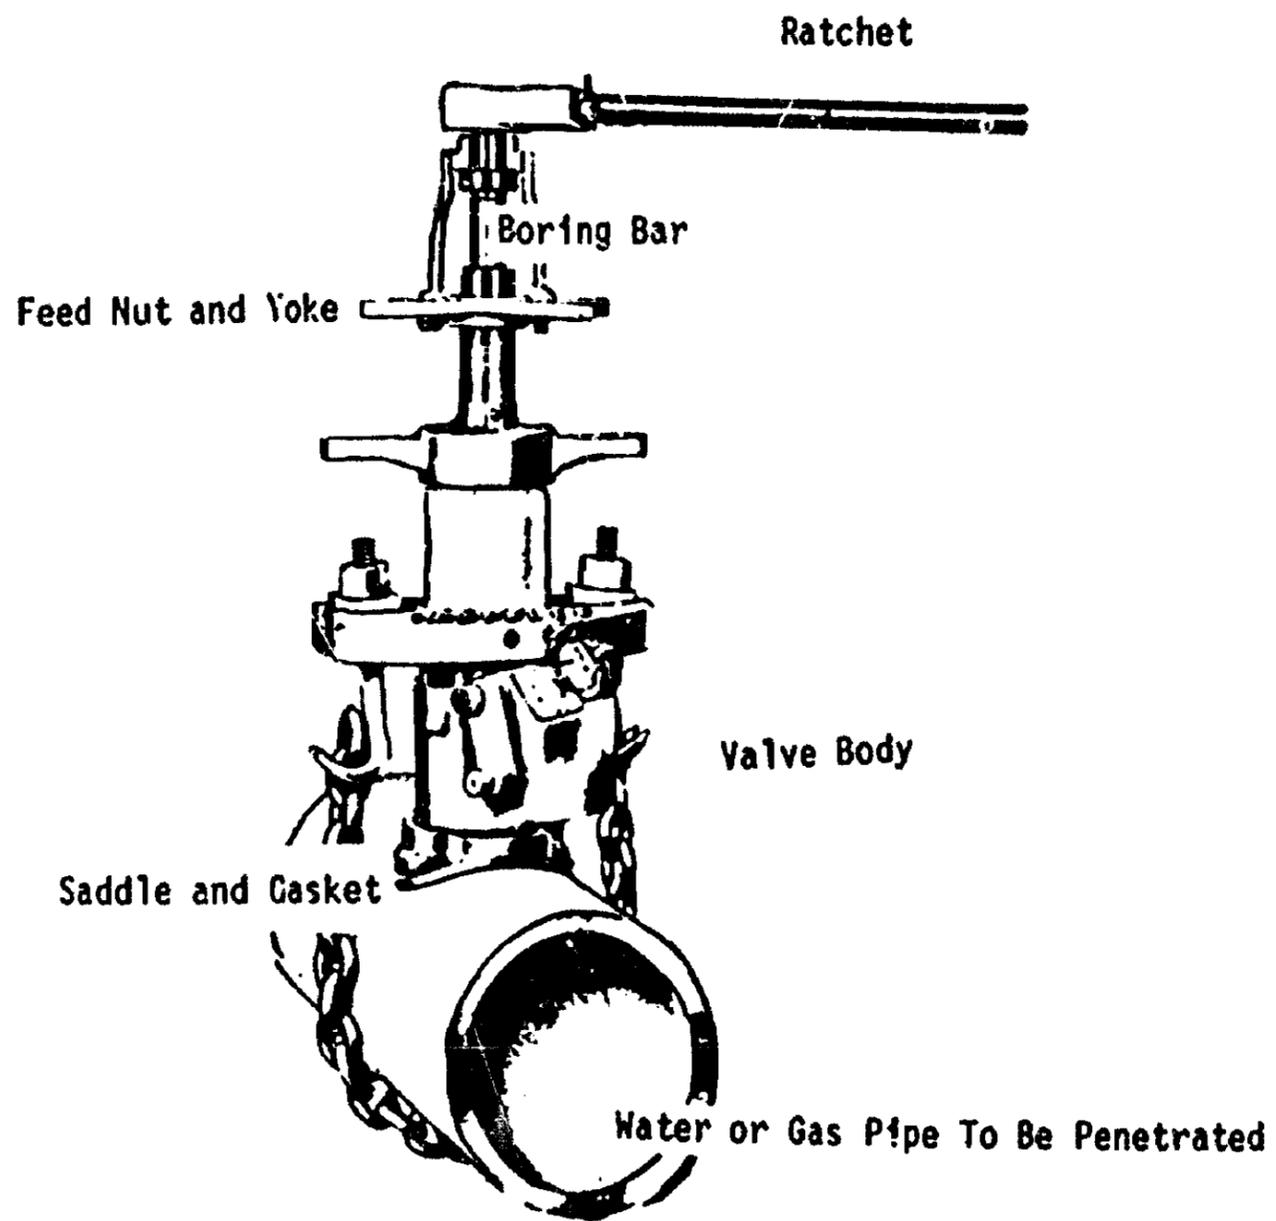
Figure 2.--Mueller Co. "B" drilling and tapping machine
in designed application.

6/ The equipment was a 2 1/2-inch Mueller Drilling and Tapping Machine modified by the subcontractor for tank car applications by removing the base plate (saddle fitting). As supplied by Mueller, this device is intended for tapping water and gas mains up to 8 inches in diameter and 1-inch thick. It has a maximum working pressure of 90 psi. The Mueller Co. does not recommend this device or any of their products for tank car penetrations. Mueller representatives were not aware that this device had been modified by the subcontractor for tank car penetrations and later expressed concern about the capability of the modified equipment to provide an adequate seal when used to tap tank cars.
