Special Investigation Report - Failure of
Cargo Tank Transporting Hazardous Waste on the
Washington, DC. Beltway, I-95
Fairfax County, Virginia, August 12, 1985

(U.S.) National Transportation Safety Board
Washington, DC

13 May 86

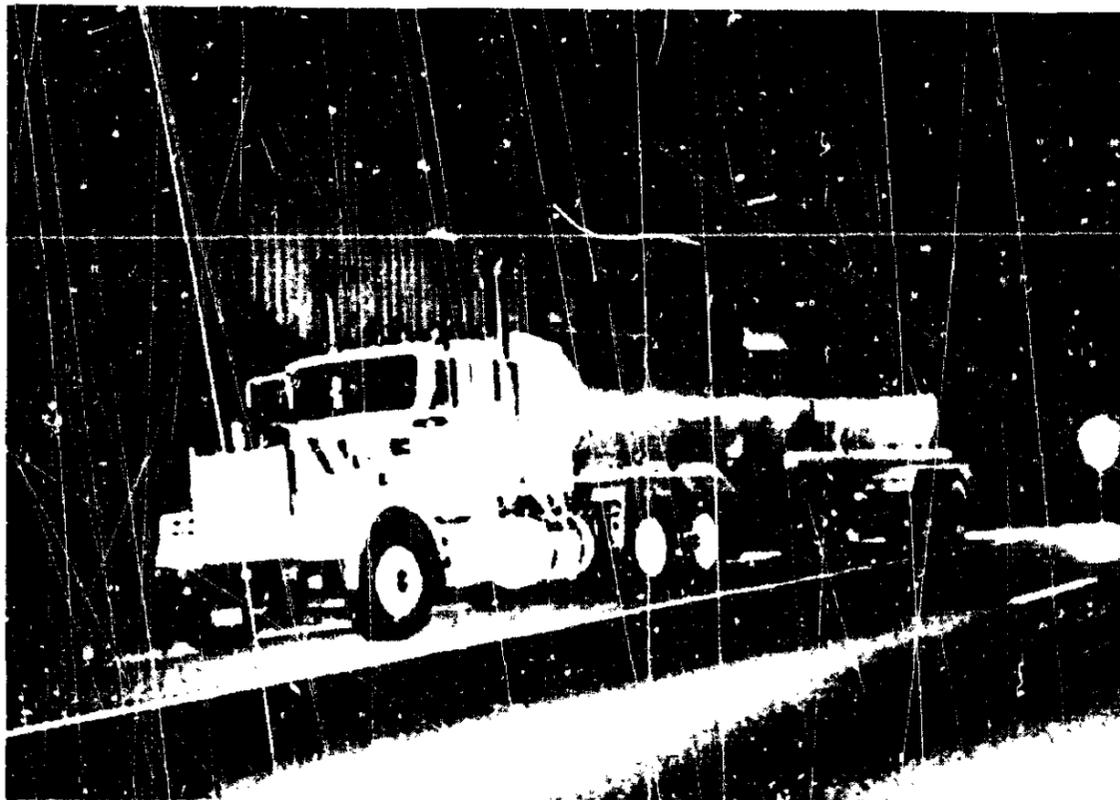
Figure 1.--Cargo tank on right shoulder of Washington, D.C., beltway in Fairfax County, Virginia.
